Re: Proposed development at 55 Edisford Road, Clitheroe, BB7 3LA

Thank you for your request for a bat survey.

We understand that the proposal is for a two-storey extension to the east elevation (replacing an existing garage) and the construction of a new garage to the west elevation (replacing an existing car port and timber storage building).

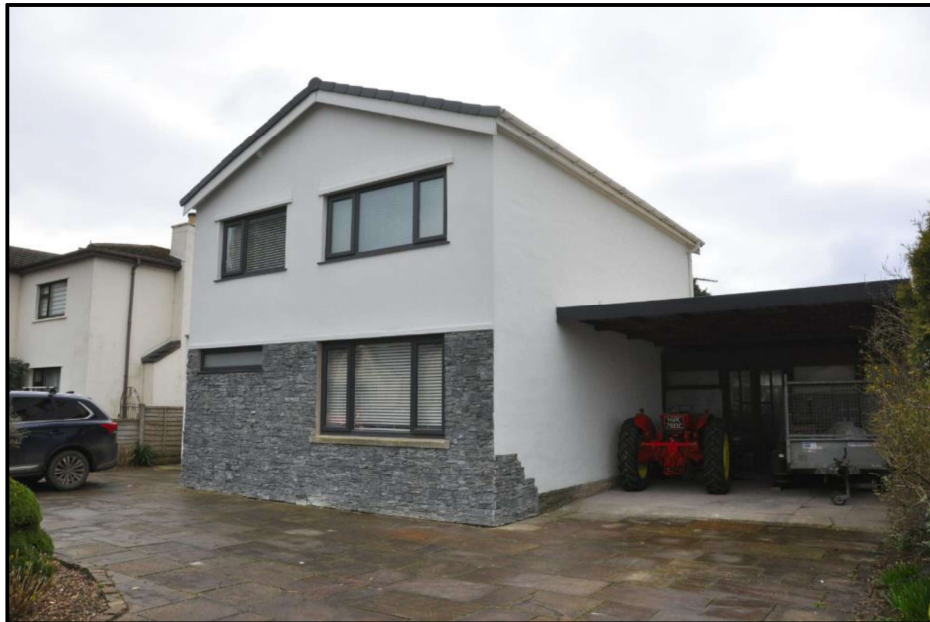
55 Edisford Road is a two storey, detached dwelling house, constructed of brick rendered walls with part stone cladding on the front (north elevation). There is a dual pitched roof covered with cement tiles and upvc windows, doors, soffits and verge covers along the roof edges.

Image showing north (front) elevation at 55 Edisford Road

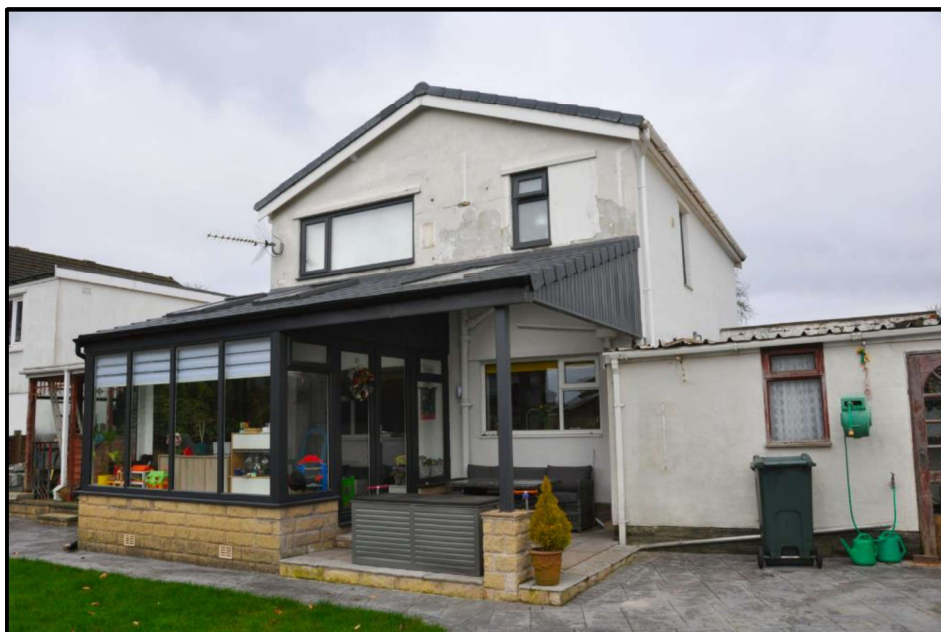
To the rear (south elevation) is a single storey conservatory and covered, outside seating area. To the east is an adjoining single garage and store room with a flat metal sheet roof and to the west is a car port and covering a timber framed storage building.

Image showing south (rear) elevation at 55 Edisford Road

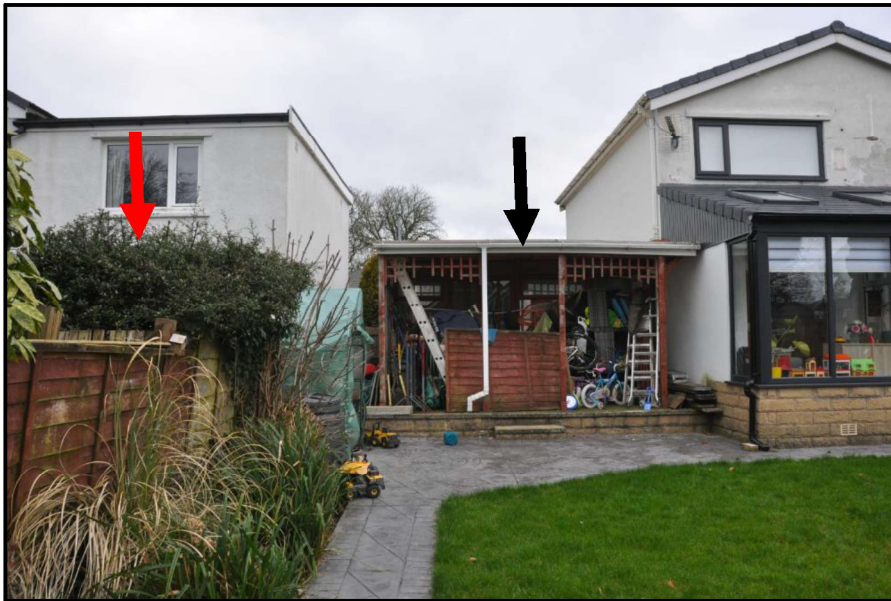
There is high potential for nesting birds to utilise the boundary trees and shrubs located in the neighbouring gardens to the immediate south and east during the nesting season (February to September). This vegetation is close enough to the proposed works for any nesting birds to be subject to disturbance.

Image showing rear garden with boundary vegetation (example of potential bird nesting area indicated by red arrow), car port and timber building (black arrow)

Protected species	Impacts, Issues & Rationale	Action Required
Nesting birds	<p>There are potential impacts (disturbance, damage and destruction) to nesting birds, nests and eggs as a result of the proposed works.</p> <p>It is advised that there is high potential for birds to be nesting within the adjacent garden vegetation during the bird nesting season (February to September).</p> <p>Under the Wildlife and Countryside Act 1981 (as amended), wild birds are protected from being killed, injured or captured, while their nests and eggs are protected from being damaged, destroyed or taken.</p> <p>There is no provision under the Wildlife and Countryside Act 1981 (as amended) for licensing the disturbance of nesting birds or the destruction of nests which are in use for the purpose of development.</p>	<p>Advice (mitigation): It is advised that the most appropriate way to address the risk to nesting birds is:</p> <p>Avoid disturbance to the building during the nesting season.</p> <p>Or</p> <p>If works cannot be delayed, the proposed work area should be carefully checked, immediately prior to works commencing. Checks should be carried out by a suitably experienced ecologist. If the risk of nesting birds remains, then monitoring for nesting bird activity should continue for the duration of works. Prior to any work commencing (checks) and throughout works in nesting season (monitoring).</p> <p>Advice (mitigation):</p> <p>If works are to be undertaken during the nesting season, all people working at the proposed development site should attend a toolbox talk delivered by an appropriately experienced person, to be made aware of the likelihood of encountering nesting birds and how to identify them, the legal protection of nesting birds and their own</p>

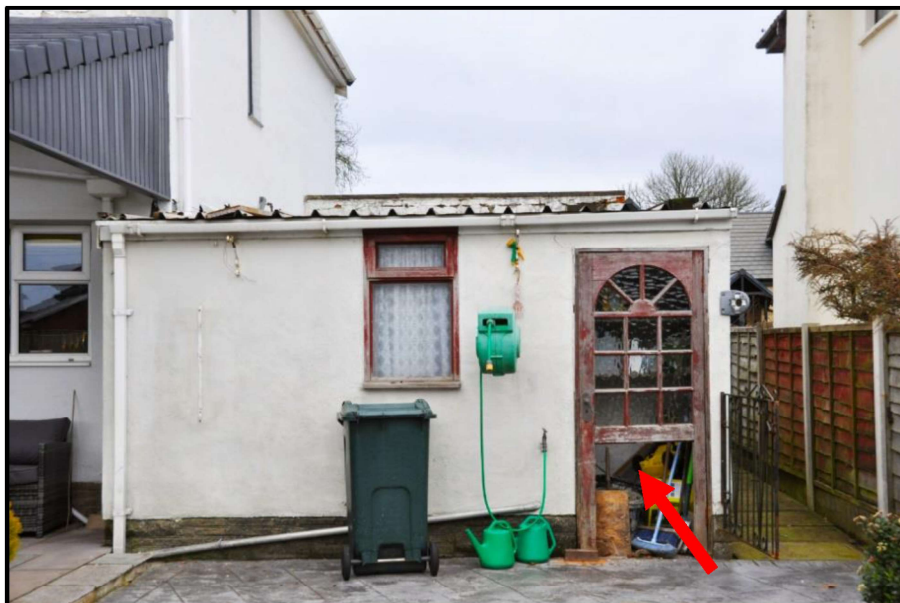
The part open storage room on the garage and ledges associated with the car port area are suitable to support nesting birds. Whilst it is recognised that both of these areas are likely to be in regular, daily use and that this may deter birds, there is still some risk of birds nesting during the breeding season (February to September).

Image of garage storage room, showing potential access for use by nesting birds (red arrow)

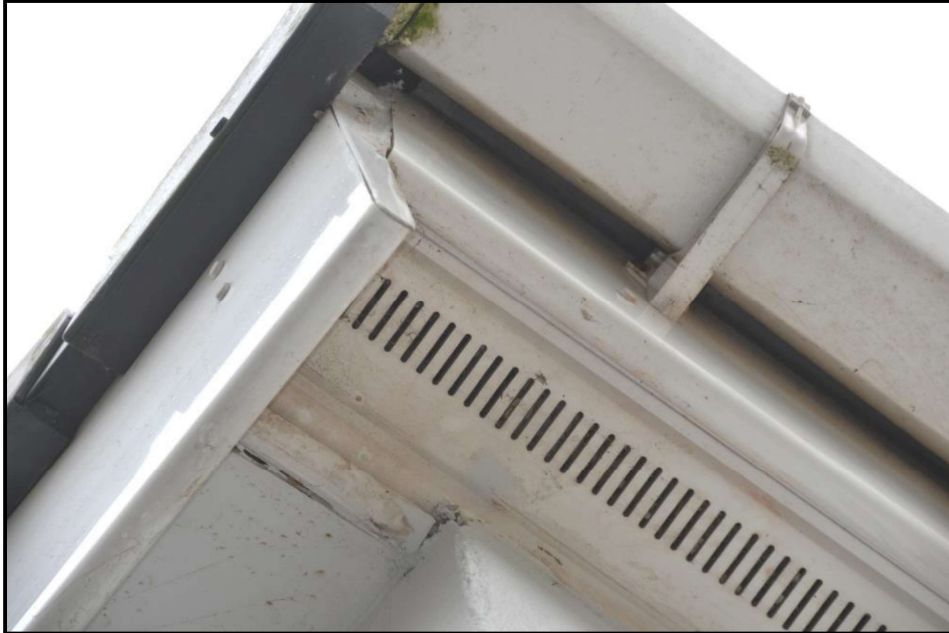
All external and internal features on the house, garage and car port, including the roof coverings are well sealed with no visible gaps that are suitable for use by bats.

Image showing example of sealed soffit with no potential access for use by birds or bats

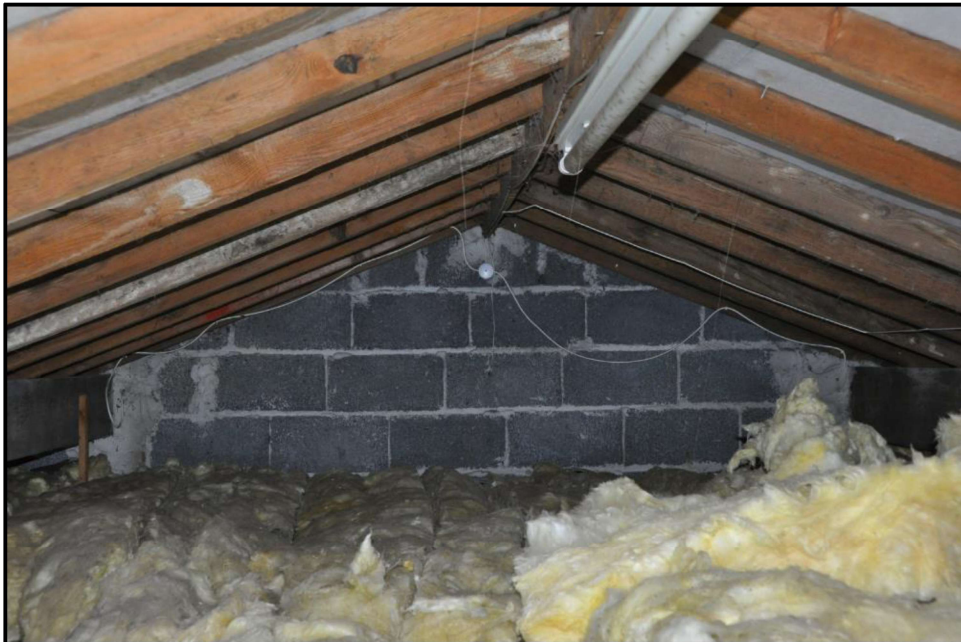
There is a single, shallow roof void above the house with timber roof supports, modern roof liner and rock wool insulation on the floor. There are no roof voids associated with the garage, car port or storage areas.

Image showing shallow roof void, no potential access points present

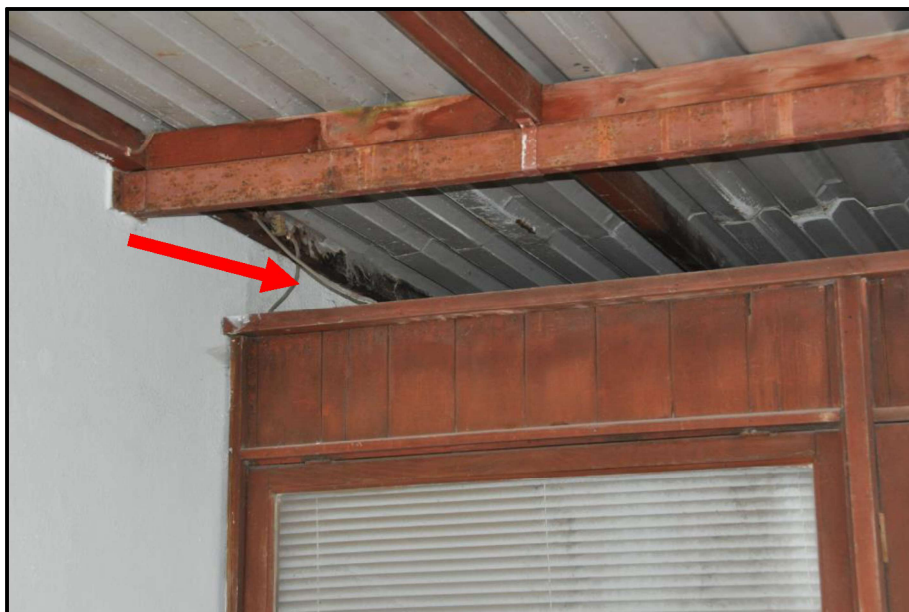
The car port has features (e.g. ledges) and the garage contains a part open storage room, both of which are suitable for use by nesting birds during the nesting season (February to September).

Low potential – the car port area has very low potential for use by night roosting bats; the potential is limited by landscape context and extent of artificial lighting

Image showing potential bird nesting area associated with car port and timber building

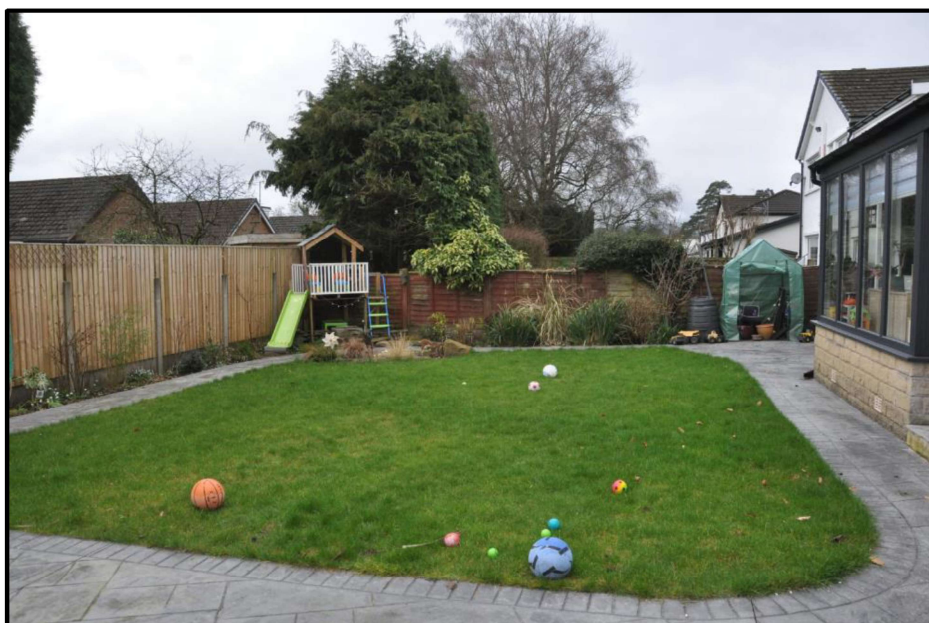
Image showing well maintained rear garden. Neighbouring trees and shrubs along the boundaries have potential to support nesting birds during the breeding season (February to September)
