**BAT SURVEY AT -
OVERDALE
YORK LANE
LANGHO
BB6 8DT**

Update emergence survey- 6th April 2023 7.30pm

REFERENCE NO. 6767

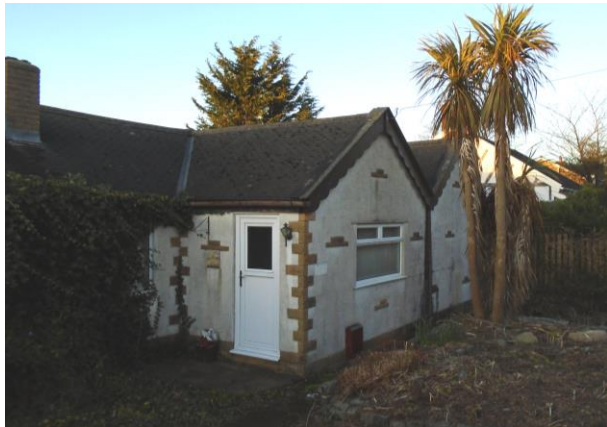
Front South elevation April 2023

A single storey detached prefabricated bungalow with a garden to the front and rear landscaped gardens, hardstanding driveway and rear patio. Possibly dating from the 1950's/60's

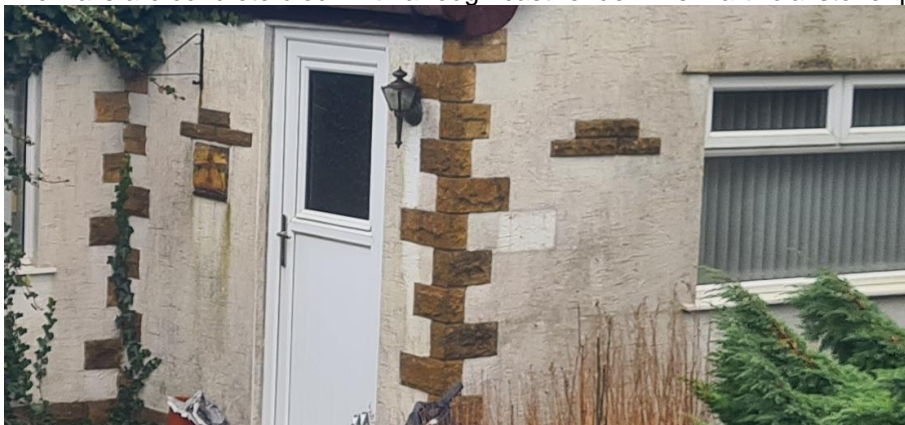
The walls are concrete block with a rough cast render finish. artificial stone quoins.

The walls whilst in aged condition have no cracks or crevices in the render finish, there are no access points.

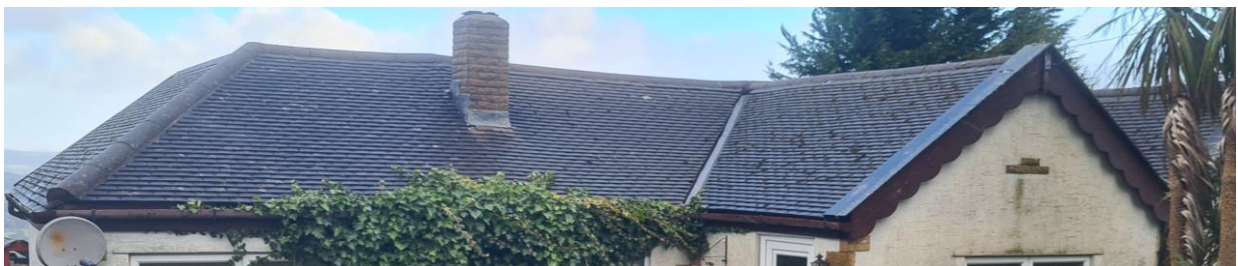
The roof construction is pitched, gabled and hipped with a tile finish with timber barge boards, fascia's and soffits.

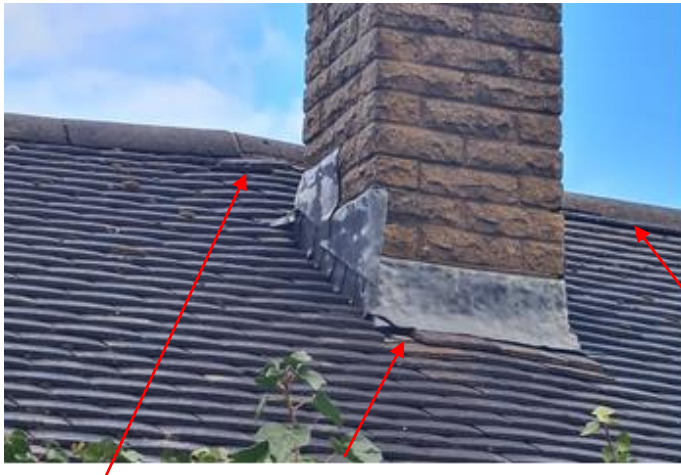
The roof tiles are in reasonable condition with no significant breaches, the exception being

The top tiles which have a marginal gap and a slipped tile adjacent to the chimney (see below)

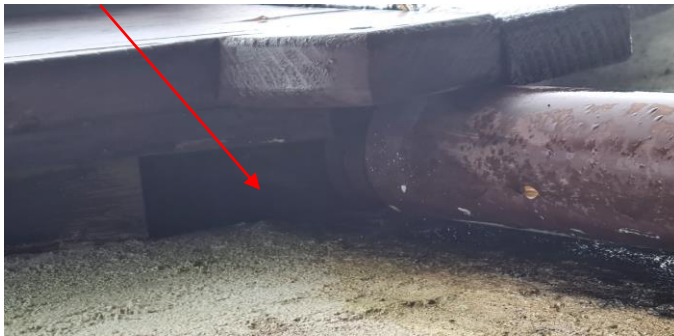
Further gaps were noted in the soffit at the valley abutment of the two adjacent gables to the front elevation

The gaps in the soffits and the roof abutments could be examined with the endoscope the results were negative and there were no signs of grease marks or staining surrounding the openings.

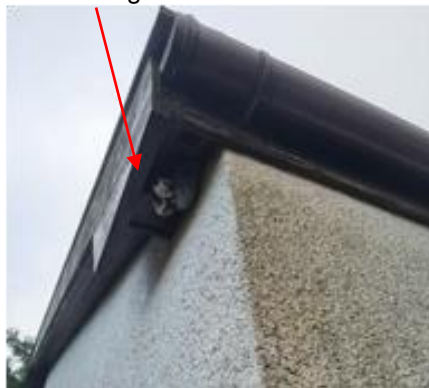
The rear right hand corner of the left hand rear outshot. (the gap had been plugged with a cloth)

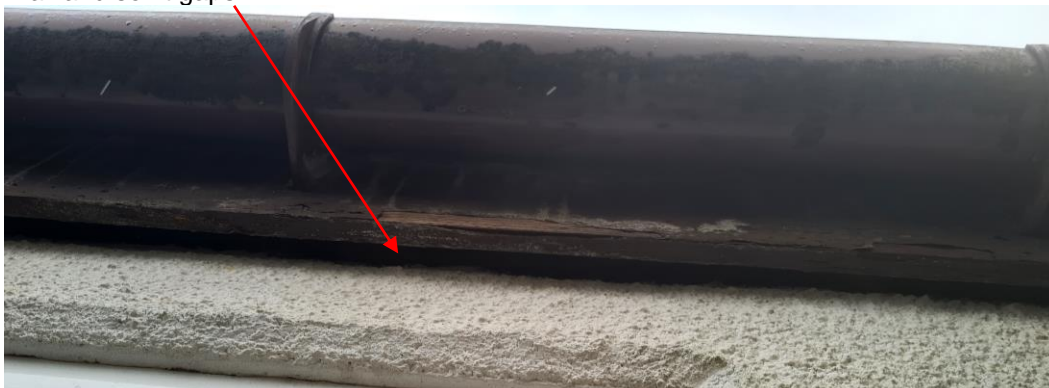
Wall and soffit gaps

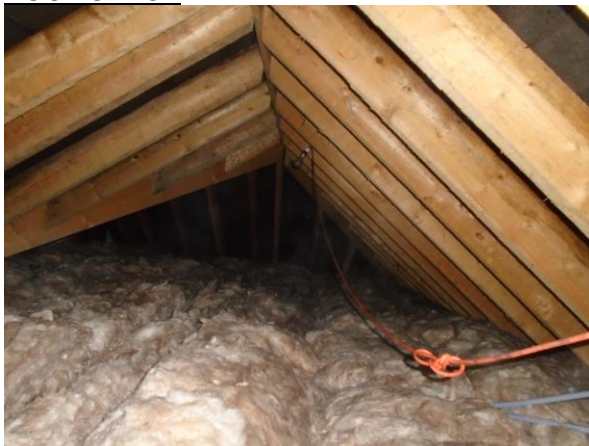
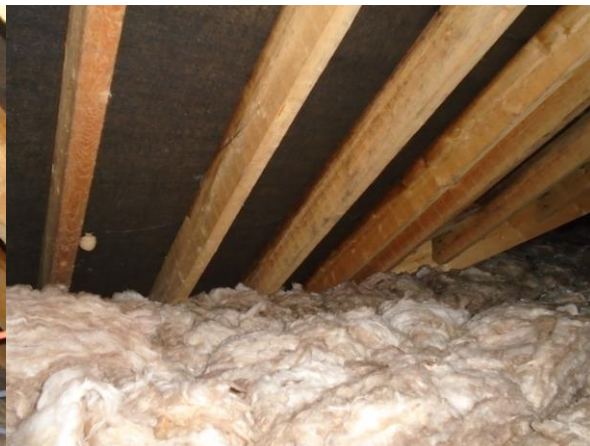
ROOF SPACE

The roof space is a timber rafter structure with felt and insulation quilt. The timbers and felt are in excellent condition and the quilt is clean and free from any dropping or insect remains (feeding evidence) The space did not provide any high value roost potential for bats and evidence of current or historic use was not evident.
