**BAT SURVEY AT -  
OVERDALE  
YORK LANE  
LANGHO  
BB6 8DT**

**DATE AND TIME OF VISIT  
31<sup>ST</sup> Jan 2023 9.00am**

**REFERENCE NO. 6767**

A single storey detached currently uninhabited prefabricated bungalow with a garden to the front and rear landscaped gardens, hardstanding driveway and rear patio. Possibly dating from the 1950's/60's

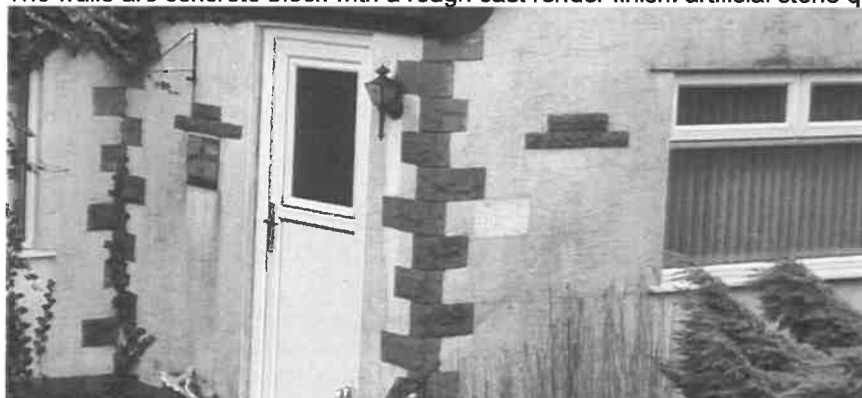
The walls are concrete block with a rough cast render finish. artificial stone quoins.

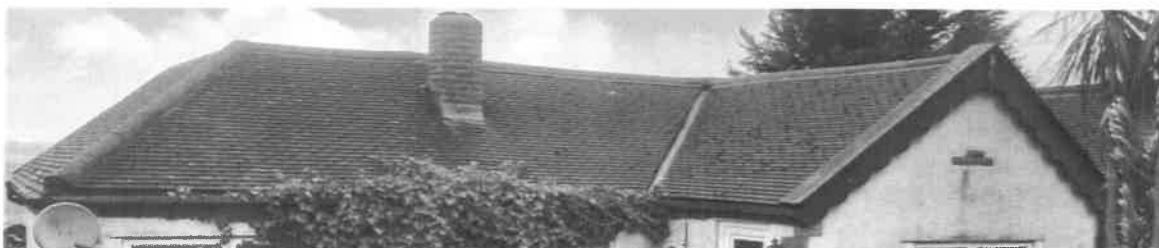
The roof construction is pitched, gabled and hipped with a tile finish with timber barge boards, fascia's and soffits.

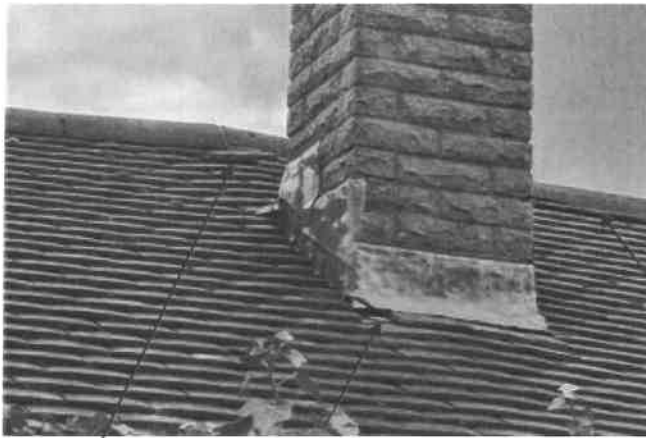
The roof tiles are in reasonable condition with no significant breaches, the exception being the top tiles which have a marginal gap and a slipped tile adjacent to the chimney ( see below)

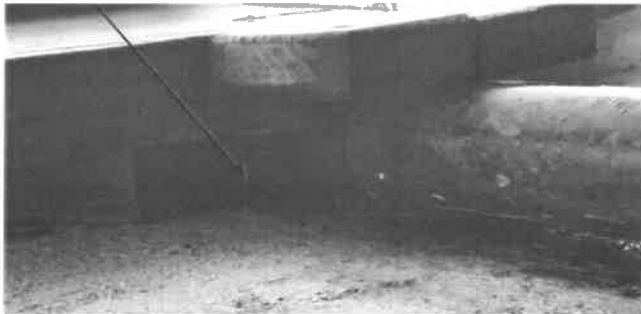
Further gaps were noted in the soffit at the valley abutment of the two adjacent gables to the front elevation

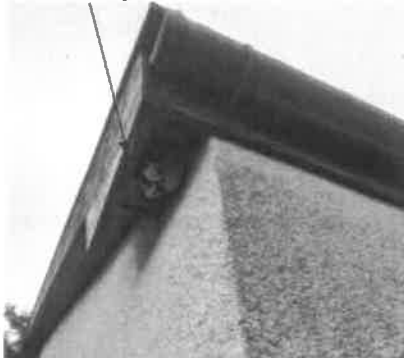
The rear right hand corner of the left hand rear outshot. (the gap had been plugged with a cloth)

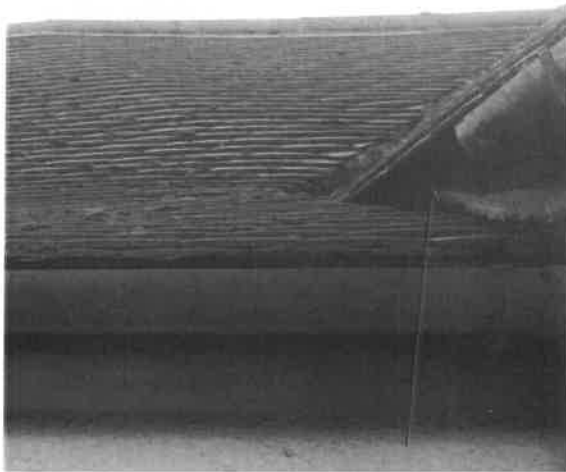
Gaps in flashing at outshot roof abutments with main roof.

The gaps in the soffits and the roof abutments could be examined with the endoscope the results were negative and there were no signs of grease marks or staining surrounding the openings.
