**BAT SURVEY AT -**  
BENT HOUSE FARM  
LONGTONS LANE  
TOSSIDE

DATE AND TIME OF VISIT  
16<sup>TH</sup> Dec 2022, 2.30pm

REFERENCE NO. 6681

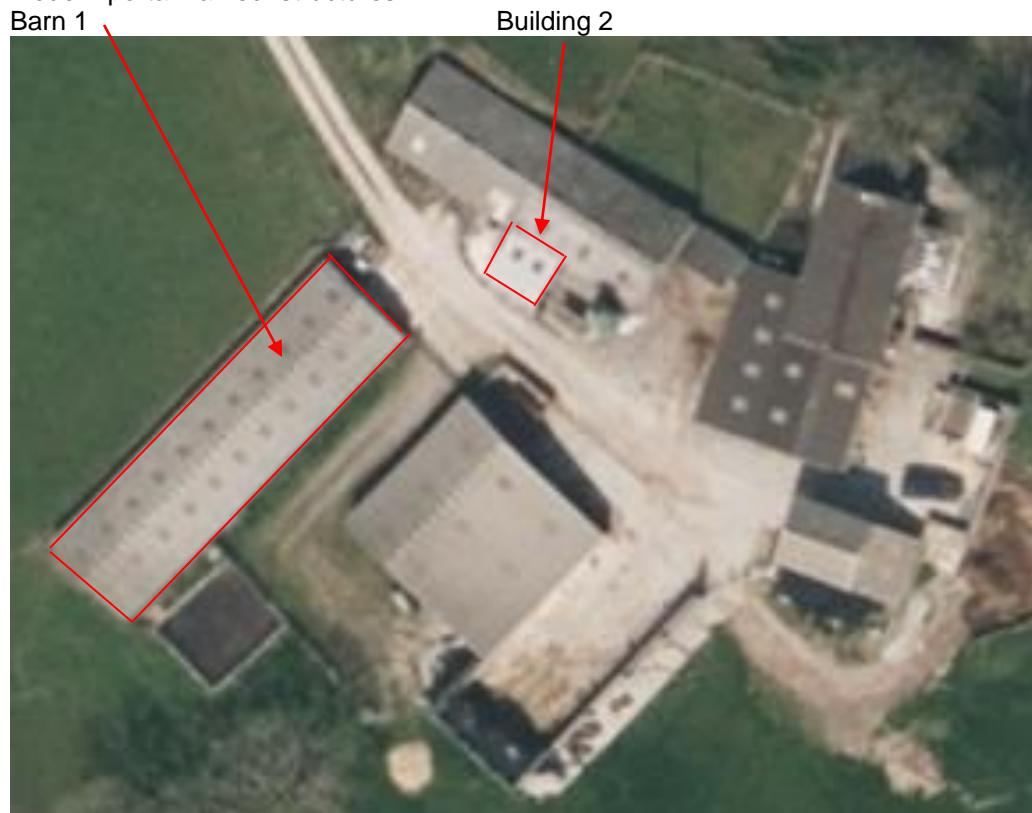
The 2 no agricultural buildings ( indicated below) which form part of this application are part of a working Farmstead comprising of a farmhouse and 6no barns of traditional stone construction and modern portal framed structures.

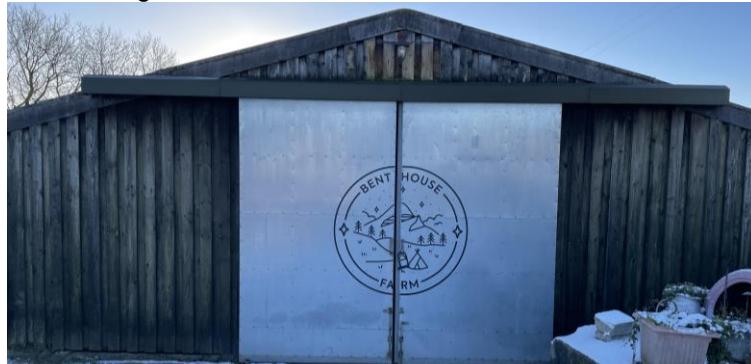
North east gable elevation

A large modern steel portal frame detached building located on the north west edge of the farmstead. The building maintains its agricultural appearance and will remain unchanged.

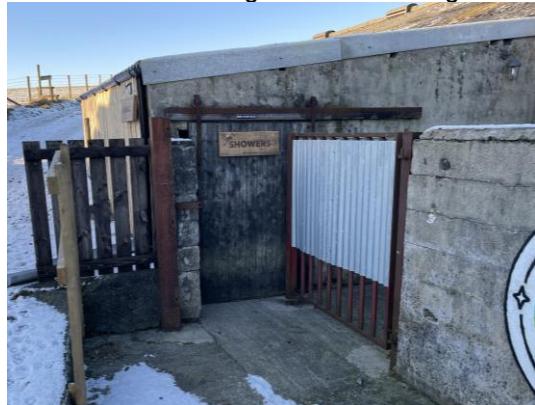
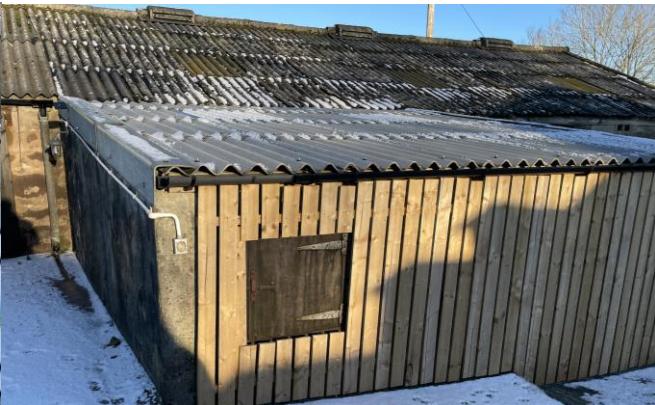
South east elevation

This building is a modern concrete block addition (lean to) to an original traditional stone barn. With the exception of the recent addition of the timber cladding the building has not been altered from when it functioned as an agricultural building and will have no further alterations.

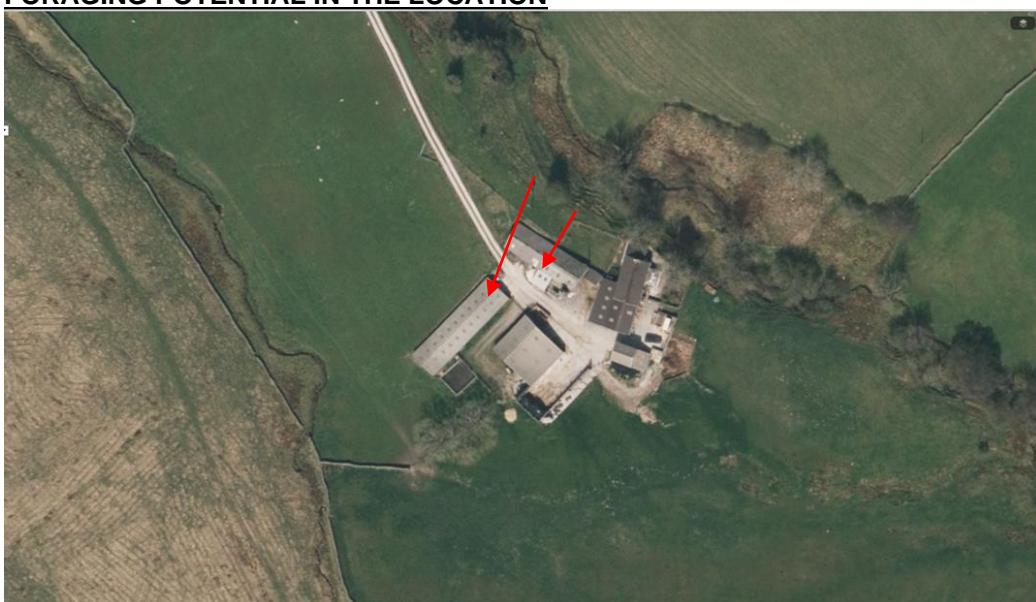
## **FORAGING POTENTIAL IN THE LOCATION**

The farm and its buildings are surrounded by rough large acreage pasture land in an exposed high altitude location. The area is generally considered to have sub optimal forage habitat, the nearest group of trees being approx. 48m to the north east which line Holden brook. This line of trees continue in a south easterly direction descending in elevation.

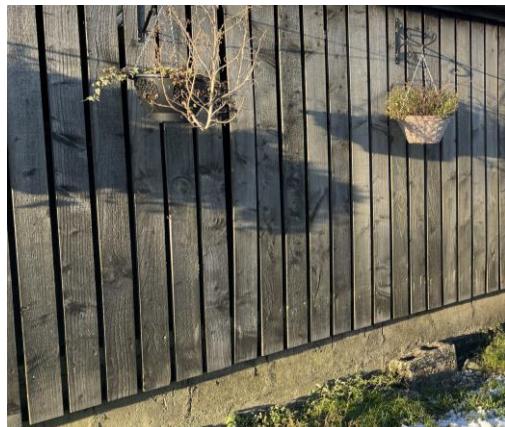
Barn 1 - the walls are timber boarded with a rendered concrete block base wall internally to the side elevations.

Barn 1 – the Yorkshire boarded walls are in good condition with no rot present. There were no voids behind the boards, access to the interior was not possible via the walls, nor were any cracks or crevices evident with the potential to provide roost habitat.

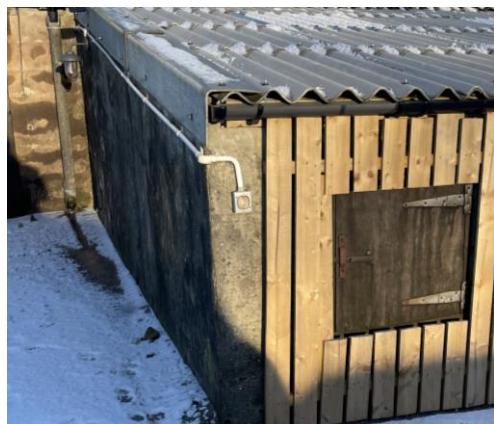
Building 2 – the walls are concrete block with a render finish the south west elevation has a decorative timber boarded finish.

Building 2 – the block walls had some holes at high level in the south east elevation, close inspection with an endoscope did not reveal any current or historic use by bats. The boarding detail fixed to the south west elevation is relatively new, there are voids behind however no bats are present.

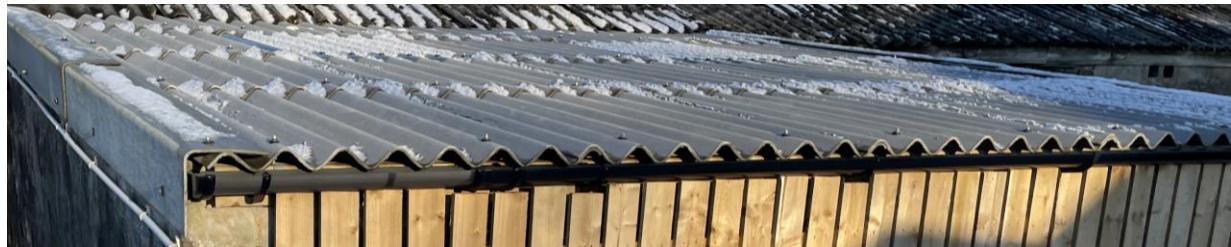
The lean to roof is corrugated fibre cement with proprietary trims to the sides. upvc gutters at the eaves on brackets.

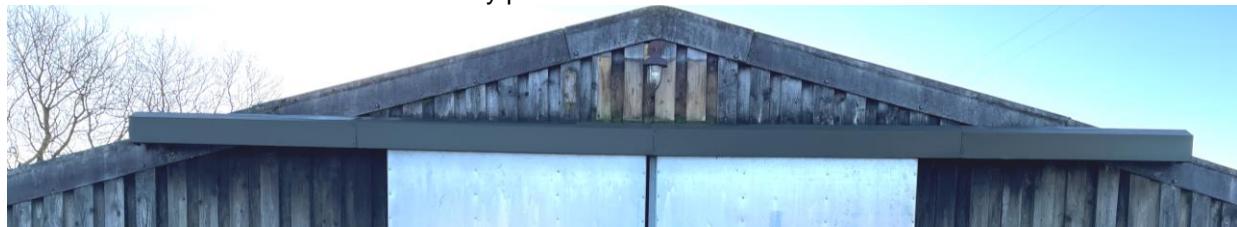
Barn -1 The gaps at the eaves formed by the corrugations allow access to the interior. The sheets are in excellent condition and do not form any potential bat roost crevices.

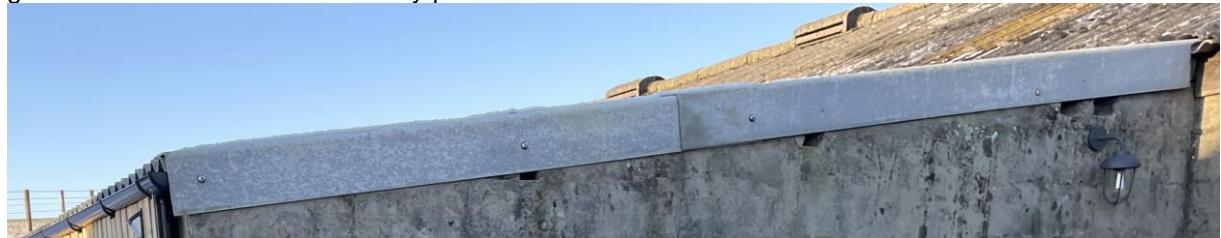
Building 2- The roof as before has gaps at the eaves allowing access, the sheets however are in good condition and do not form any potential bat roost crevices.

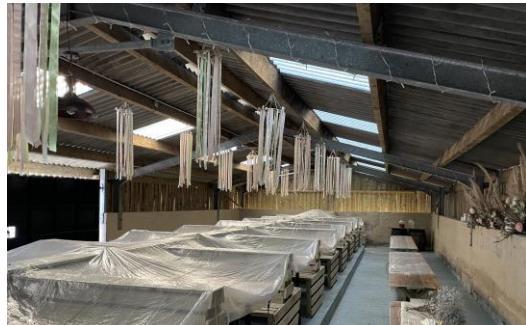
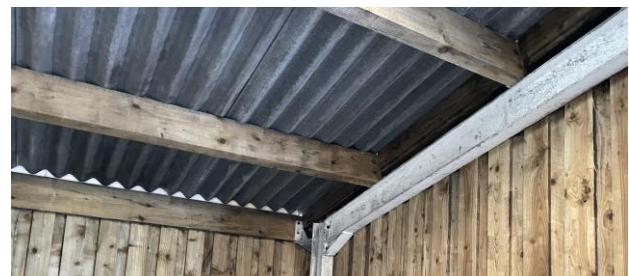
Barn 1- There is no enclosed roof space the steel portal frame timber purlins and underside of the sheets are fully visible. All the structure is in good condition and does not provide any potential roost habitat for bats.

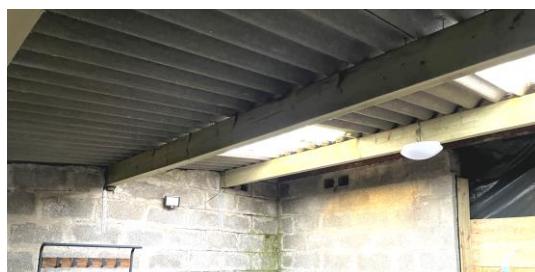
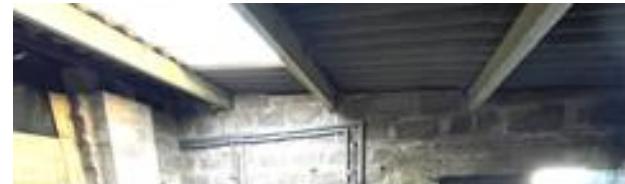
Building 2- There was no enclosed roof space the timber purlins and roof sheets were fully visible. All the structure is in good condition and does not have any cracks or crevices with the potential to provide roost habitat for bats.

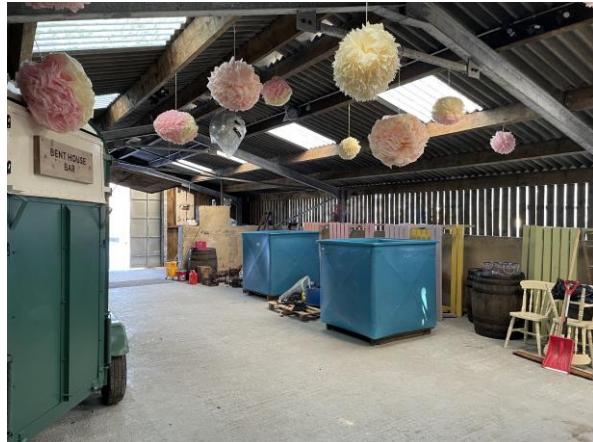
Barn 1

The interior of the buildings were closely examined for any of the above evidence the spaces were clean and the result was negative . The interiors did not provide any high value roost habitat nor forage potential. Both buildings have not been altered from their original form with the exception of the shower heads which have been installed in Building 2.
