The Black Horse Inn, Pimlico  
Historic Building Survey

January 2023

An archaeological building survey was required prior to the refurbishment of The Black Horse Inn, Pimlico. The work was carried out by Steven Price of The Archaeology Co.

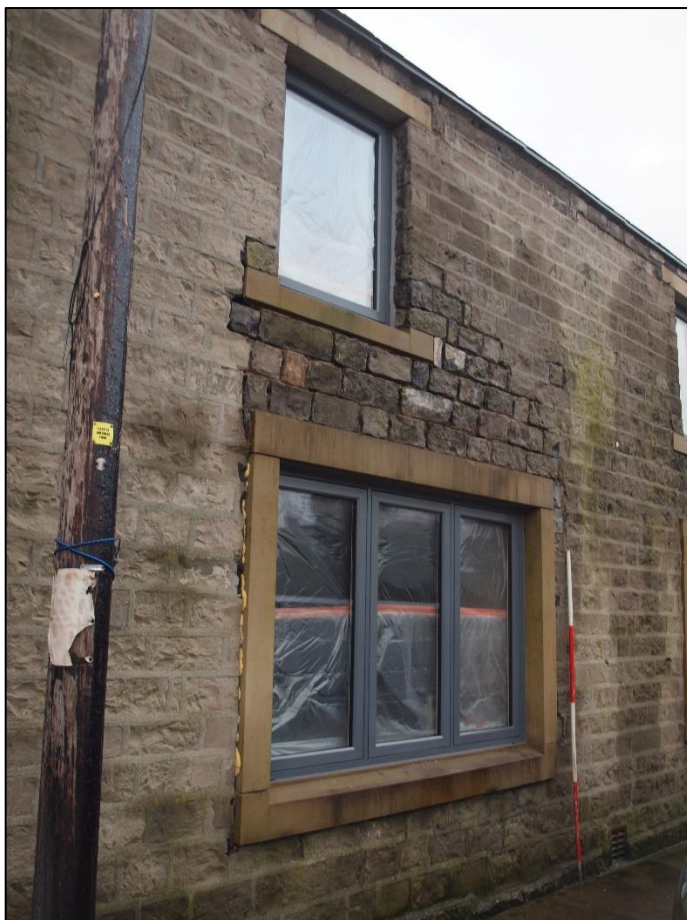
Plate 6: Rebuilding between ground and first floor windows

- 6.2 West elevation (Plates 1 - 7). This forms the main frontage of the building and is three bays wide. The central bay contains the main entrance to the building. This is a personnel doorway with timber panelled door hung and simple light over. The surround is sandstone square columns to either side with fluted capitals. A sandstone lintel lies over with simple dog-tooth detailing to the underside. Flanking the doorway are a pair of tall, narrow portrait windows. The surrounds are sandstone and the windows themselves are modern uPVC. Bays 1 and 3 each contain a large landscape window at ground floor level with sandstone surround. uPVC frames are present of 8 lights in a sash appearance and both show evidence of having been inserted. At first floor level each of the three bays contains a portrait window with sandstone cill and lintel. Modern frames are again present. Those to bays 1 and 3 show rebuilding between the cill and the lintels of the windows below, suggesting they may have been altered. The window to bay 2 lies slightly north of centre, rather than directly above the doorway. To the south of the face is where part of the elevation has been demolished. Set back from the main elevation, the cellar door is still present. This has a sandstone surround and the visible basement walls are of rough rubble occasionally brought to course.

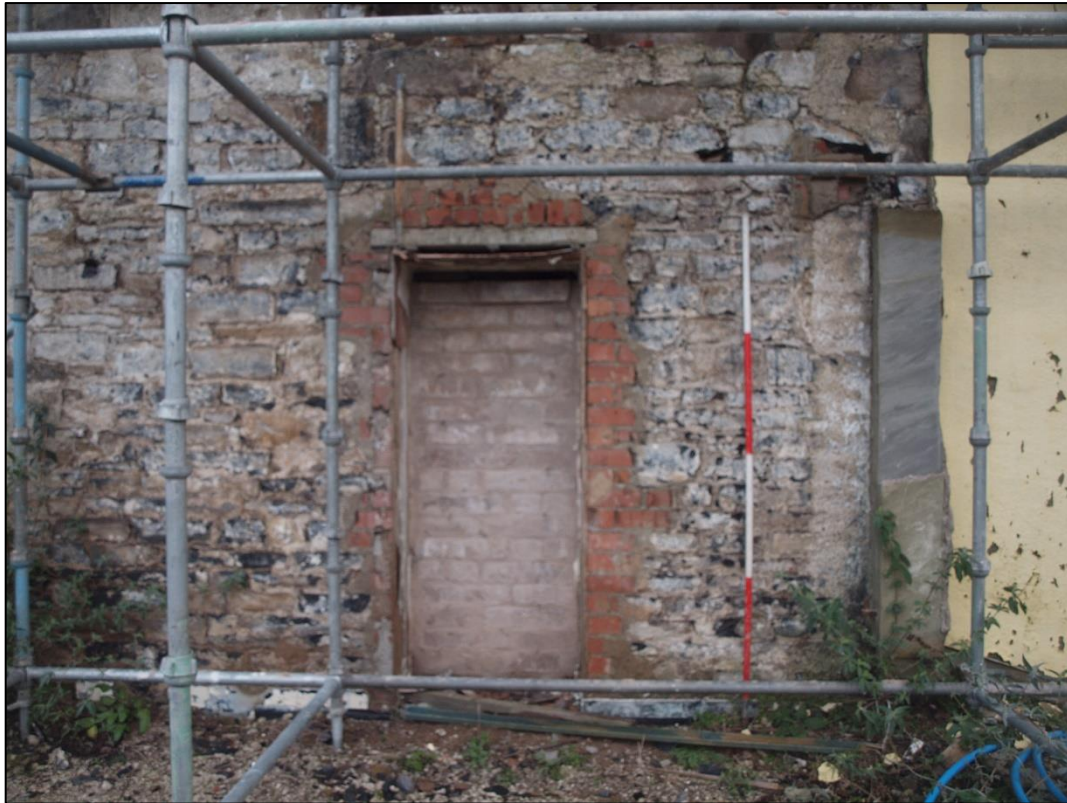
Plate 9: Ground floor of gable showing inserted and then blocked doorway

blocked personnel doorway roughly in the centre. This has been inserted, shown by the brick around the doorway. Above, at first floor level and slightly to the right, is a further blocked doorway, also inserted. Bay 3 retains the cement render and is featureless.

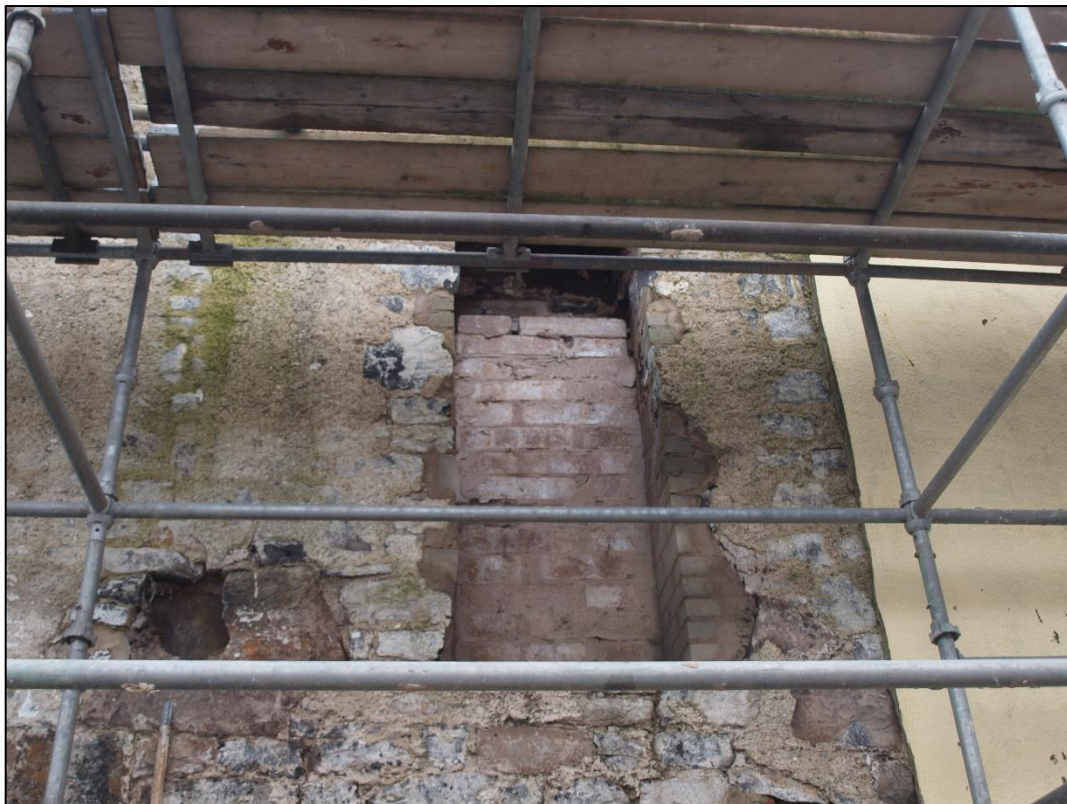
Plate 10: First floor inserted and blocked doorway

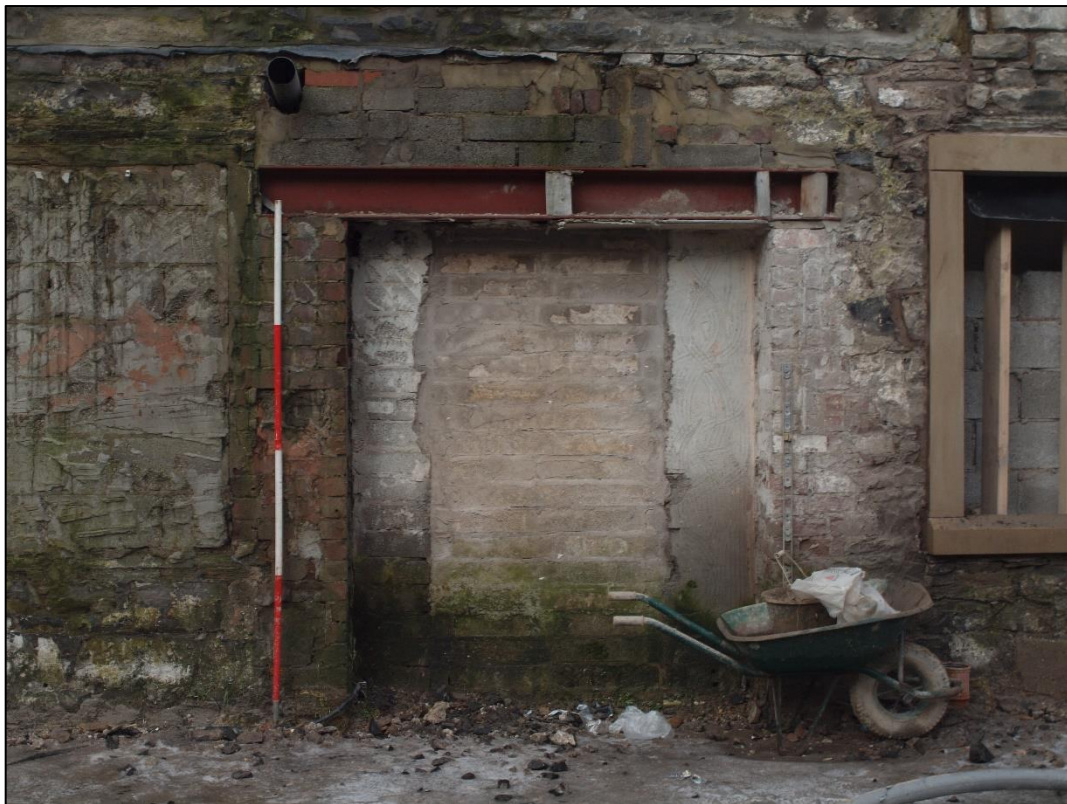
Plate 20: Inserted and blocked loading bay opening with blocked personnel doorway within it

- 6.4 East elevation (Plates 12 - 22) This forms the rear elevation of the building and is constructed in shaped sandstone occasionally brough to course. The three bay structure seen on the front elevation is not apparent here at ground floor level, but is at first. Here bays 1 and 3 each contain a square window with modern uPVC frame and sandstone surround. Adjacent to them, towards the centre, is a matching portrait window. Bay 2 contains a single square window, matching those in bays 1 and 3. At ground floor level, to the south side, a further matching square window is present, set south of the windows above. To the north a personnel doorway lies between the first floor windows bay 1 and 2, with a painted sandstone surround. A timber door is hung with a single light over. Directly below the central first floor window to bay 2 is a blocked window with rough sandstone cill and lintel. This lies adjacent to a large inserted loading bay opening to the north. This has an RSJ lintel with brick jambs. The opening has been blocked with brick and a personnel doorway within this has also been blocked. At the northern end of the face is a further modern square window below the matching window above, this has been blocked internally. Finally, to the north of this is a small window blocked with stone. The whole of the ground floor shows traces of whitewash.

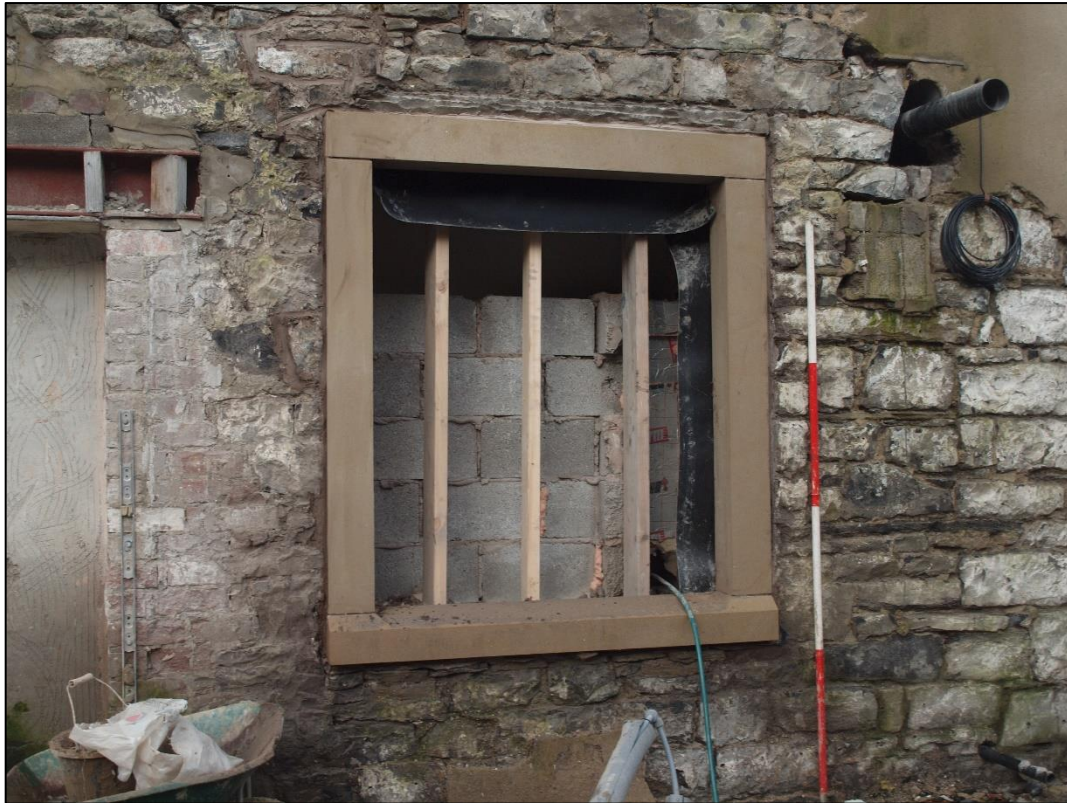
Plate 21: Ground floor window showing internal blocking

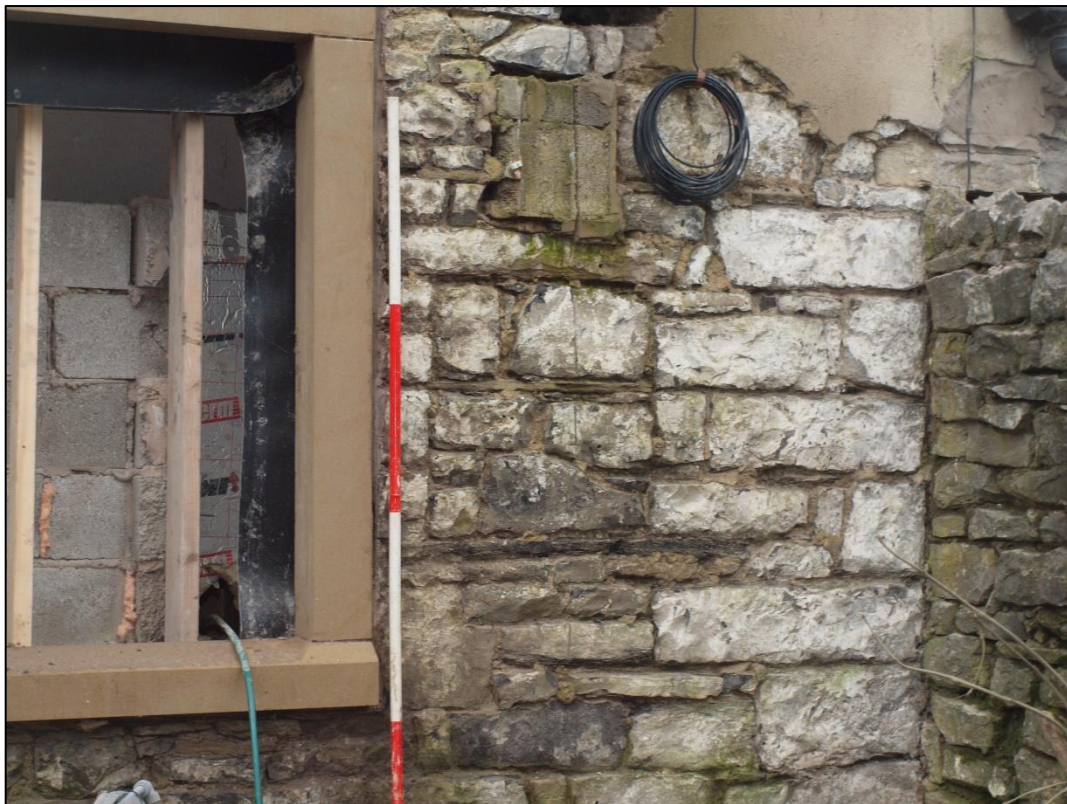
Plate 22: Small blocked window at north end of elevation, blocked with stone

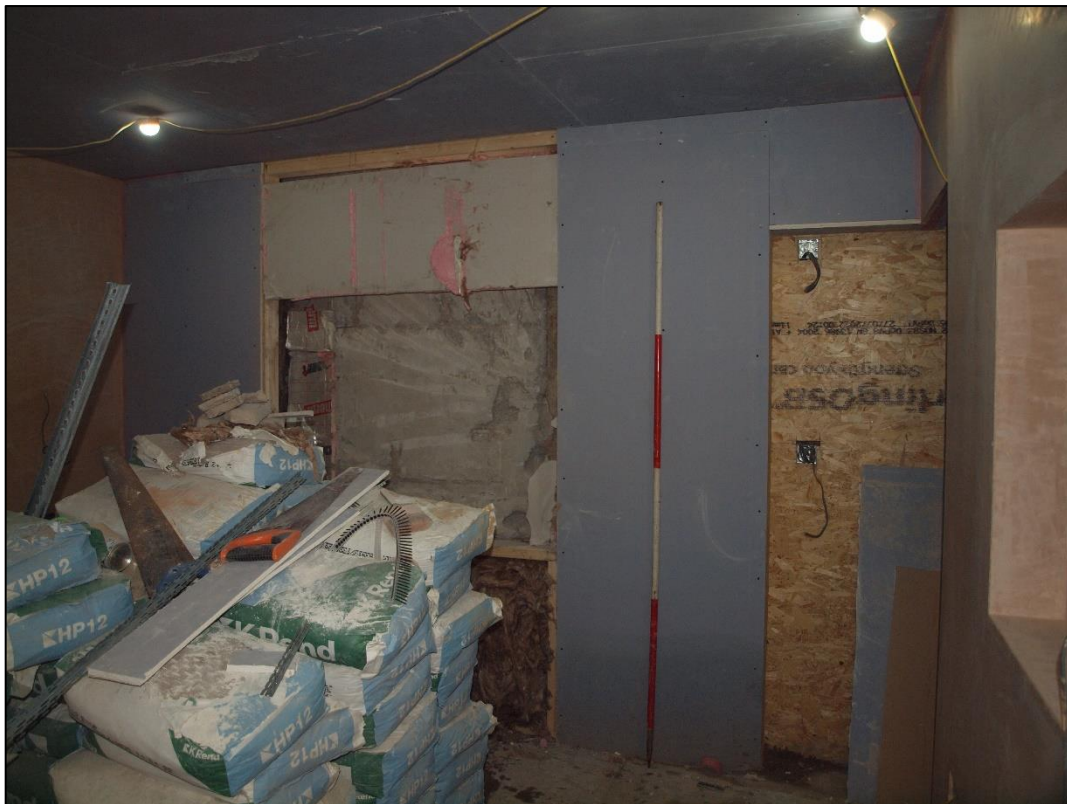
Plate 26: Northern room eastern end showing blocked openings

- 6.5 The front entrance leads into a small lobby area (plate 23) with doorways to the left and right and a window in the wall directly opposite. The doorway to the north leads to a large open room with plasterboarded walls and ceiling and plywood floor (plates 24 & 25). The wall to the south contains a blocked opening and to the east a doorway leads to a further room (plates 26 & 27). This has likewise been plasterboarded, although here the blocked window and adjacent blocked loading doorway are visible. A further doorway in the east end

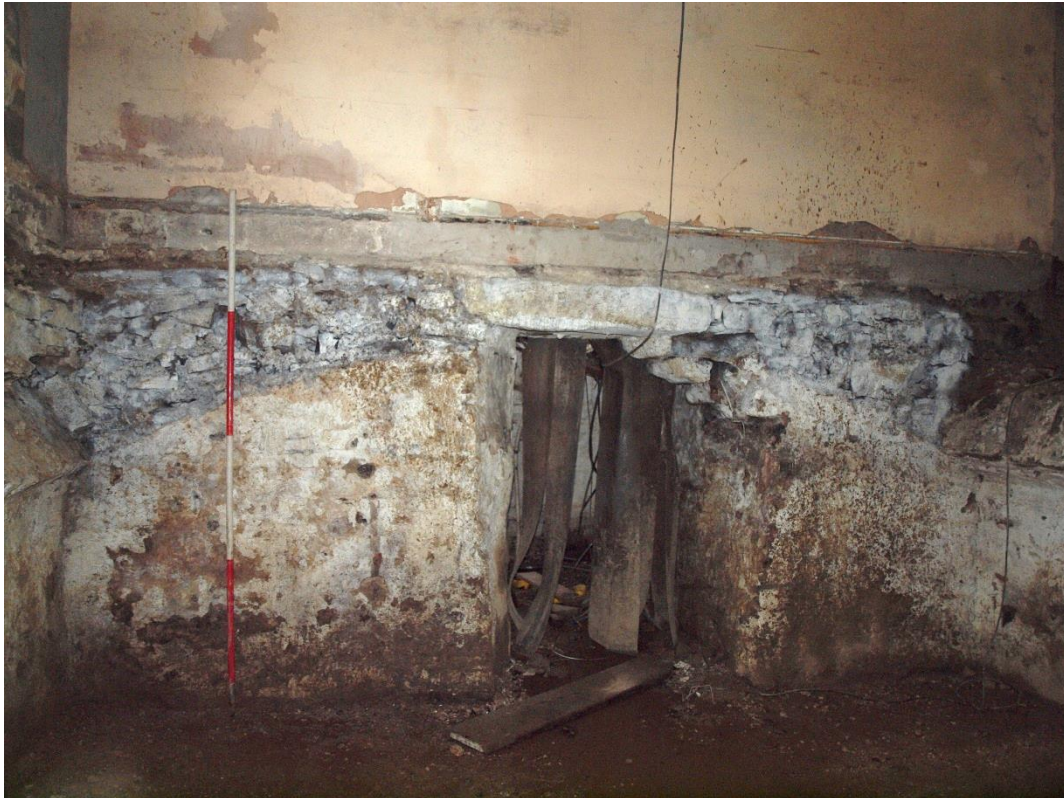
Plate 35: Southern wall of cellar showing doorway and scar of former arch with scar of removed ground floor level above

- 6.6 The cellar (plates 34 – 41) is accessed via the stone steps and leads into a small corridor area. The remains of a stone thrall lie at the bottom of the steps, the stone uprights only remaining. From here a doorway led to the south and into the main cellar room (plates 34 – 38). A scar is visible in the south wall showing the former arched vault ceiling and the raised ground floor level in this area to accommodate it. The walls are all stone and whitewashed throughout, and a doorway lies in the southern wall. This leads to a small L-shaped passage which bends to the west to enter a further small room (plates 39 – 41). This has an arched ceiling, although it has been truncated and topped with concrete slabs. A wide loading door lies in the west elevation to the exterior.

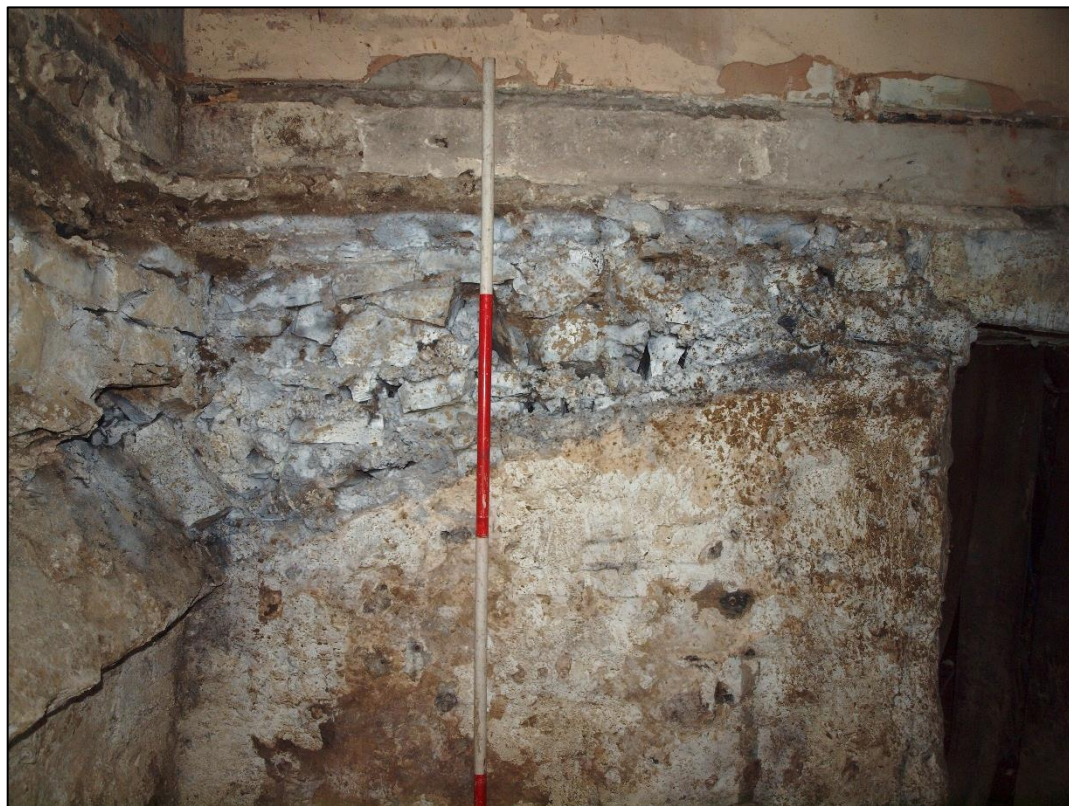
Plate 36: Detail of scars shown above
