## **Method Statement - European Protected Species (Bats)**

### **Reasonable Avoidance and Mitigation Measures**

**2 Walled Garden,  
Woodfold Park,  
Mellor,  
BB2 7QA**

**22.02.2023**

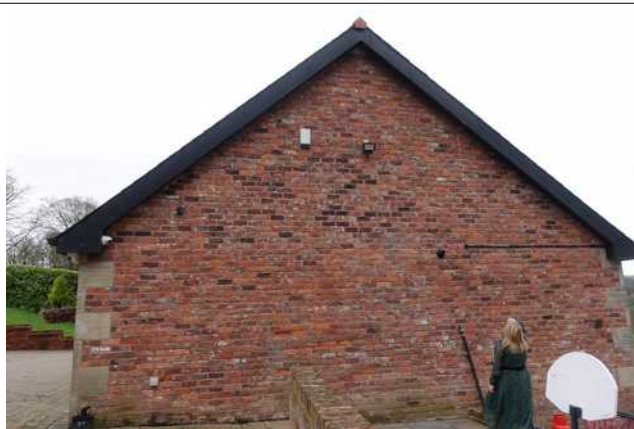
Western gable end

Gaps were present at the apex of both the eastern and western gable ends allowing access to the wall tops.

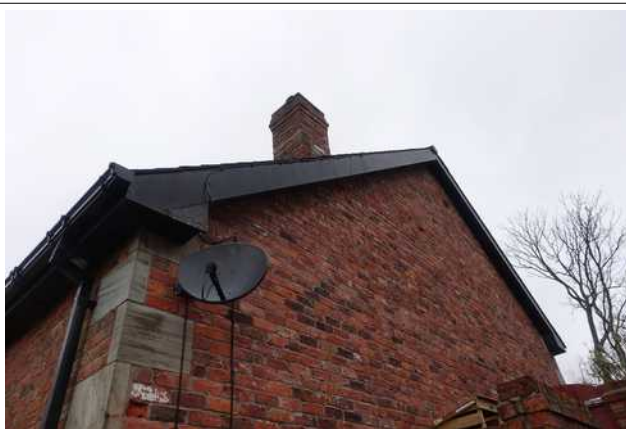
Eastern gable end

Inspection of the eastern gable within the loft revealed pipistrelle droppings overspilling from the wall top to the interior.

Droppings were consistent with a maternity roost of pipistrelle bats being present within the gable cavity walls.

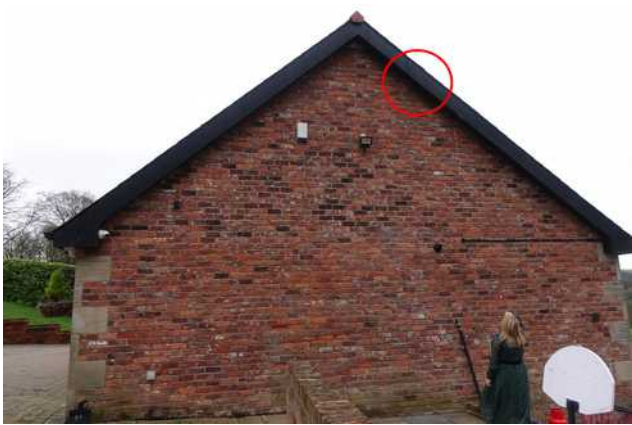
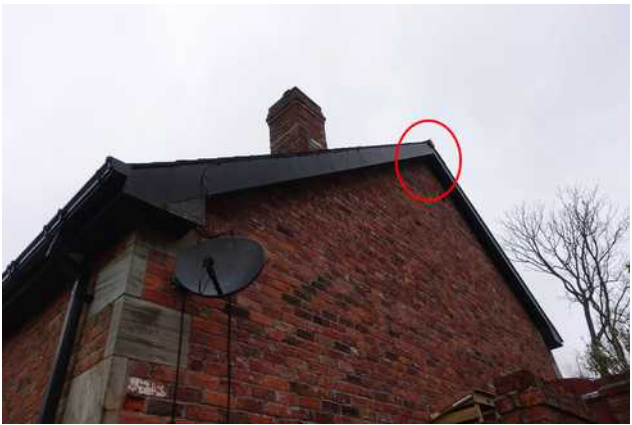
| <i>Location of roost entrance on western gable</i> | <i>Location of roost entrance on eastern gable</i> |

A small pipistrelle maternity roost was observed using the eastern and western gable of the existing building with roost entrances located high on the apex of the gable ends.

Scaffolding should avoid areas of the western and eastern gable ends identified as roost entrances to ensure flighlines remain undisturbed.
