BAT SURVEY AT -
7-9 King street
Clitheroe

DATE AND TIME OF VISIT
4th April 2023 2.00pm

REFERENCE NO. 6726

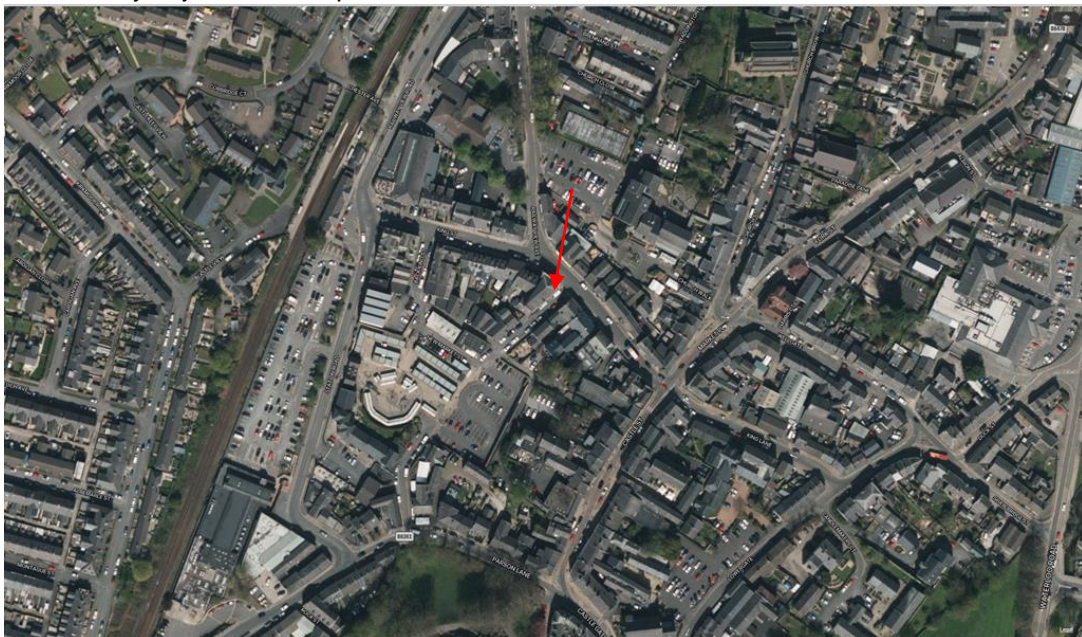
LOCATION SD742419 elevation

The shop is located in the centre of Clitheroe at the junction of Market street and King street immediately adjacent to the pavement .

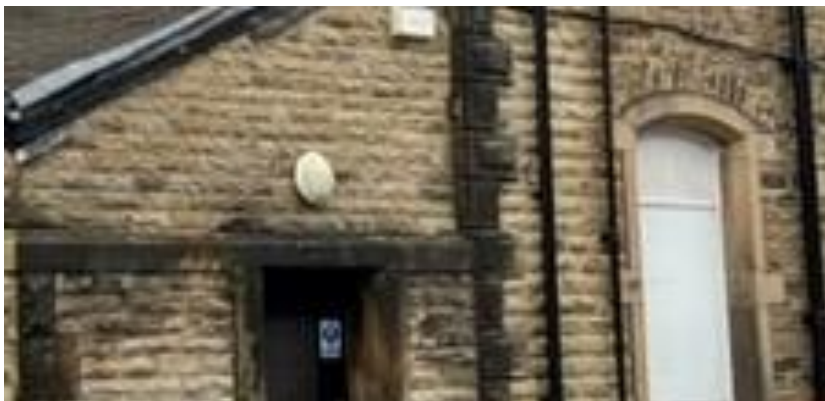
The walls are natural coursed stone.

No access points, cracks or crevices are present in the walls.

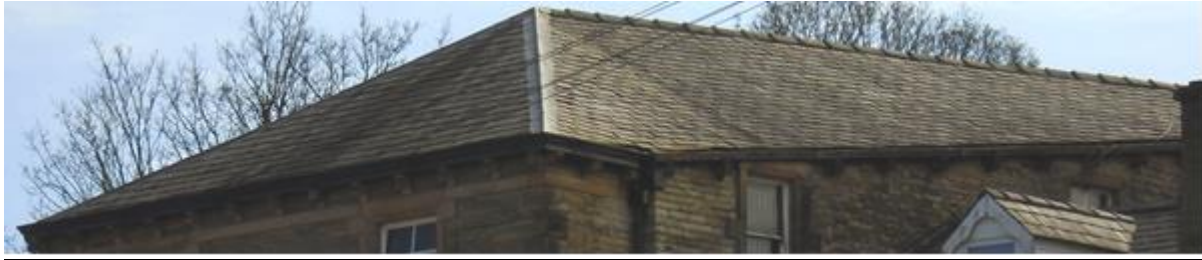
The main roof is a tapering pitch with the front elevation being hipped. Blue slate finish with hip and ridge tiles. Large cast iron gutters are present to the eaves.

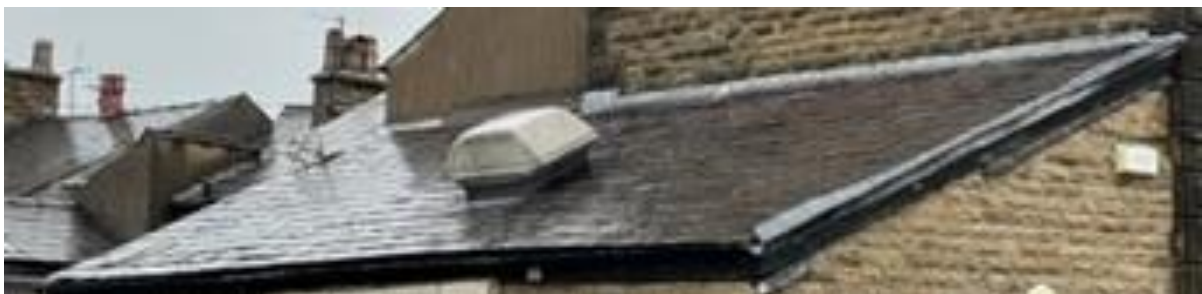
Lean to roof has a slate finish, lead flashed to the main wall. Timber flush fitting fascia and barge board is present.

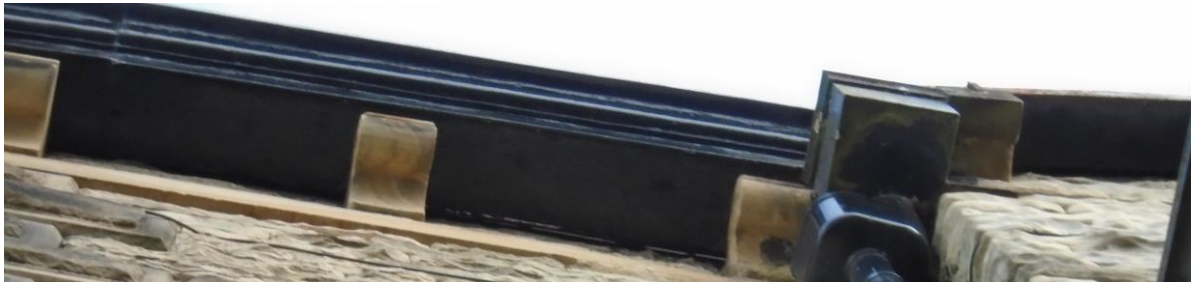
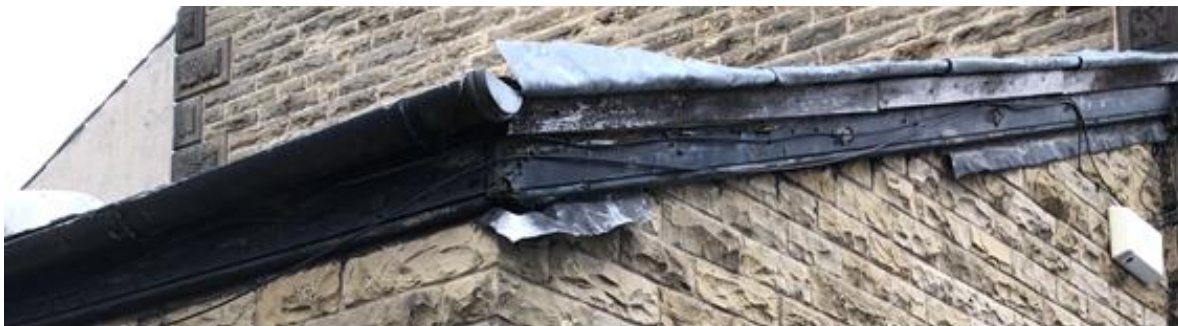
The main roof was viewed from ground level with the aid of binoculars. The slates were all tight fitting, the ridge and hip tiles were in reasonable condition with no visible access points. The gutters were very tight fitting, the stone plinth below the gutter was examined for any dropping or staining evidence, the result was negative.

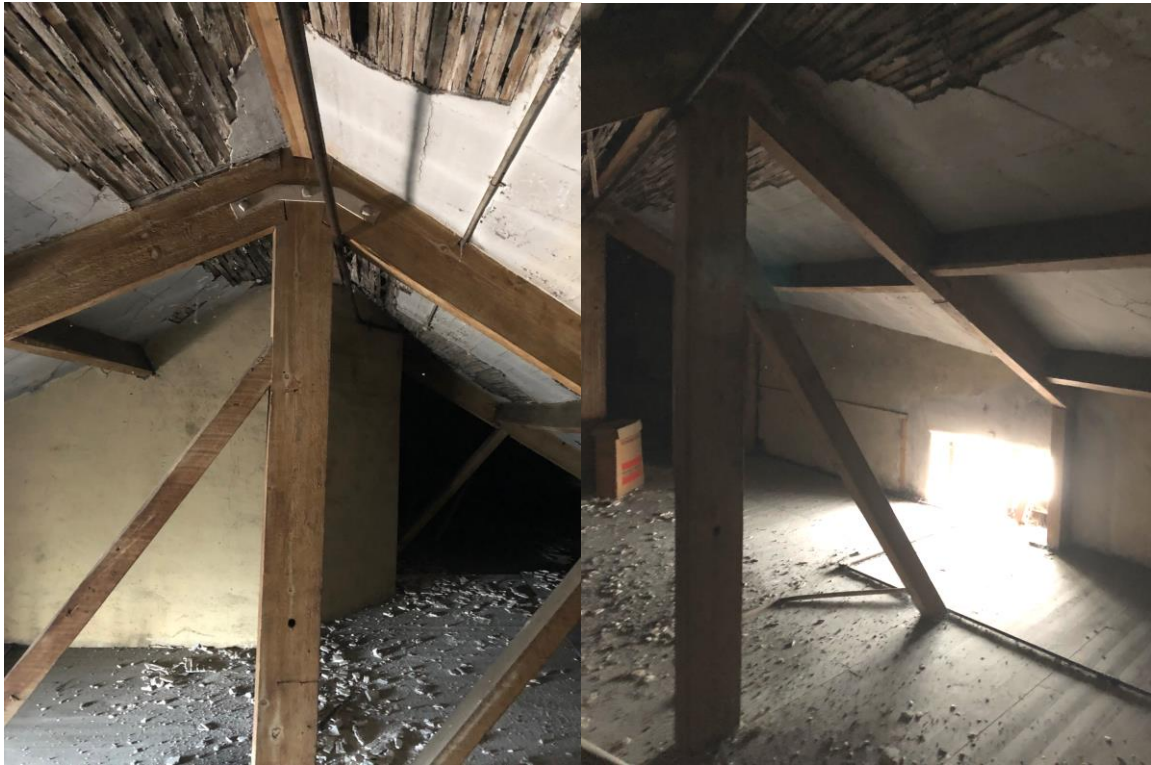
The roof space has a boarded floor and is accessed from the second floor via a stair. The timber trusses are in good condition with no signs of rot. There is a plaster finish to the underside of roof pitch which has crumbled in places exposing the lath. The space is lit by a window

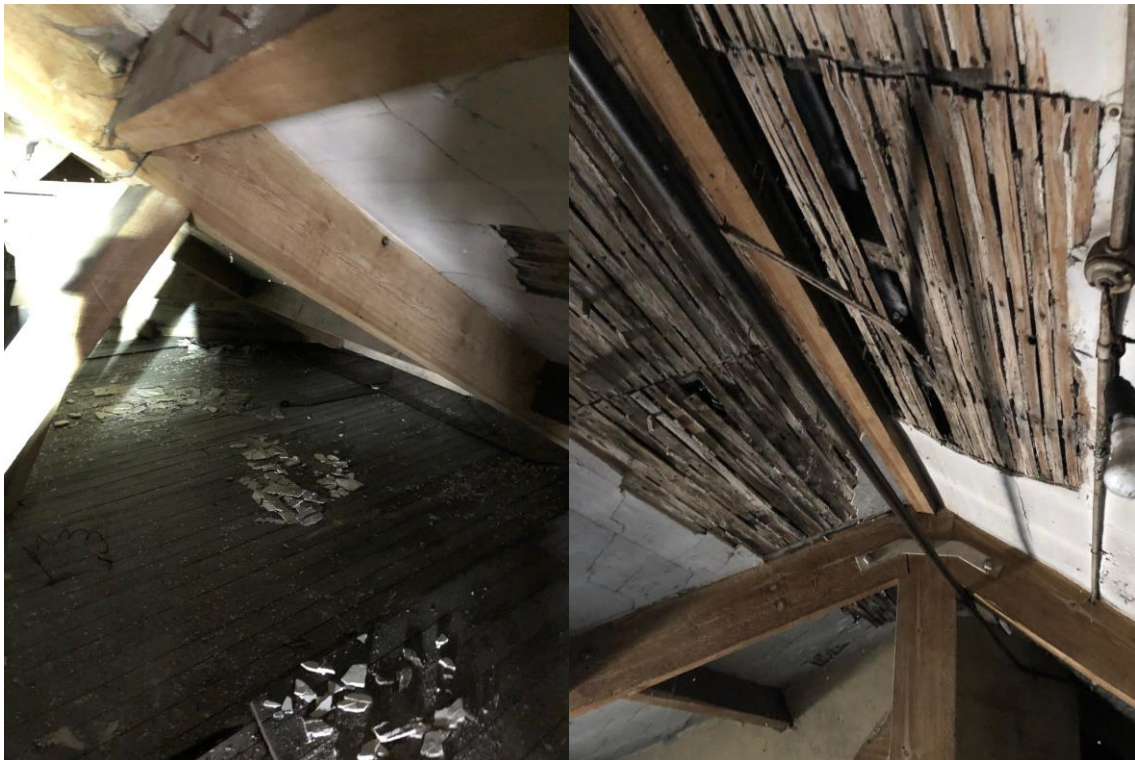
It was possible to see the underside of the slates where the plaster had crumbled, close inspection did not reveal any bat presence. The floor was dusty and covered with plaster debris but no signs of droppings or insect remains were evident. The space provides sub optimal roost potential, signs of current or historic presence were not found.

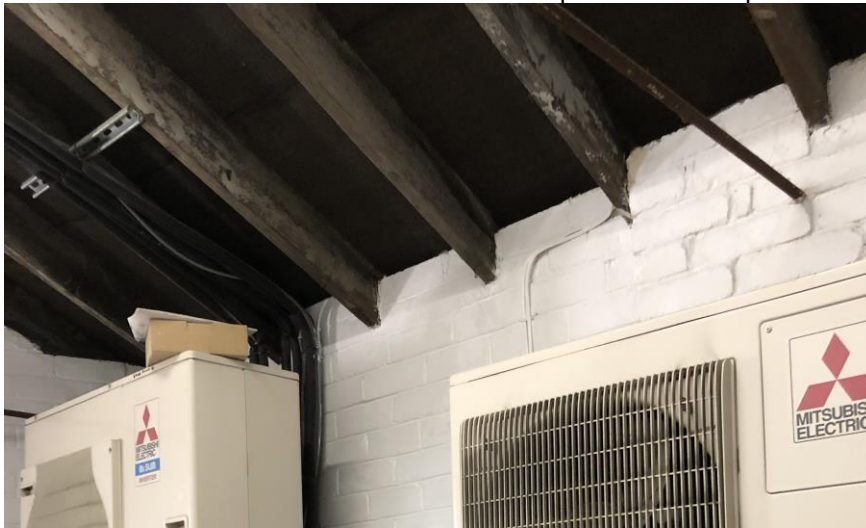
The lean to roof does not have an enclosed roof space the rafters are visible, the structure is in reasonable condition as is the felt. No bats are present in this space.
