ARBORICULTURAL IMPLICATIONS ASSESSMENT

PROPOSED DEVELOPMENT

HILLSIDE
MOOR LANE
WISWELL

Author: C. Salisbury
Date: 26 June 2023
Ref: TRE/HML/Rev C

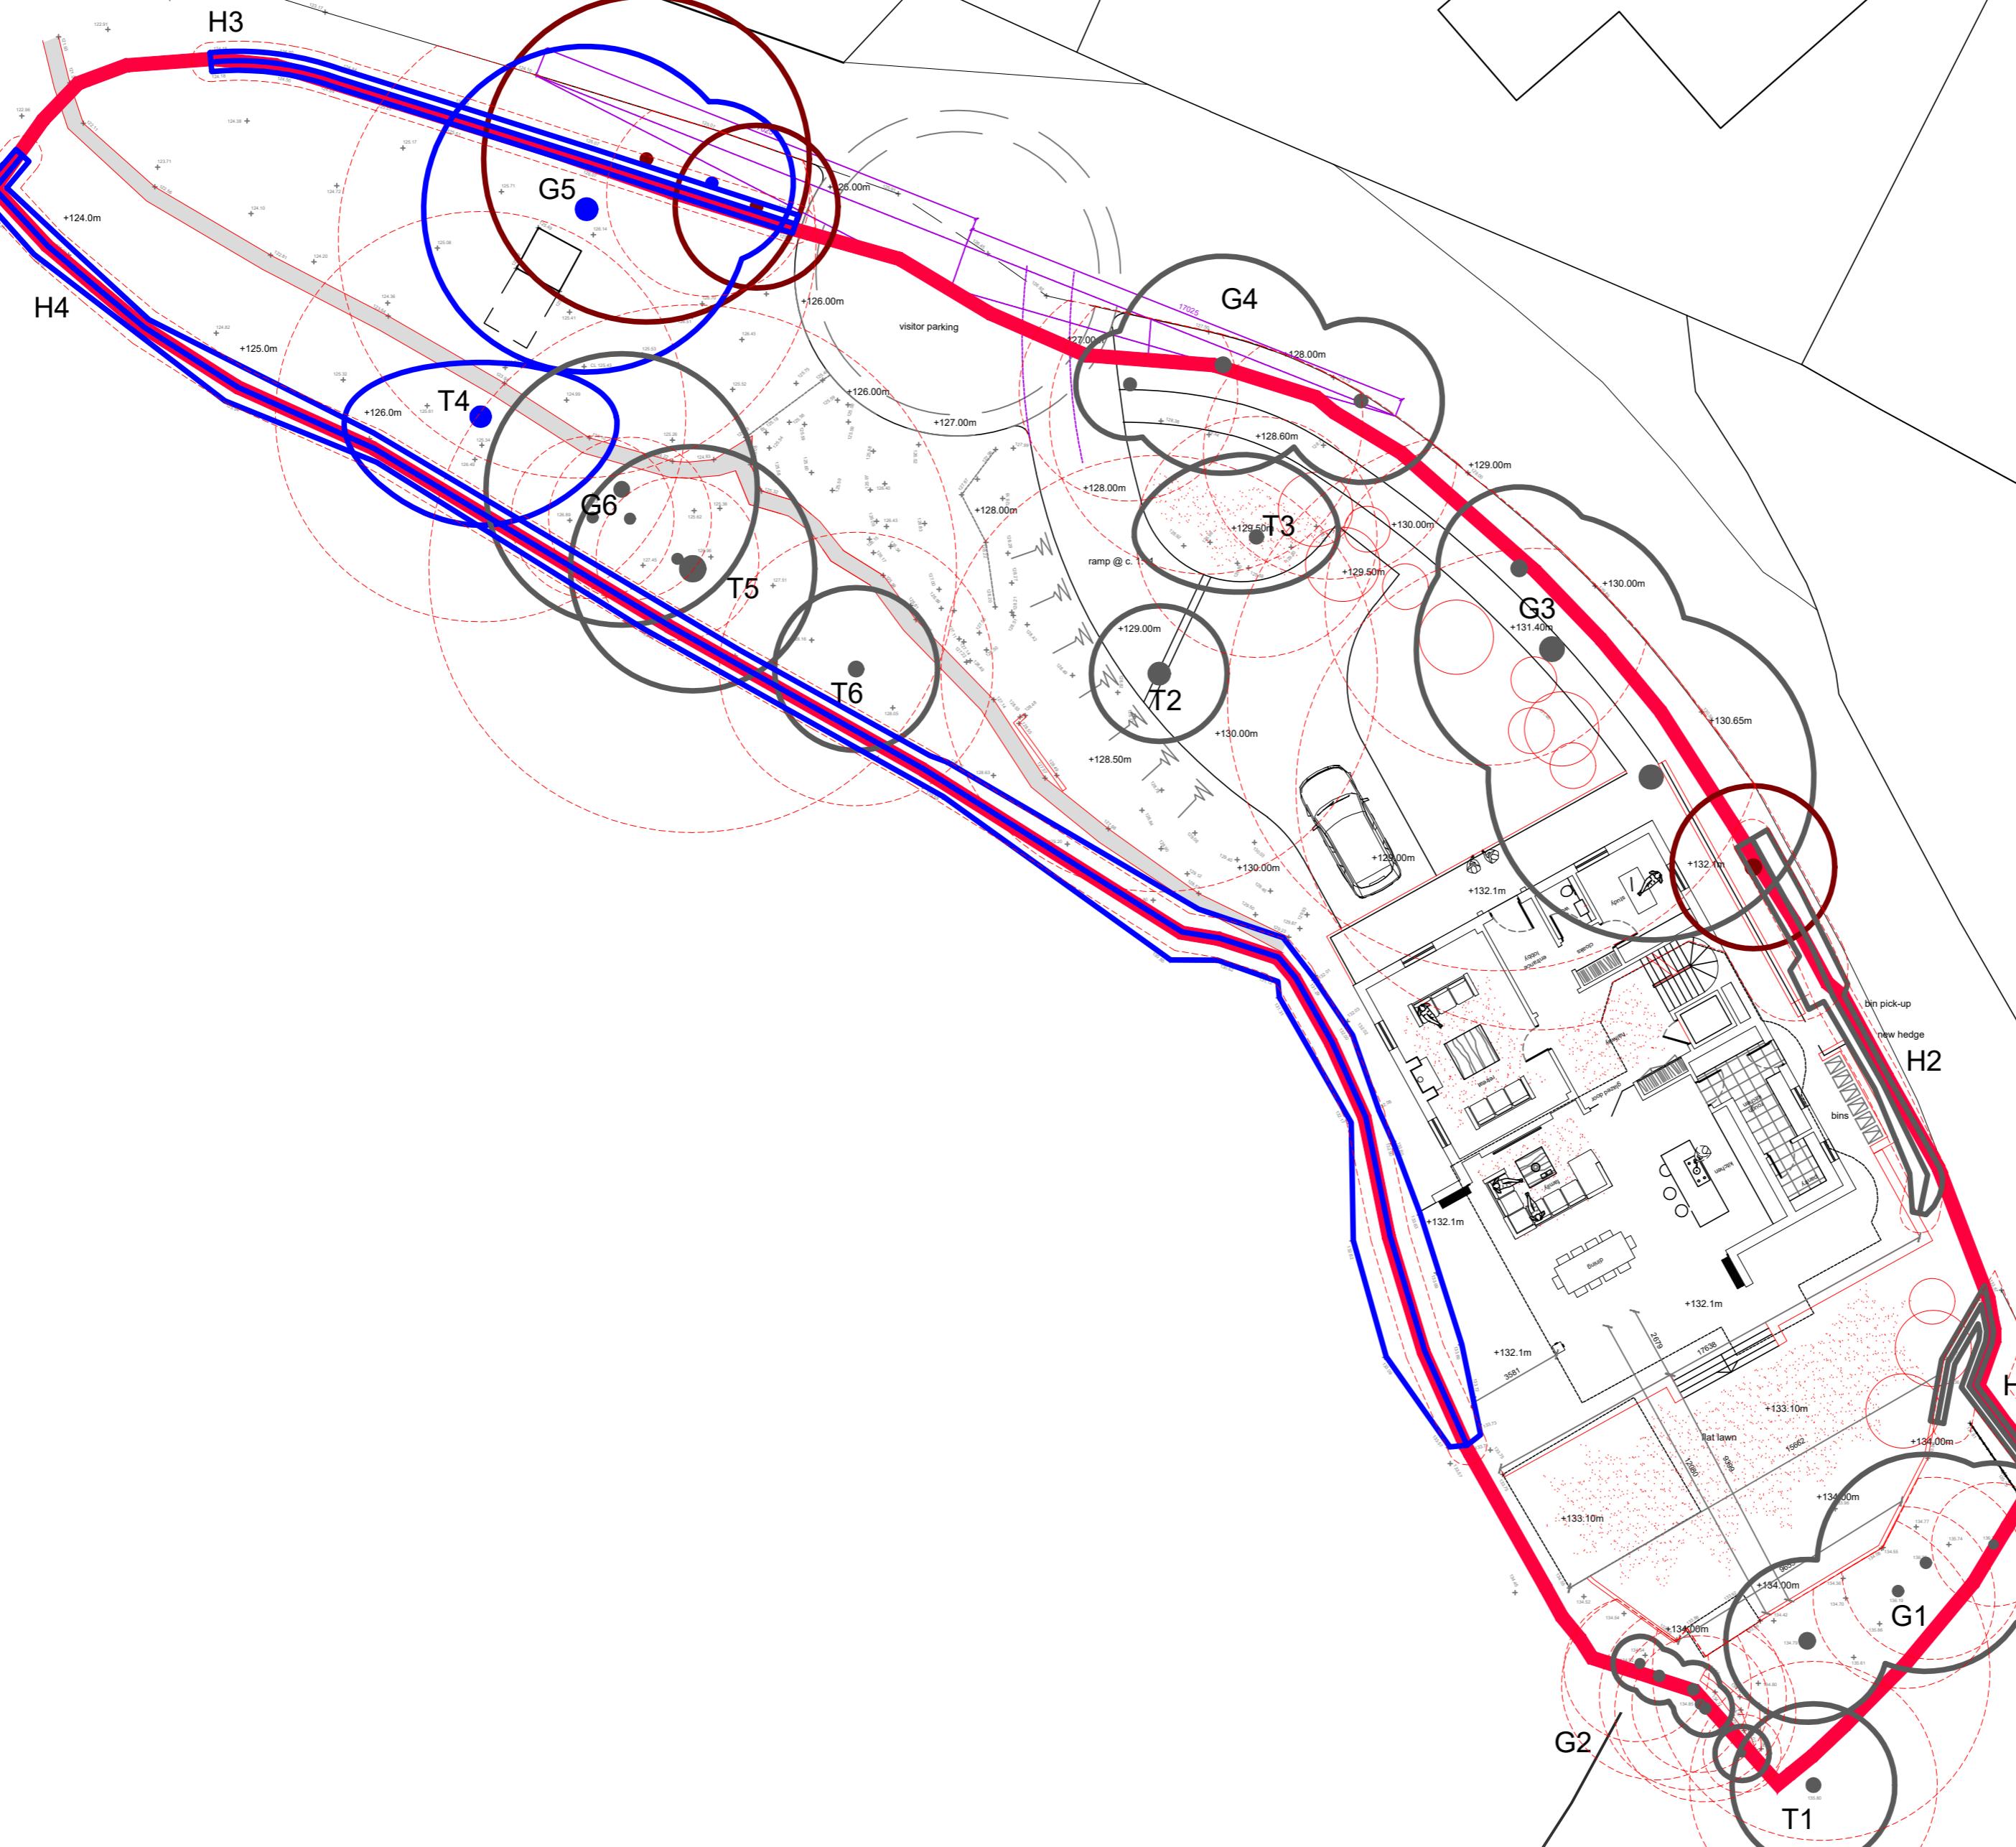
Site Address:	Hillside Moor Lane Wiswell
Drawing Title:	AIS Plan
Drawing No:	HMLW/AIS/01 Rev C
Date:	26/06/2023
Scale:	1:200
Drawn by:	CS

- 3.1 Due to the proposed development and its associated infrastructure there are a number of locations where the proposals are in close proximity to the trees surveyed. The Site Layout Plan within appendix three identifies the trees in relation to the proposed development.
- 3.2 In order to fully assess the impact of the proposals an Impact Table has been created detailing each tree, which shows the proximity of the associated works to the tree.
- 3.3 This can then be assessed in accordance with BS 5837:2012 to determine whether the development will have a detrimental impact on the health of each tree. Once this has been determined remedial measures can be detailed to reduce the impact the proposals will have on the treescape.

5.2.1 The location of these trees falls outside the required visibility splay, however to ensure their canopies do not encroach they should be crown lifted to 3.5m over the highway.
