Hillside, Moor Lane, Wiswell

Further Bat Dusk Survey

30th August 2022

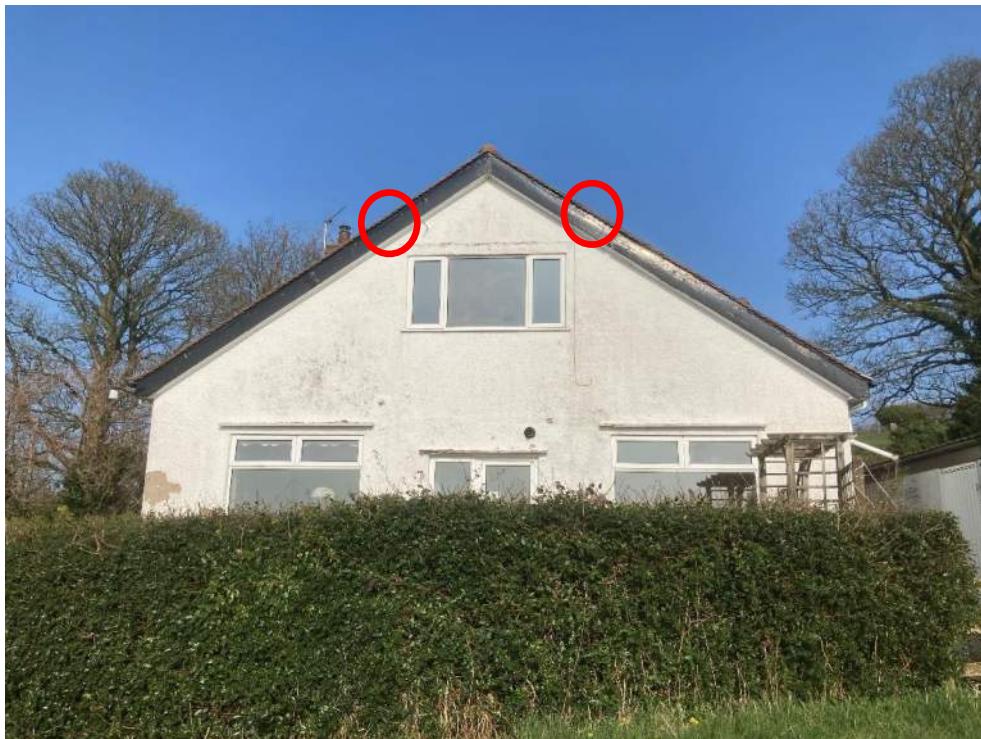
Photograph 1- Roost at Target Notes 2 and 3

In summary, survey recorded moderate levels of activity comprising of occasional noctule passes over the site, and intermittent common and soprano pipistrelle foraging activity. One soprano pipistrelle was identified roosting at the site, emerging from a gap between tiles at the west facing gable at 21.57 (Target Note 2 on Figure 1). The first pipistrelle activity was recorded at 21.45 with a common pipistrelle pass at the front of the house.

One soprano pipistrelle and one common pipistrelle bat were identified emerging from the west facing gable. The common pipistrelle emerged at 21.21 from a crevice between the gable tiles (Target Note 3) and the soprano pipistrelle at 21.28 from a further crevice between gable tiles (Target Note 2). The first bat activity was recorded at 21.06 with a common pipistrelle pass at the front of the house.

Any works to the roof gables or ridge would need to be undertaken under supervision of the named ecologist. These areas of roof would need to be disassembled by hand until the licensed bat worker is satisfied that all potential bat roosting habitat has been fully investigated. Any bats encountered during works would be moved to the pre-prepared bat boxes by the licensed bat worker.

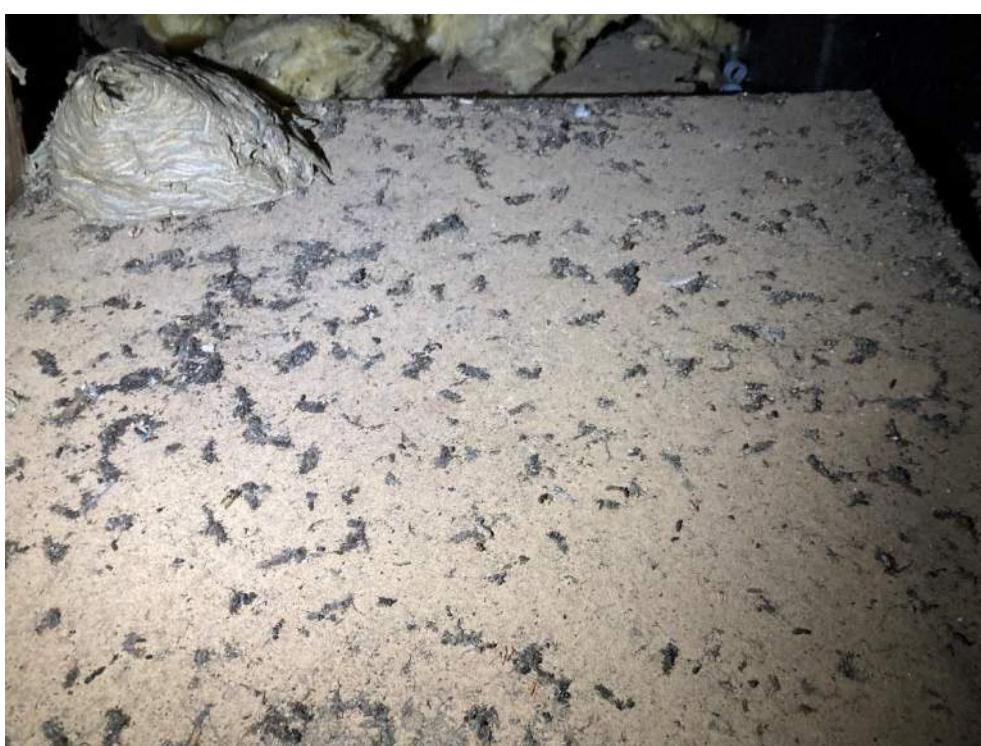
Photograph 2- Old brown long-eared bat droppings at Target Note 1

Internally, the house has a small loft space which is approximately 90 cm tall. The loft space is lined with fibrous insulation felt which extends to the eaves of the roof whilst the internal face of the roof is lined with bitumastic hessian felt. Small numbers of moderately old brown long-eared bat droppings (approximately 20 droppings) were found scattered beneath the ridge beam of the loft space (Target Note 1 on Figure 1). The ridge beam was also observed to be bare of cobwebs above the bat droppings. No fresh bat droppings were found within the loft space.

Otherwise, the main roof and ridge tiles are mostly intact and tightly fitted. There is a single raised ridge tile which corresponds with the location of the old bat droppings within the loft space (Target Note 1). The external render extends up to the base of eaves and so there are no gaps or crevices here.

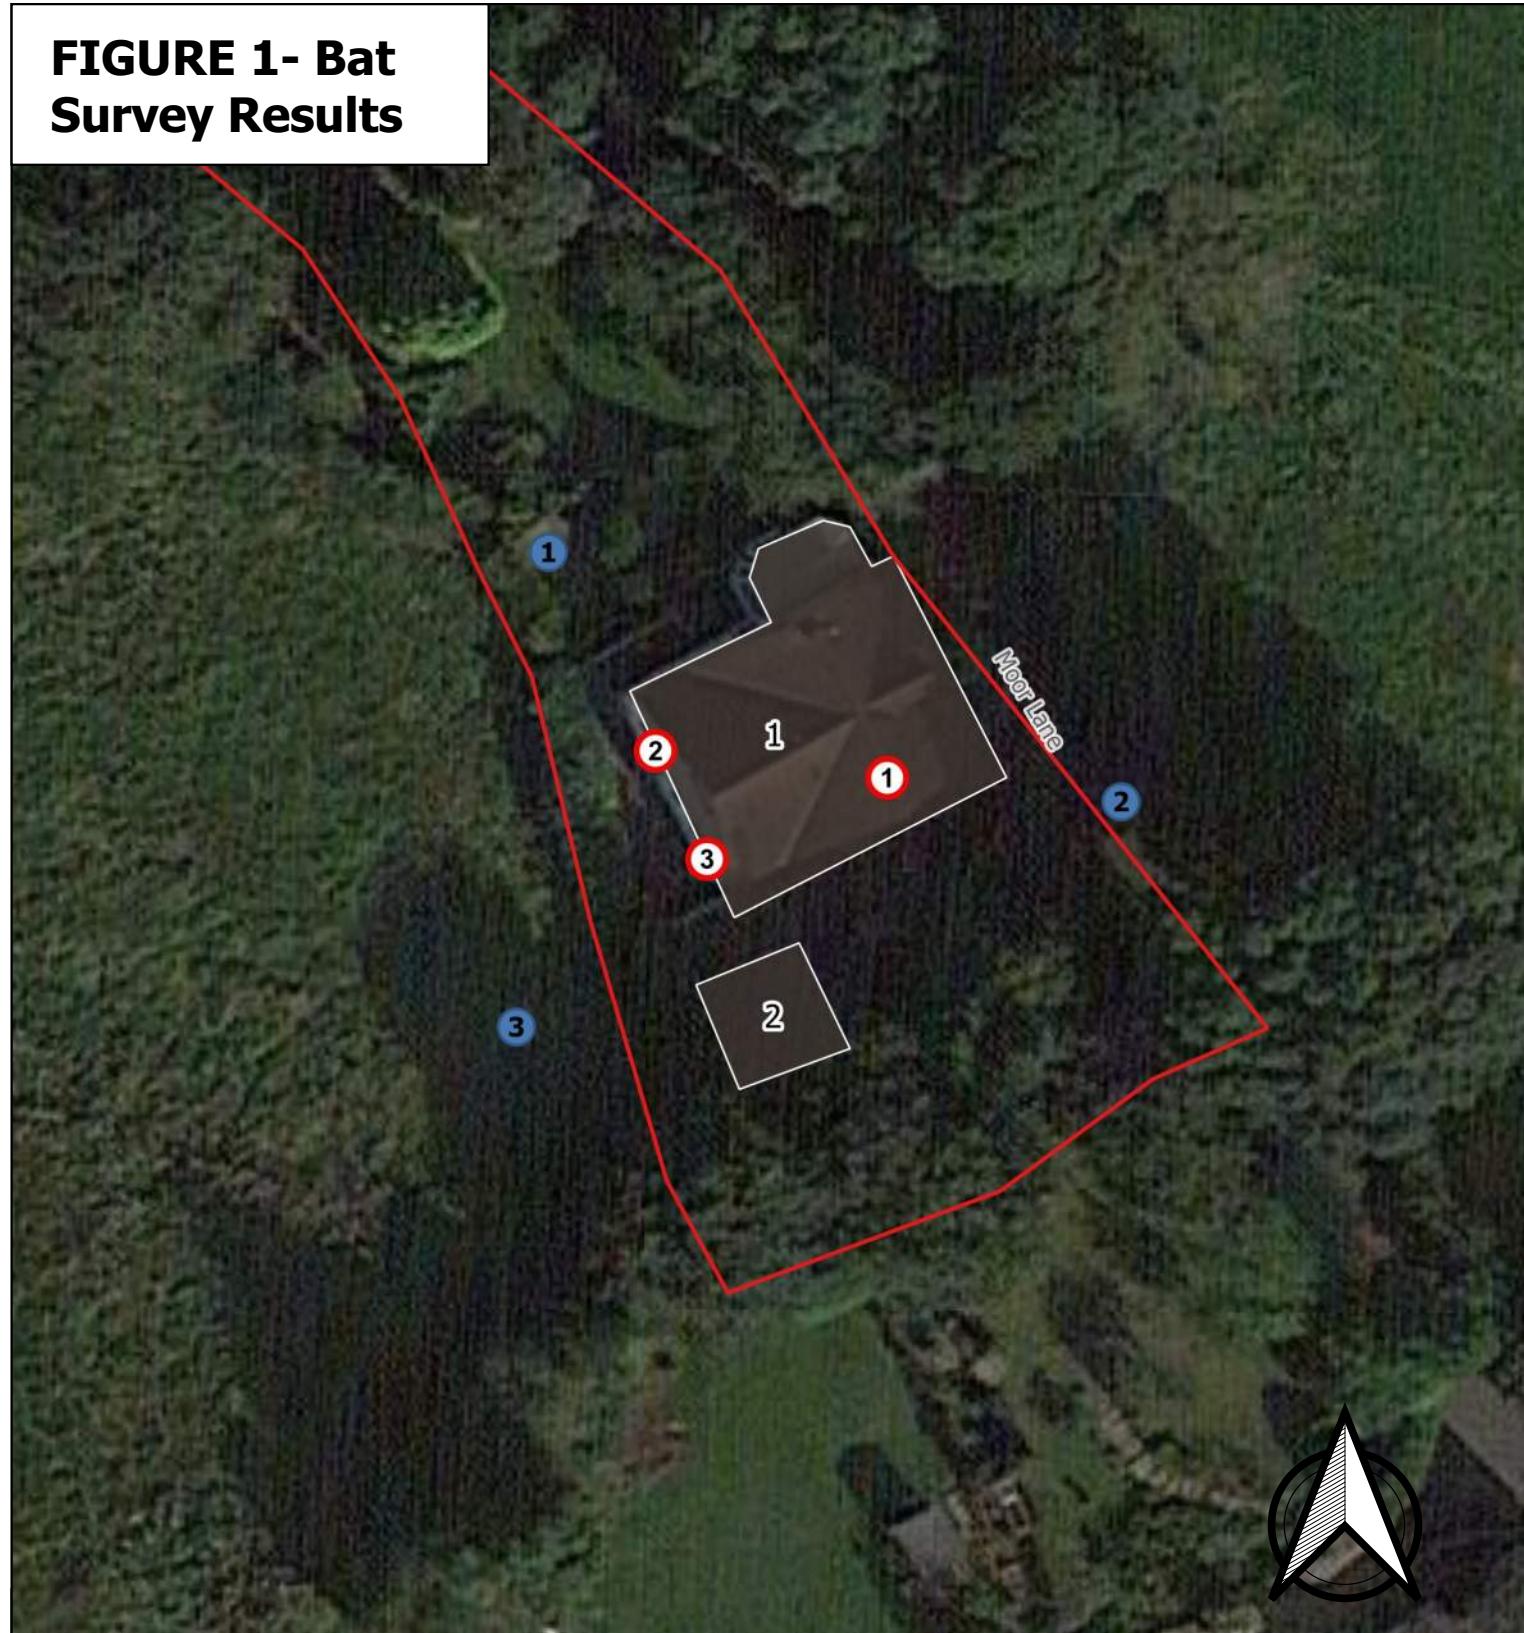
FIGURE 1- Bat Survey Results

Given the size of the building and site layout, it was considered appropriate to use three surveyors to allow full coverage of all potential bat roosting features identified at the site. This comprised of one surveyor positioned at the north, east and west faces of the house (surveyor locations shown on Figure 1 in the Appendix).

The further bat emergence surveys have confirmed the presence of individual roosting common pipistrelle and soprano pipistrelle between tiling at the west facing gable of the house and have also identified the loft space as having been used by roosting brown long-eared bats in the relatively recent past (Roost locations at Target Notes 1-3 on Figure 1).
