BAT SURVEY AT -
95 MELLOR LANE
MELLOR

DATE AND TIME OF VISIT
13th April 2023 5.30 pm

Insertion of solar panels in the rear roof pitch of the property, and removal of existing single storey rear lean to prior to construction of new single storey extension.

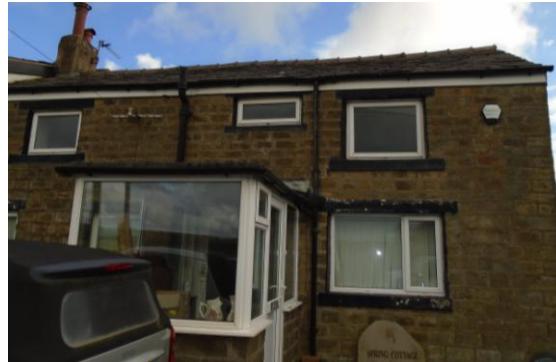
Front elevation

The property is an end terrace cottage .

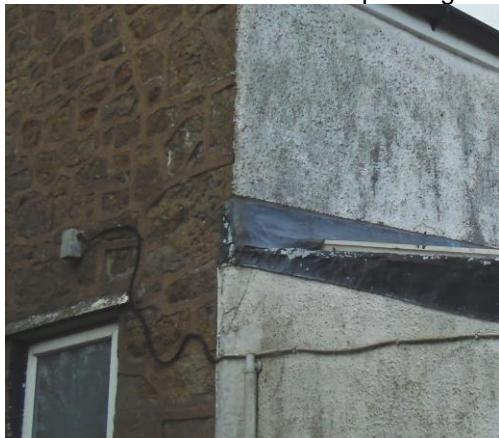
The walls are stone with flush pointing. The rear elevation has a render finish as does the lean to .

The walls are in reasonable condition with no access points, cracks or crevices, with the potential to provide bat roost habitat.

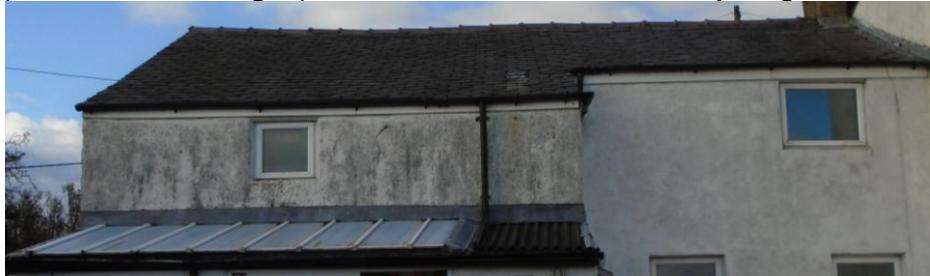
The main roof is pitched with a slate finish. Fascia boards are flush fixed to the walls. The verge is pointed. Lead flashing is present at the abutment with the adjoining house wall.

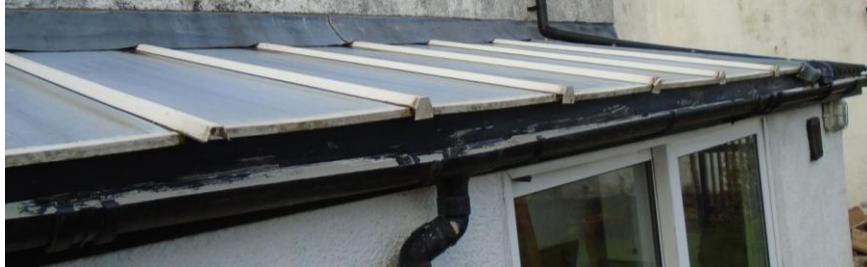
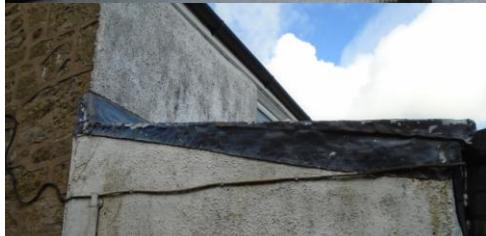
Lean to verge

The lean to roof is in average condition, the lead flashing to the wall abutment and to the verge is very tight fitting. The eaves were closely inspected for any cracks, crevices and access points non were found.

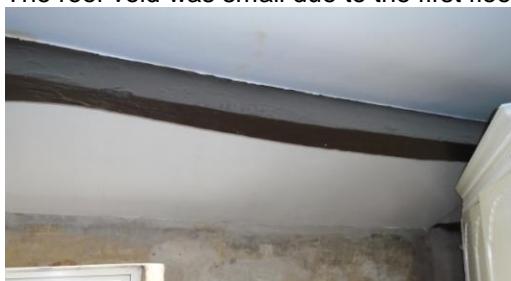
The roof void was small due to the first floor ceiling joists being higher than the eaves.

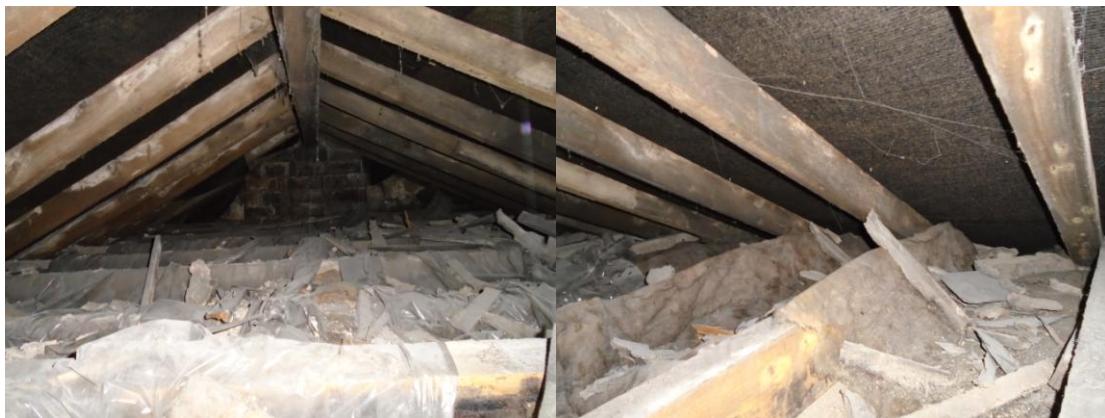
The timber rafters and felt underlay were in reasonable condition , the space was dusty but free from any dropping or insect remain evidence of bat presence. The space provided sub optimal roost habitat.

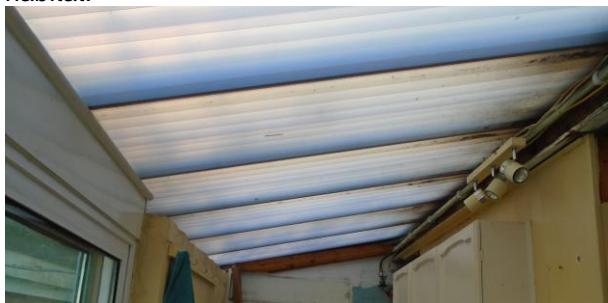
The lean to roof did not have an enclosed roof void, the space did not provide any potential bat roost habitat.
