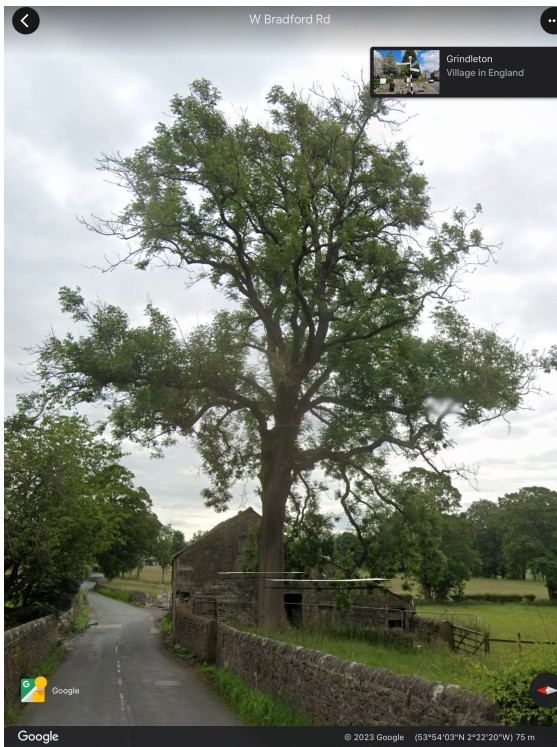
Photo 1 - 2022

The tree adjacent to the development site is a mature ash tree and during 2022 ( photo1) shows signs of Ash die back.

A further survey is recommended once the tree is fully in leaf.

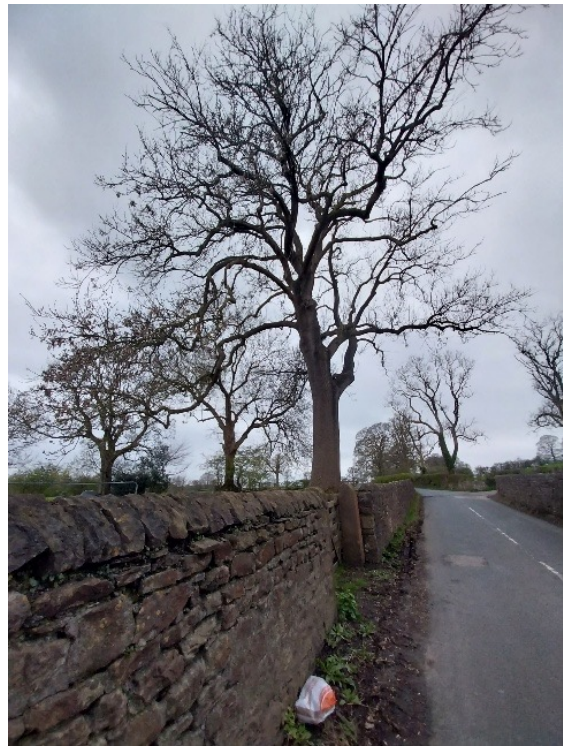
Photo 2 - April 2023

Photo 2 taken in April 2023 shows the tree has yet to come into leaf.
