## Ecological Appraisal and Bat Preliminary Roost Assessment Bridge End Farm, Wood House Lane, Slaidburn

Project: **Bridge End Farm, Slaidburn**

Report Reference: **AE66-R01**

Date: **13<sup>th</sup> April 2023**

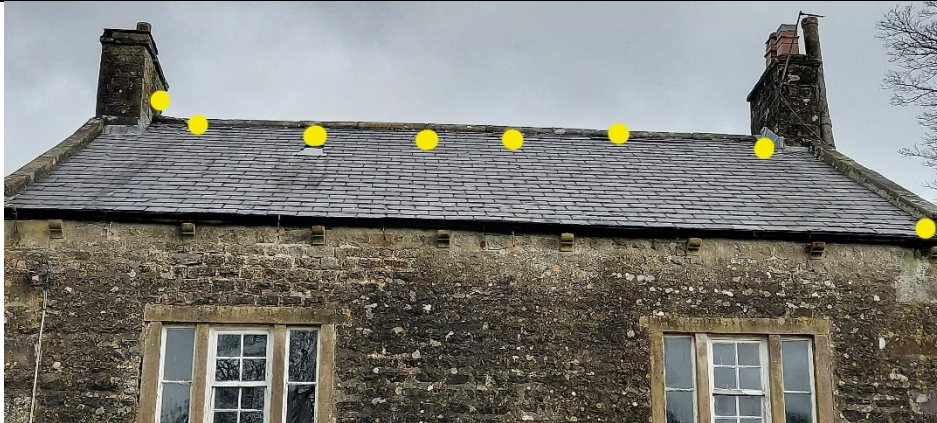
- 4.13. There are multiple roost features on the roof to the front, including gaps underneath ridge tiles, lifted face tiles, gaps around lead flashing on chimneys, gaps around skylight fittings. On the front face of the building there are suitable gaps around the lintel casings for the windows.

Building B1 (farmhouse) – south elevation (front) - yellow indicates lifted tiles & gaps under flashing.

- 4.18. Based on the evidence from the PRA survey, due to the existence of a high number of suitable PRFs and good habitat connectivity, the main farmhouse (B1) was classified as having ‘**High**’ bat roosting potential and following the standard guidance requires three nocturnal surveys.

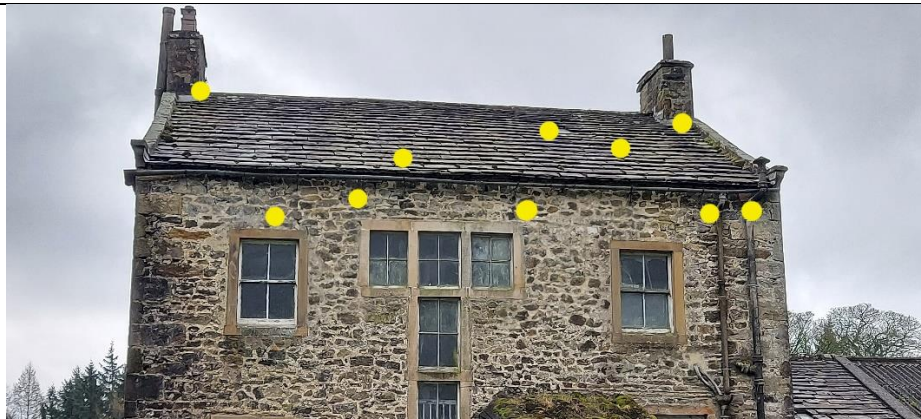
- 4.14. On the east facing side of the building there were gaps in the gable end roof mortar, and gaps in stonework where the render had broken away.
- 4.15. On the north face of the building there are large numbers of PRFs on the roof created by gaps under the York stone tiles, gaps in the lead flashing of the chimney stacks, and multiple gaps in the stonework where there are cracks and dislodged stones etc.

Building B1 – north elevation (rear) - loft interior gaps under York stone tiles, cracks in walls etc.

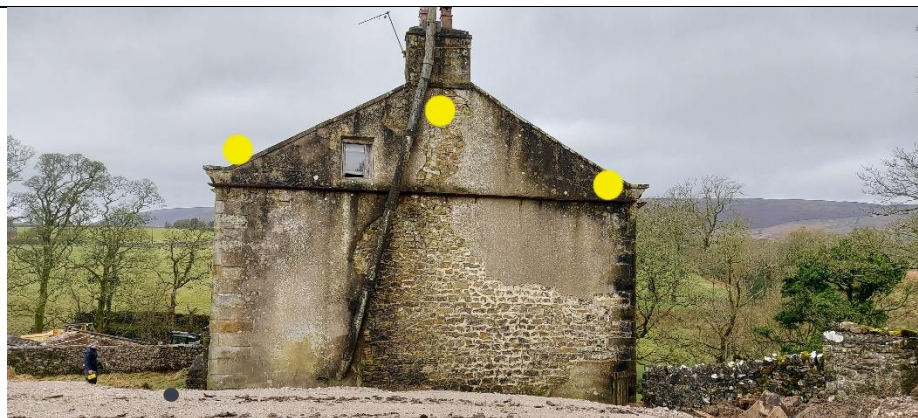
Building B1 – east elevation – gaps and cracks in brickwork

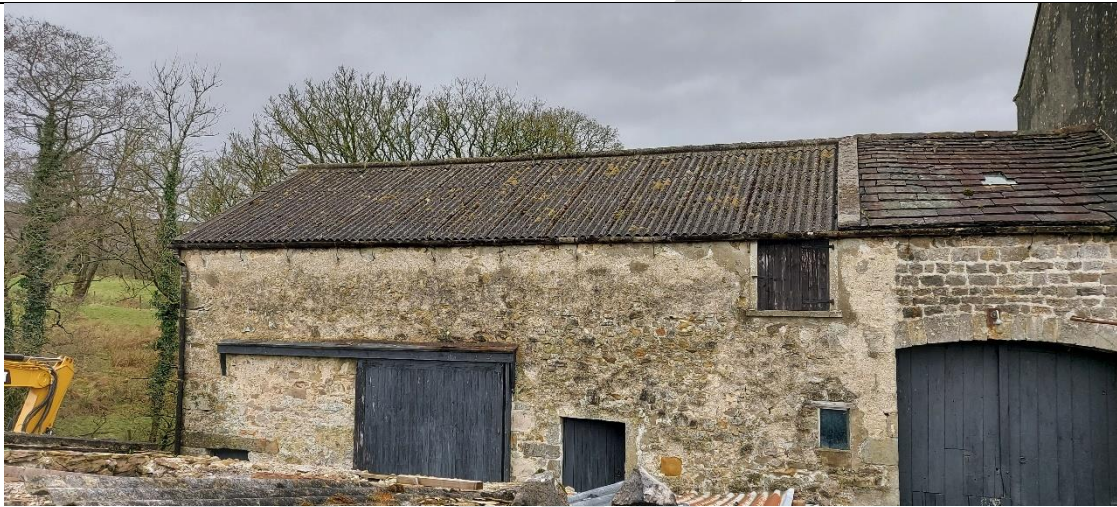
B2a (right) and B2b (left) – adjoining barns

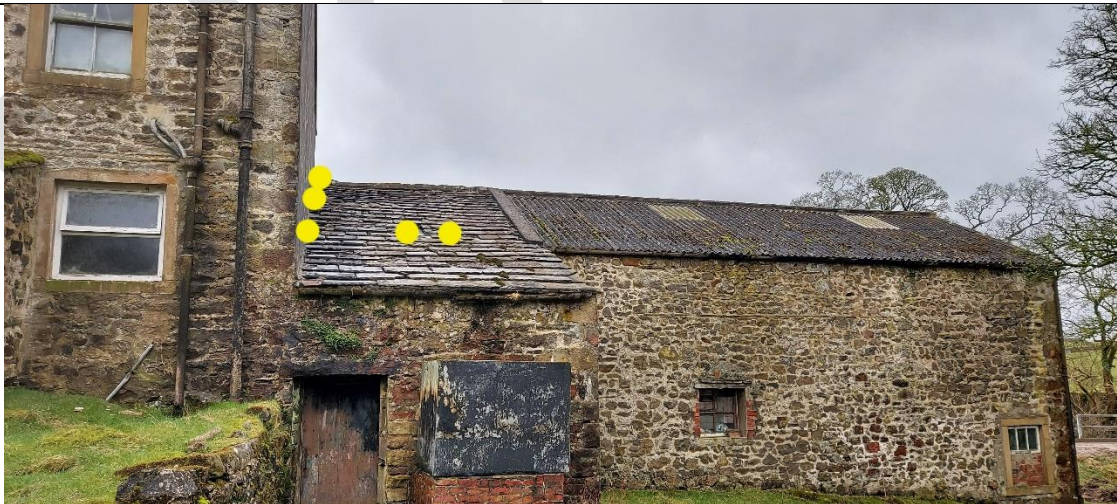
- 4.19. A small barn with access front and rear. Simple apex-style roof with ridge tiles and York stone roof tiles to the front and rear. The roof adjoins the mid-level of the house, but due to a change

B2a (adjoining barn) – north elevation – gaps under York stone roof tiles.

- 4.20. Internally, building B2a has a high buttressed roof with natural timbered crossbeams. There is no loft area, and the roof tiles are unlined. There are gaps between the door and frame at the front which could allow access for bats and birds. The barn is suitable internally for cavity bats, though no obvious signs were present. There was evidence of use by barn swallow *Hirundo rustica*.
- 4.21. Based on the evidence from the PRA survey due to the existence of a high number of suitable PRFs and good habitat connectivity, building B2a was classified as having '**High**' bat roosting potential and following the standard guidance requires three nocturnal surveys.

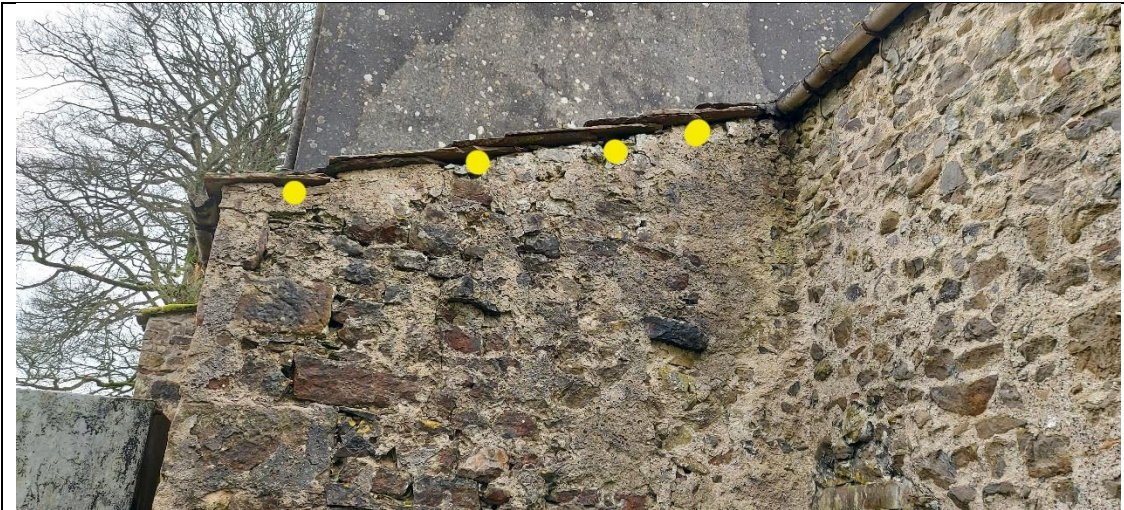
Building B2a – west elevation – missing mortar from edge tiles.

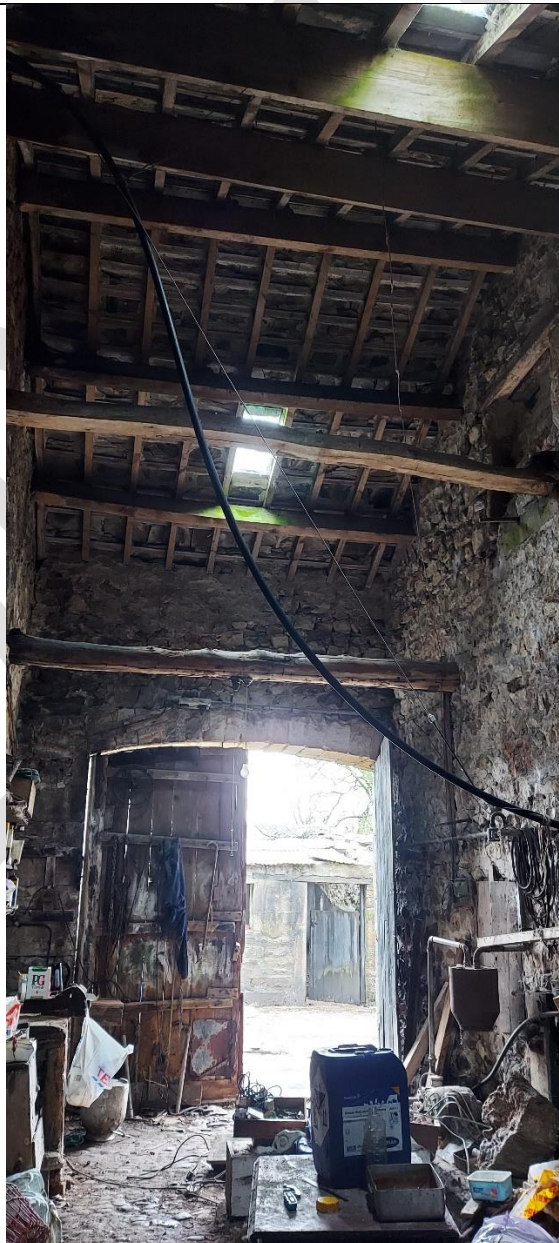
Building B2a – interior, high potential for cavity bats.

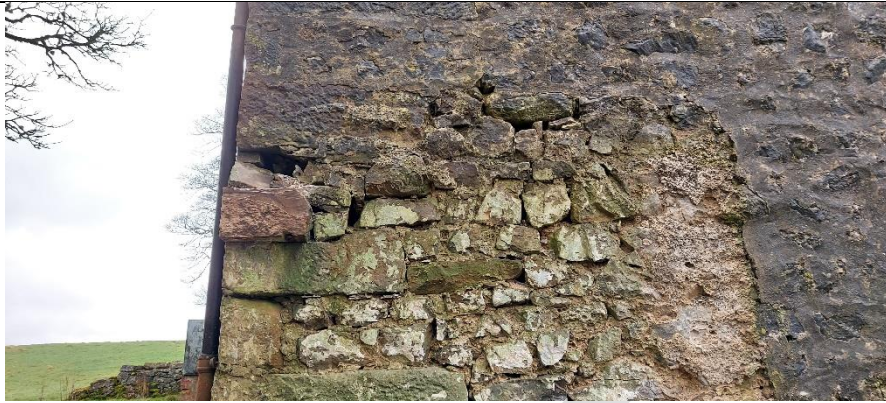
Building B2b (adjoining barn) – west elevation – gaps and cracks in brickwork.

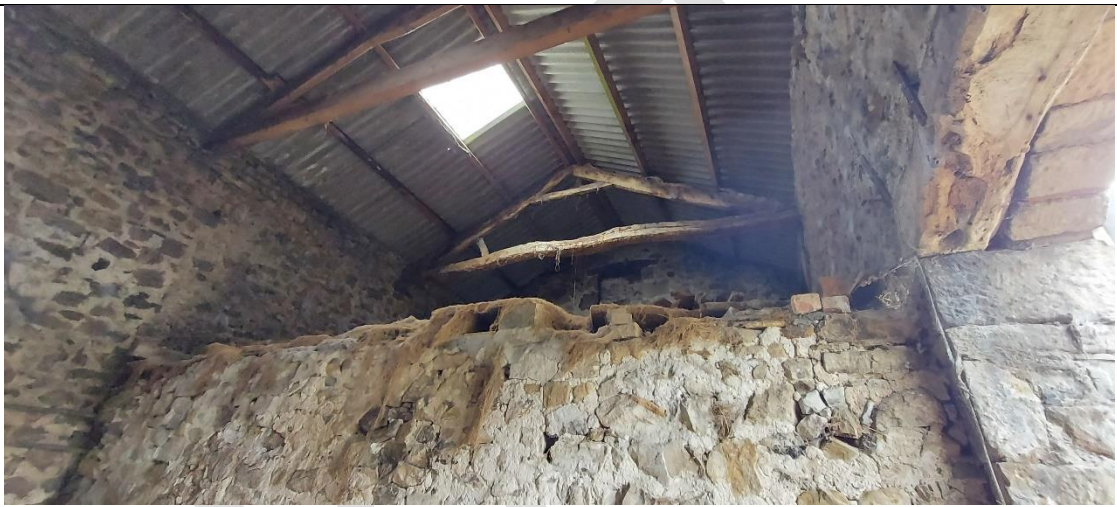
- 4.24. There are original trusses supporting the roof and more modern beams running the length of the roof. There are gaps in the stonework internally which could provide suitable PRFs for bats. No direct evidence of bat presence was found internally but there was a small scattering of old butterfly wings which could be the feeding remains of brown-long-eared bat or barn swallow, The barn is suitable internally for cavity-dwelling bat species. There was also evidence of barn swallow nests.

Building B2b – hayloft interior, potential for cavity bats.

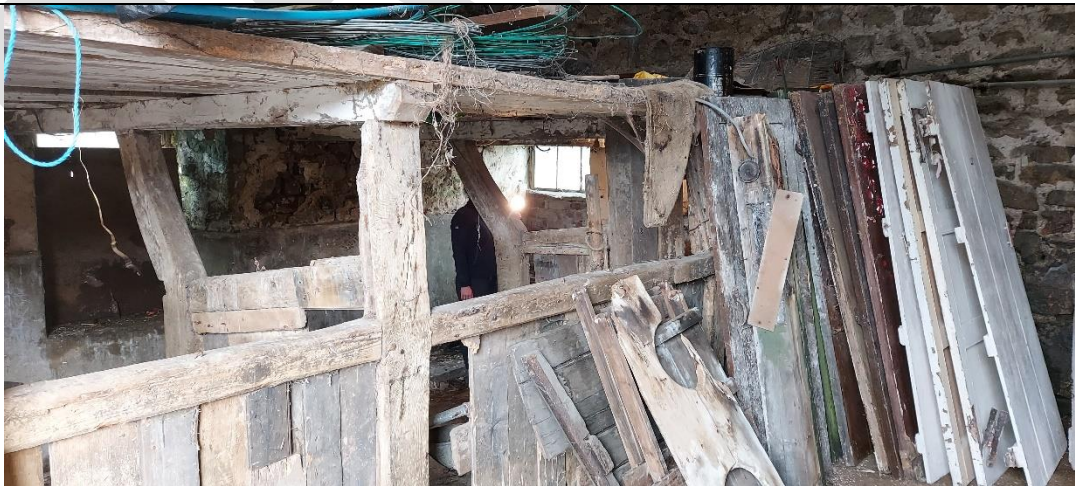
B2b – interior, derelict animal stalls.

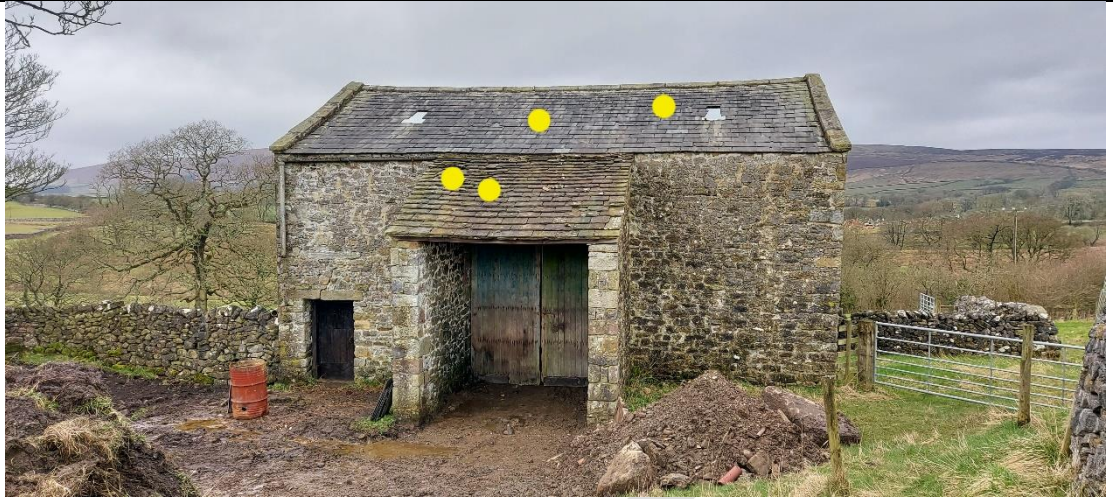
- 4.26. A traditional stone barn (B3) which is located approximately 100m northeast from the main house across a field. The building is aligned north/south with the main access on the east side. The double door access has a large open porch feature extending from the main building with a sloped, clay-tiled roof. The main roof has slate tiles to the front and rear. There are multiple lifted tiles with gaps suitable for bats on all the roof faces. Additionally, there are a small number of external cracks in the walls and gaps along the edge tiles suitable for crevice bats.

B3 (detached stone barn) – east elevation (front) – highlighting PRF gaps under roof tiles.

- Building B3 – two survey visits – using three surveyors (or two surveyors plus a NVA camera).
  - Building B4 – one survey visit – using two surveyors (standard practice). However, due to the limited scope for roosting, and ease of visual inspection, it is recommended that follow-up work is instead undertaken as repeat visual inspections prior to other nocturnal surveys.

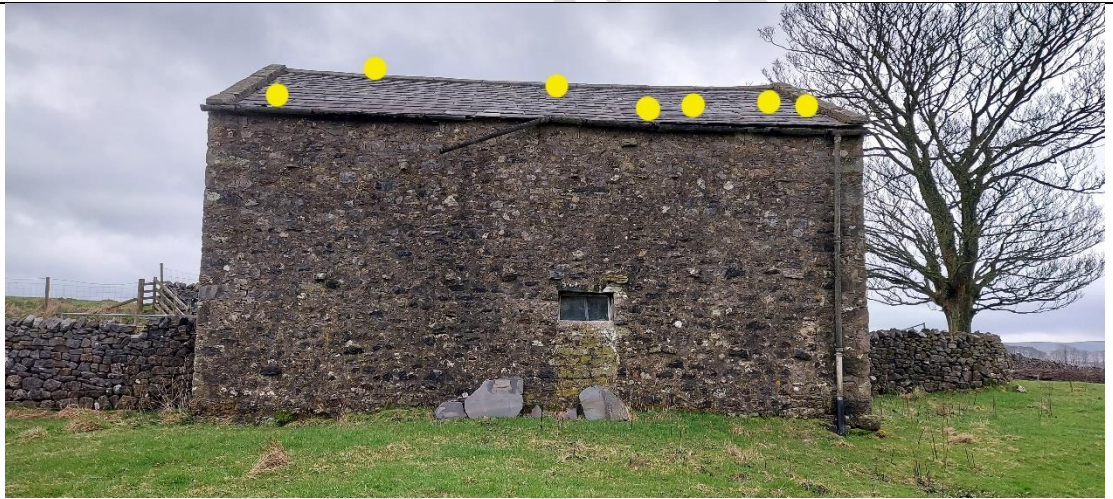
B3 – west elevation (rear) – showing lifted tiles on roof.

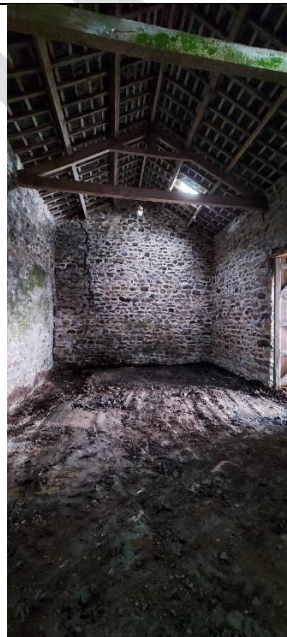
- 4.27. Internally, the concrete floor has recently been removed. There is a large crack in the end wall to the north suitable for bats to roost. There is also a vent hole suitable for bat and owl access. The roof is unlined and supported by relatively modern trusses and beams. The barn has suitability for cavity and crevice bats, but it has limited habitat connectivity.

B3 – interior of barn.

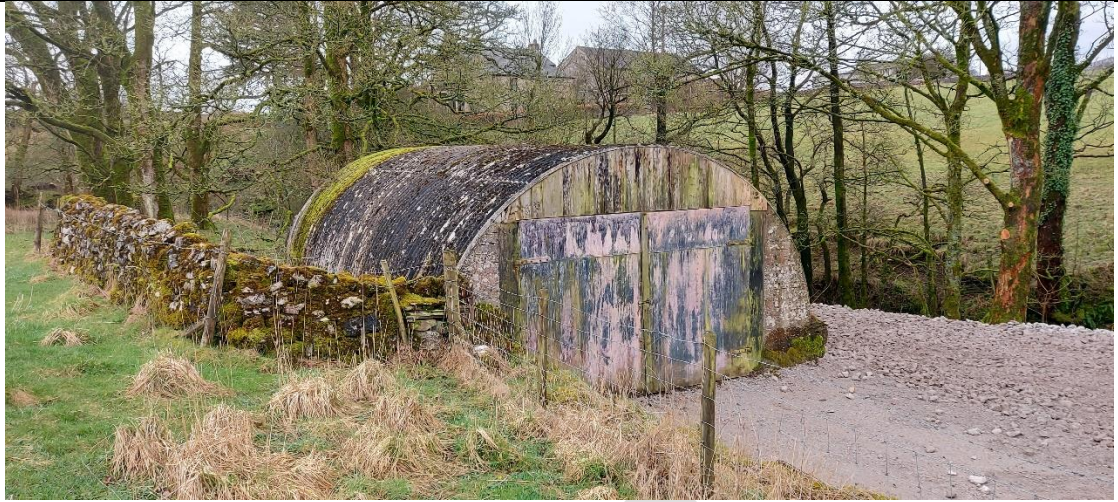
- 4.29. To the south of the farmhouse, across the farmyard, is an old 'Nissen' hut-style building (B4), with a corrugated sheet roof. The end walls are a combination of brick, stone and timber with timber double door to the front (north), and an inset window to the rear (south). The windows are broken. There are no obvious PRFs on the external areas of the building. The interior has negligible scope for roosting crevice bats, but cavity bats, such as brown long-eared, could potentially hang from the internal roof structure. There was no evidence of bats internally at the time of the survey.

B4 – Nissen Hut

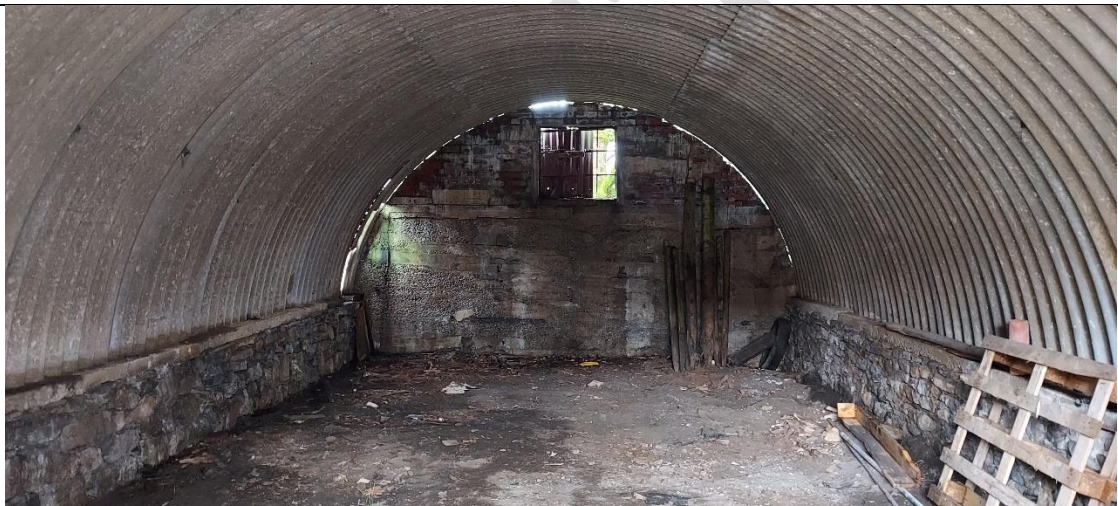
B4 – interior, showing low suitability for cavity bats and access through broken window.

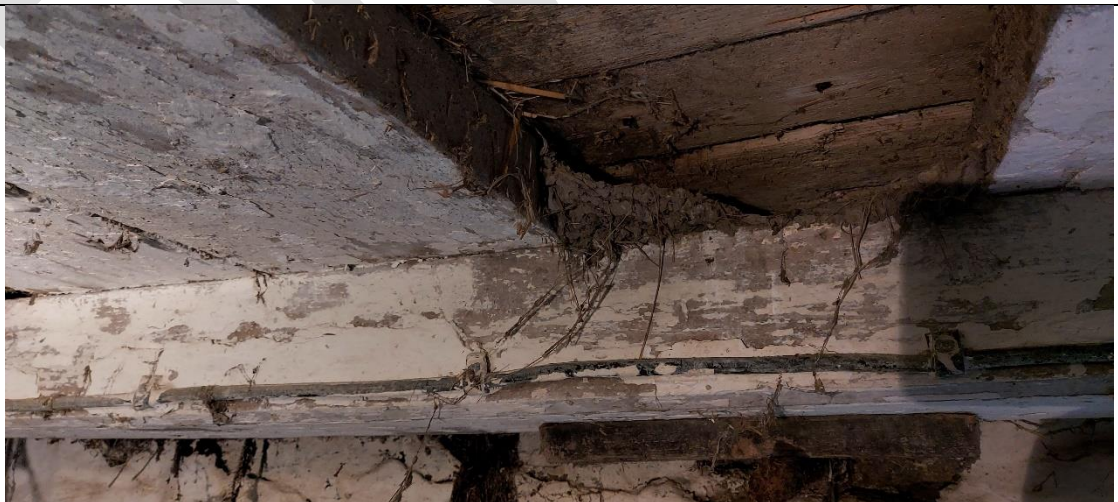
Barn Swallow nest in B2b

- 5.14. It was recorded during the PRA survey that both adjoining barns B2a and B2b have previously been used by nesting birds, notably barn swallow. It was too early in the season to assess the annual usage as barn swallows had not returned from migration at the time of the survey.
- 5.15. It is recommended that further survey and assessment of the nesting bird activity across the site is conducted in conjunction with the nocturnal bat surveys. Once the scope of usage is better understood a mitigation strategy to compensate for any likely impacts can be devised via liaison between the Client (or their architect) and the ecologist.
