Bat Survey Report and Method Statement European Protected Species (Bats)

Reasonable Avoidance and Mitigation Measures

**Fernhill,
Ribchester Road,
Clayton-le-dale,
BB1 9EE**

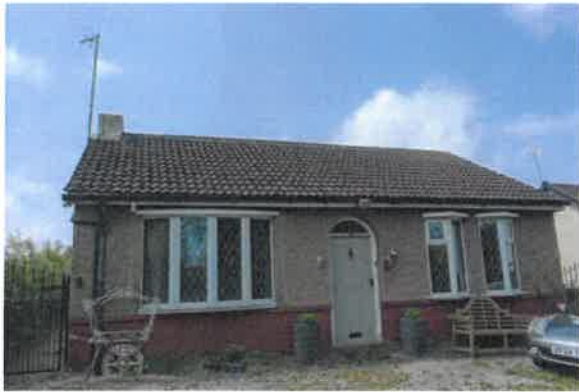
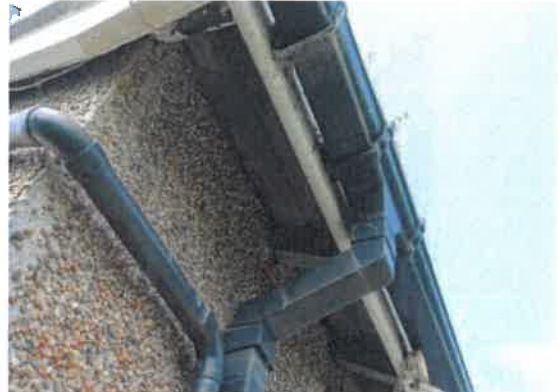
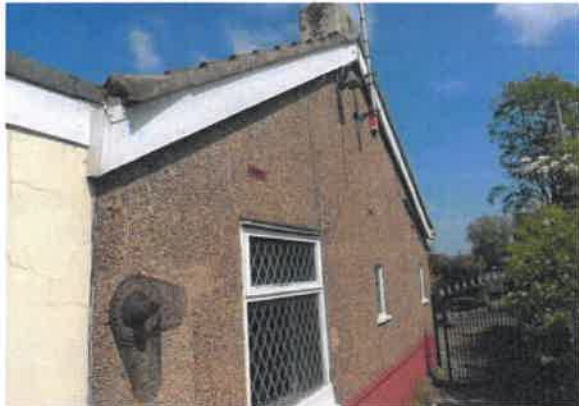
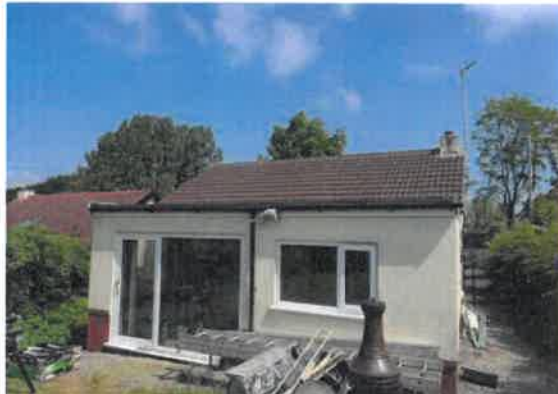
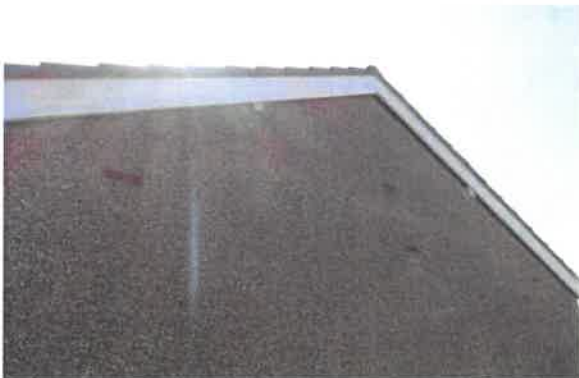
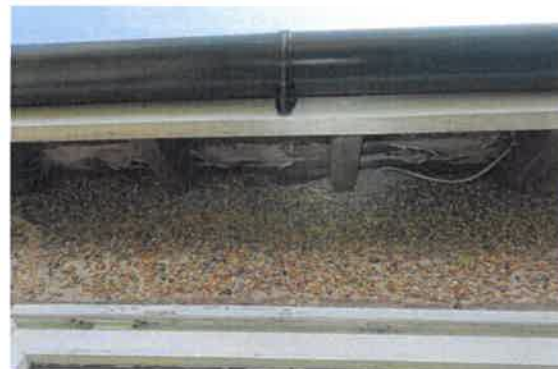
The property consists of a brick built detached bungalow with a double pitched tiled roof. The property has a flat roofed extension to the rear.

Walls are rendered and generally well pointed, with no obvious cracks, gaps or crevices. Two gaps at the eaves were observed.

Roof tiles are generally close fitting, with no lifted, slipped or missing tiles present. Ridge tiles are generally pointed and sealed.

The property was assessed as offering low bat roost potential. No physical evidence to suggest use by bats was recorded.

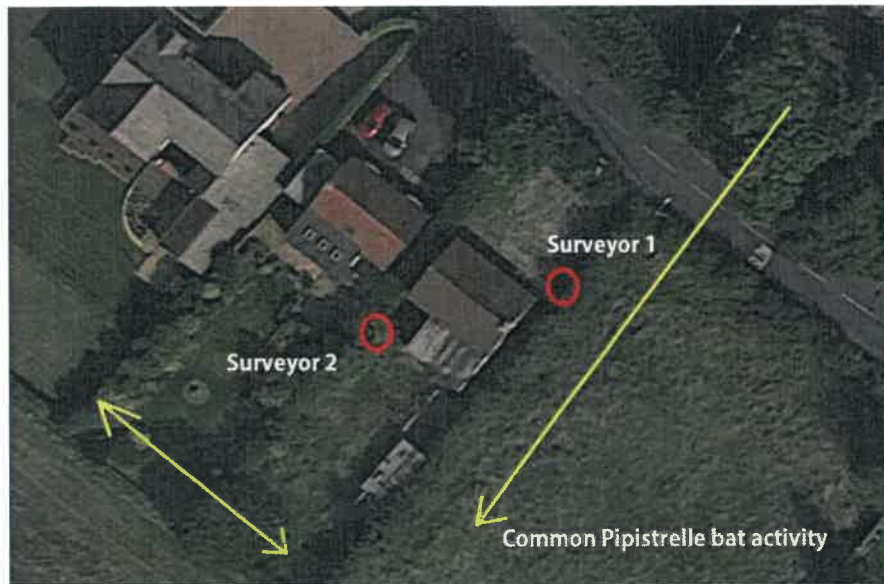
Emergence Survey - 28th May 2023

Between 22.23 and 23.56 common pipistrelle bat activity was recorded with bats observed foraging and commuting to the east and south of the property before dispersing into the wider landscape. Five bat passes were recorded foraging, a low level of activity.

No bats were recorded emerging from the building.
