**BAT SURVEY AT -
ACORN HOUSE
MITTON ROAD
WHALLEY
BB7 9JN**

DATE AND TIME OF VISIT
31ST May 2023 9.15am

REFERENCE NO. 6827

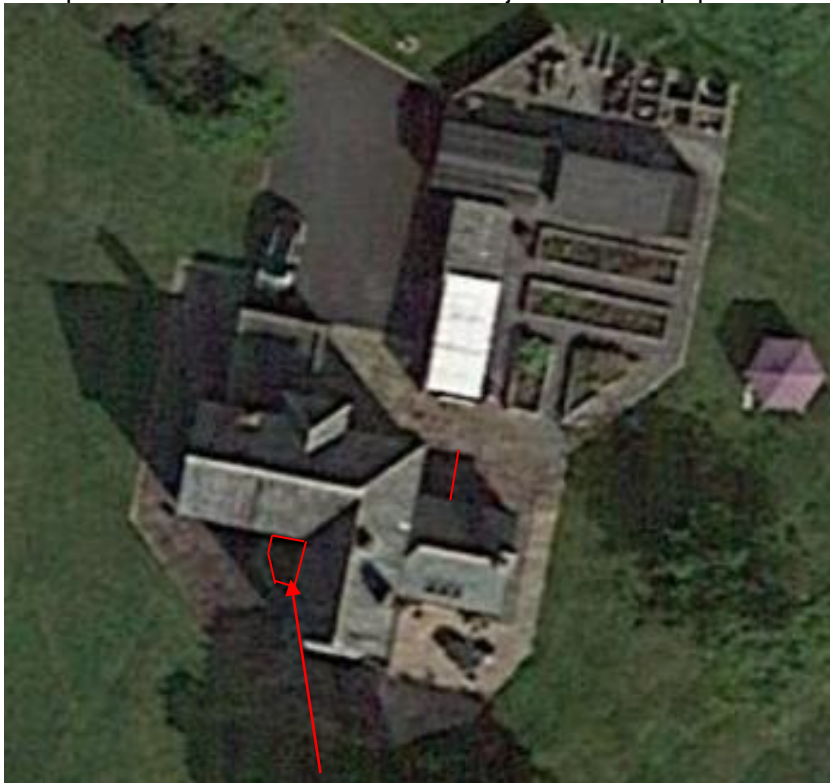
Proposed location of first floor shower room extension

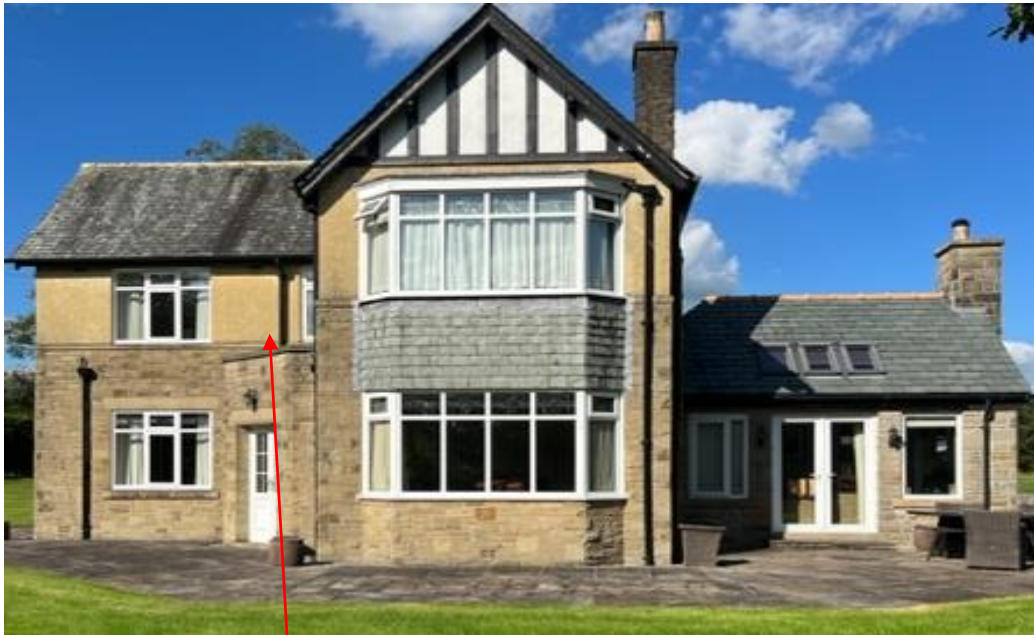
Front South Elevation

Location of proposed shower room

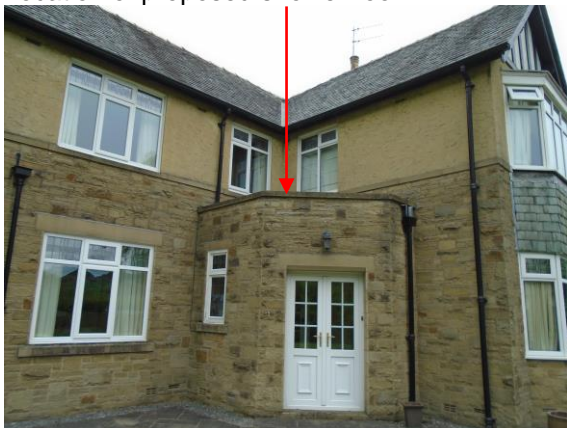
Part west elevation

Location of proposed flat roof link

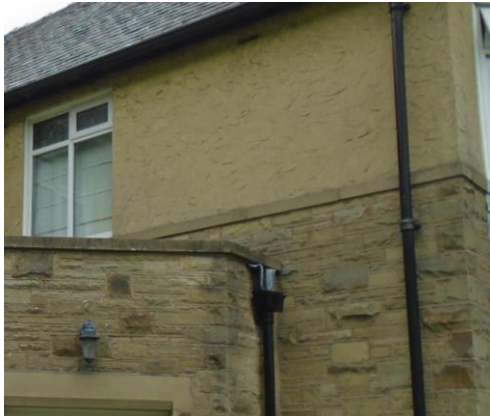
The walls are in good condition being coursed natural stone up to a plinth above which is a textured render finish.

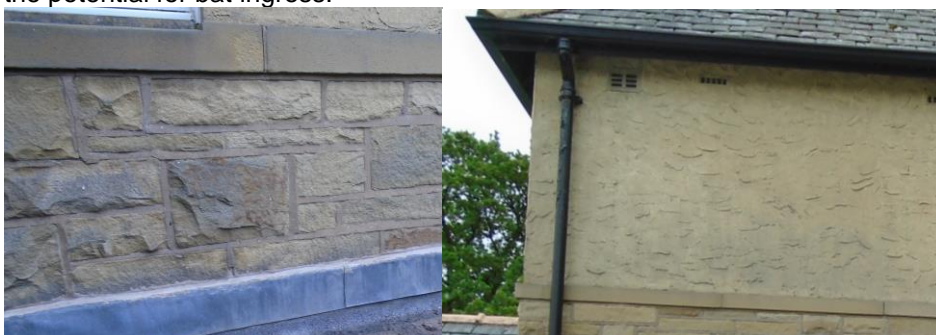
All the walls are in excellent condition and do not provide any cracks, crevices or access points with the potential for bat ingress.

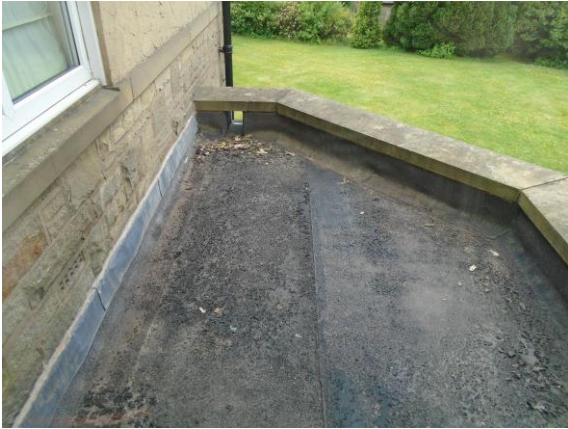
Porch roof

The garage and porch roof and has a parapet to the perimeter with an asphalt finish. and lead flashing to the adjacent house wall.

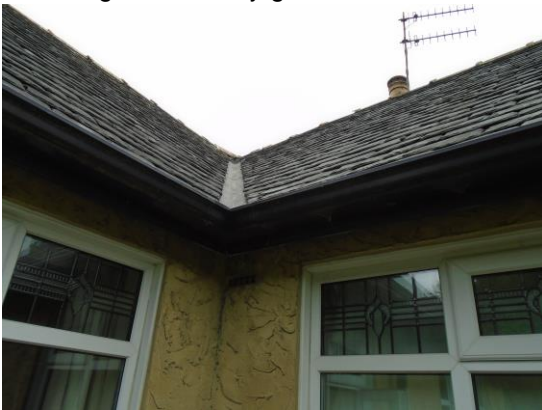
The main house roof is a gabled, pitched and hipped structure, with an exposed rafter eaves overhang. Lead valley gutters, blue slate finish and pointed ridge tiles.

roof shower extension

Eaves effected by the abutment of proposed new flat

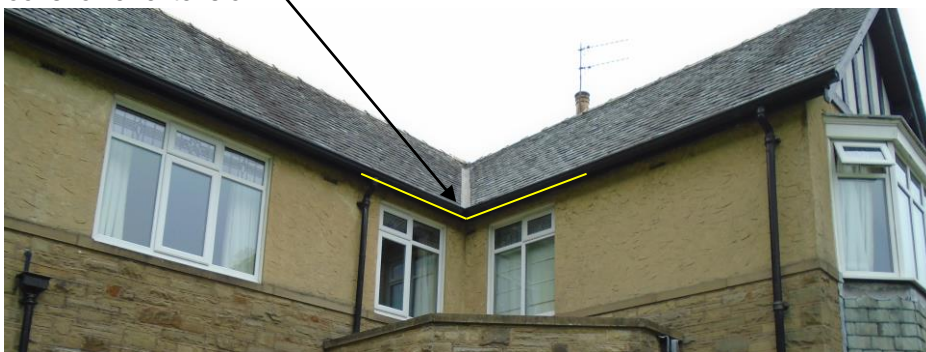
The roof of the east extension is pitched with slight eaves overhang. Slate finish with pointed ridge tiles.

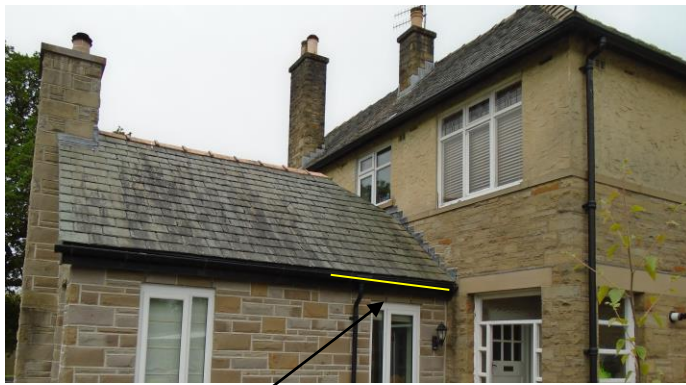
proposed extension

Section of eaves being affected by the

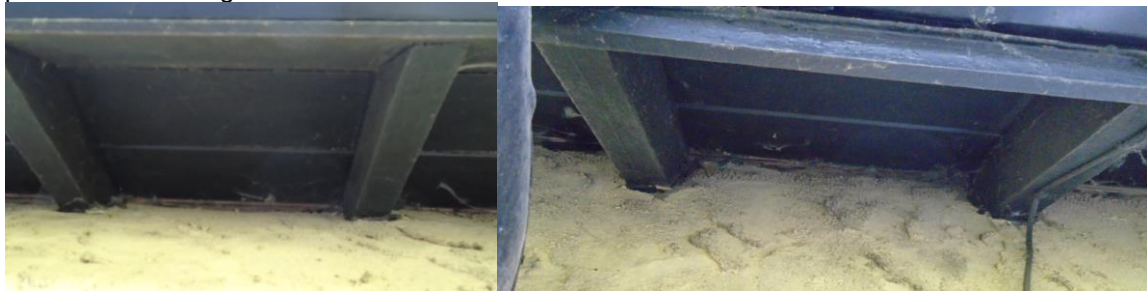
The porch roof was accessible thus it was possible to closely inspect the eaves, slates and condition of the ridge pointing of the main house roof. The slates were in excellent condition and tight fitting. The ridge pointing was in very good condition. No access points or crevices were found with the potential for Bat ingress.

Eaves adjacent to proposed shower room

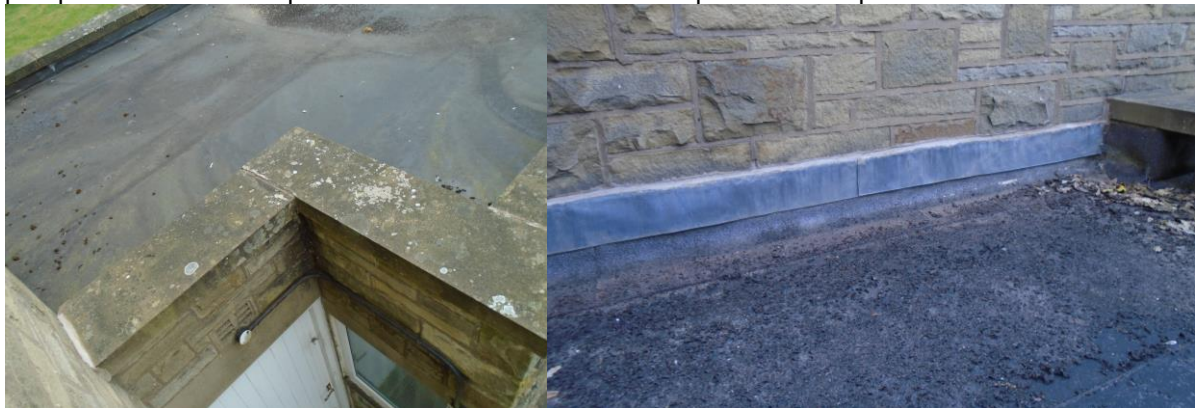
The garage and porch flat roofs were in excellent condition, flashings were very tight fitting and The parapet walls were well pointed and flashed. No bat roost potential was present in the flat roofs.

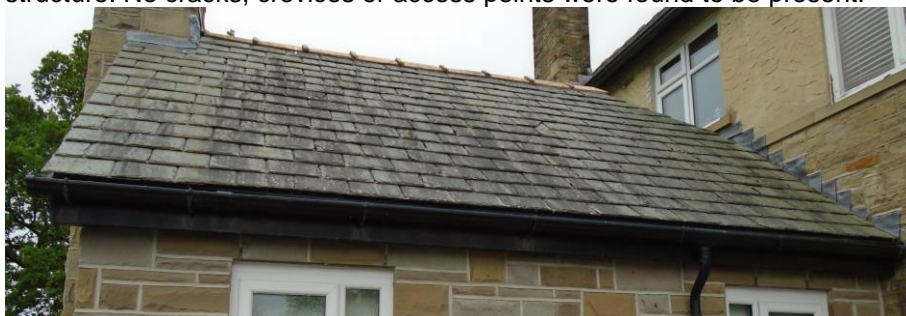
The east extension roof was in excellent condition it was possible to closely inspect all aspects of the structure. No cracks, crevices or access points were found to be present.

North roof pitch adjacent to the proposed flat roof connection.

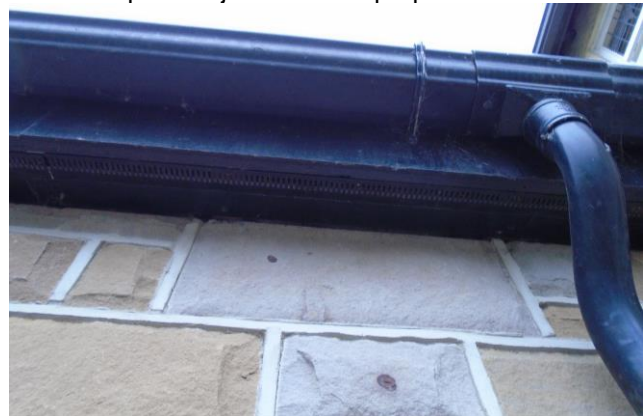
The eaves of the extension where the proposed flat roof extension will adjoin

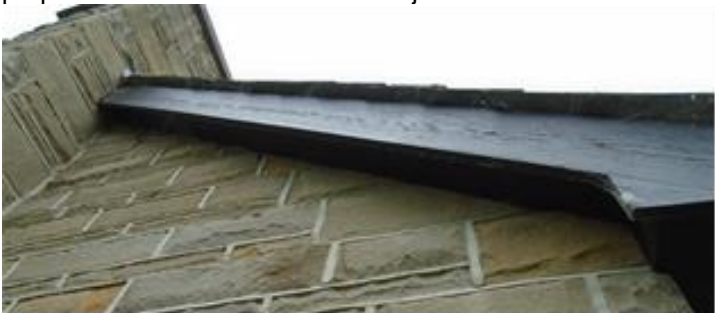
The extension gable barge board and soffit and slate abutment all in excellent condition and very tight fitting.

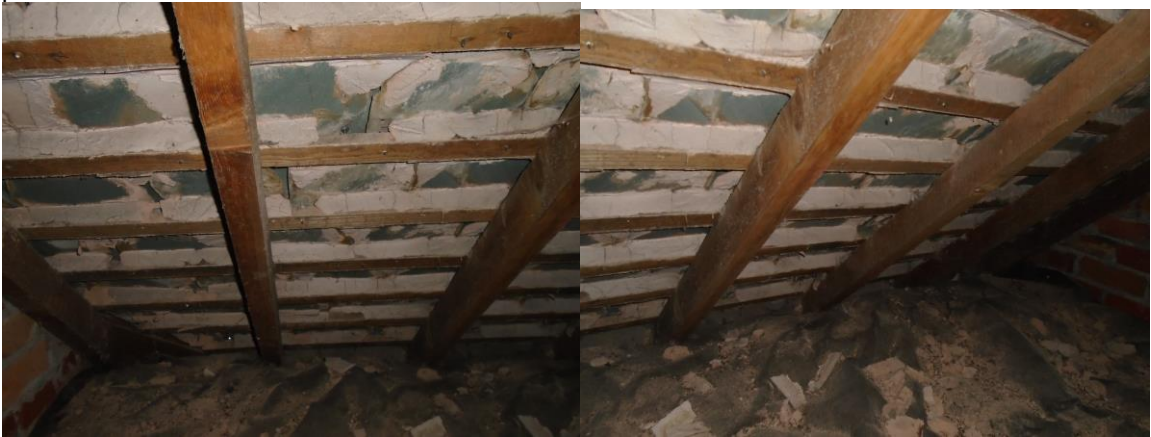
The roof space adjacent to the proposed shower room was accessible The timbers were in good condition with the slates pointed over, no underlay was present. The space was dusty, however inspection of the insulation present between ceiling joists did not reveal any dropping or insect remain evidence. The space provided sub optimal roost potential and evidence of current or historic presence was not found.
