Preliminary Bat Roost Assessment Report

Fairfield Farm,
Longsight Road,
Clayton le Dale,
BB2 7JA

19.05.2023

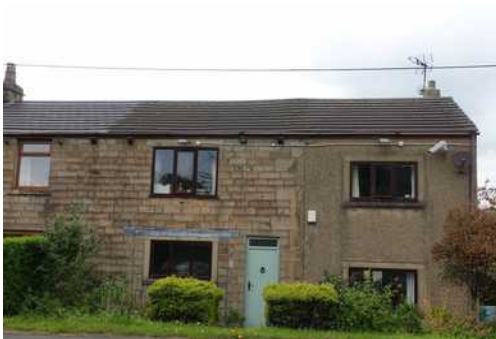
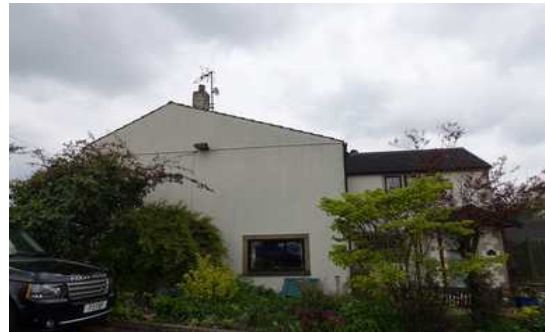
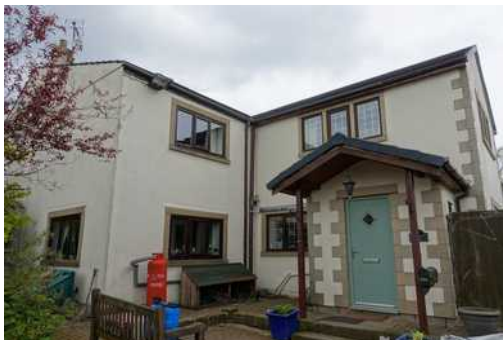
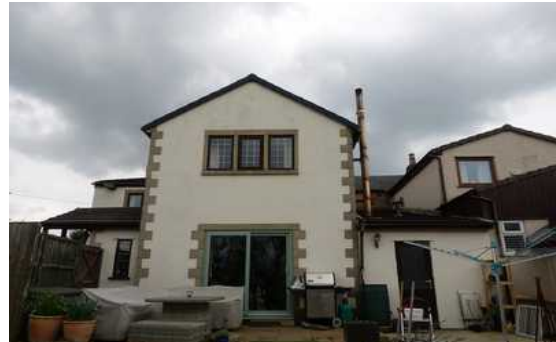
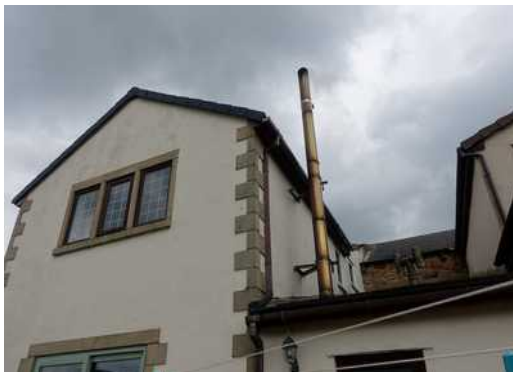
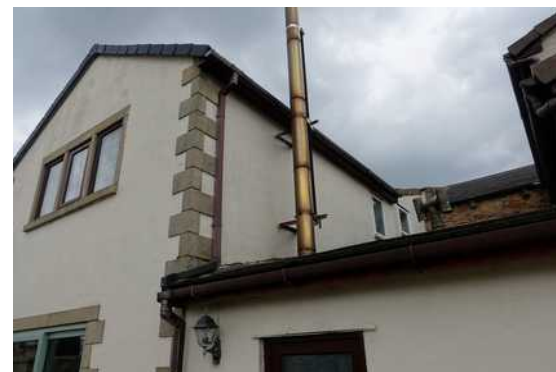
The property consists of a stone built two storey house with a double pitched tiled roof. The building has a double storey and single storey extension present to the rears.

External walls are well pointed, and partially rendered and painted with no obvious cracks, gaps or crevices present. Eaves and gable ends are pointed and sealed. Soffit boxes on the rear south west facing wall were observed to have some gaps present.

Roof tiles are close fitting, with no lifted, slipped, or missing tiles present. The ridge is well sealed.

The property can be considered to offer low bat roost potential.

The building is generally well sealed with no cracks, gaps, cavities or crevices suitable for roosting bats, however gaps were observed on soffits to the rear of the building, and was assessed as offering low roosting potential.
