Evesons Farm  
Simonstone Lane  
Simonstone

**Re: Preliminary Roost Assessment (PRA) for Bats: Evesons Farm, Simonstone, Simonstone**

25<sup>th</sup> May 2023

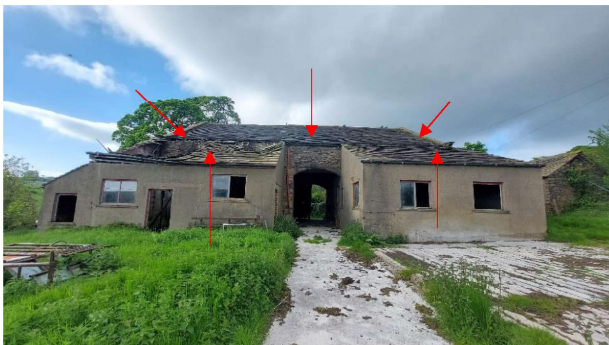
| <p>Photograph 1: Southern aspect of the buildings. Gaps throughout the roof and on gable end ridge lines.</p> | <p>Photograph 2: Northern aspect of the building. Gaps identified in the wall plate.</p> |

Potential roost features for bats identified during the external inspection were limited to a large crack between the stonework on the building's eastern aspect, gaps between roof tiles on both the main barn and the two annexes and gaps in the wall plate where the wall meets the roof.

Multiple gaps were identified throughout the roof with missing and/or slipped tiles. The roof was constructed of what were presumed to be slate tiles. The roof did not comprise any insulation and could be fully inspected internally without constraint. The annexes comprised large stone tiles with multiple gaps identified on each. The southwestern annexes roof had partially collapsed leading to numerous tiles being lifted or overlapping one another.

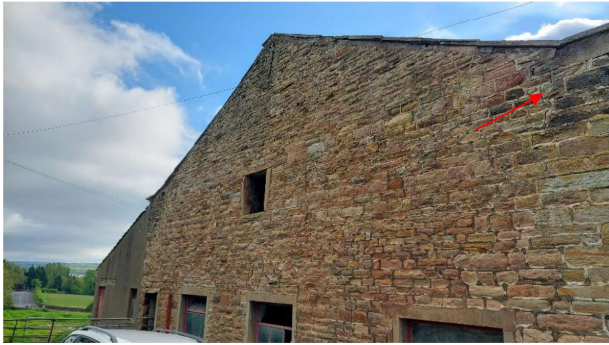
| <p>Photograph 3: Eastern aspect. Crack between stonework.</p> | <p>Photograph 4: Western aspect of the building. Gaps between wall and roof tiles and between tiles on the annex (right of photograph).</p> |

The building was constructed of stone with a double skin thus a cavity was recorded when undertaking the internal inspection (see below). The external stonework was mortared which was generally in good condition on all elevations, however a crack measuring approximately 1.5m in height was identified on the building's eastern aspect on the far north eastern corner of the building.

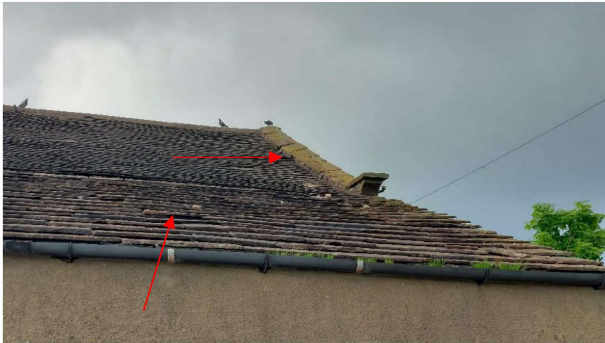
Photograph 5: Southern aspect. Missing mortar on gable end ridge line and lifted tiles throughout.

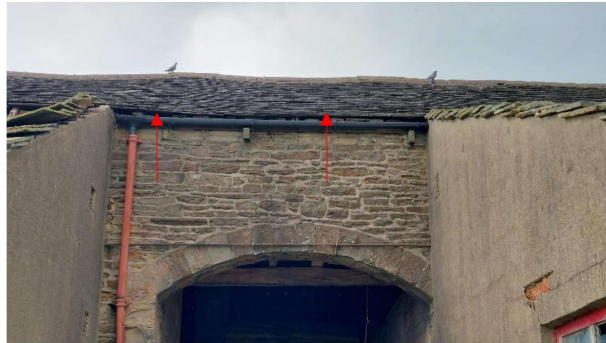
Photograph 6: Southern aspect. Gaps in wall plate.

On both the northern and southern aspects numerous gaps in the wall plate were identified that would potentially provide access for bats in to any wall cavity.

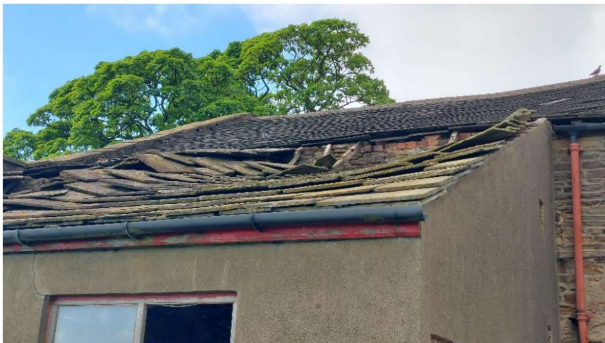
Photograph 7: South western annex. Collapsed roof had created multiple features for roosting bats (likely day roost only in this location).

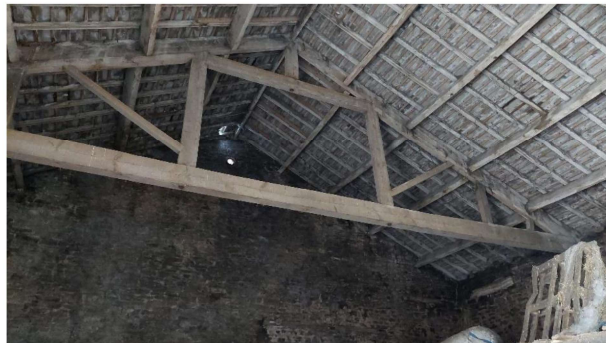
Photograph 8: Internal view of the roof frame and tiles.

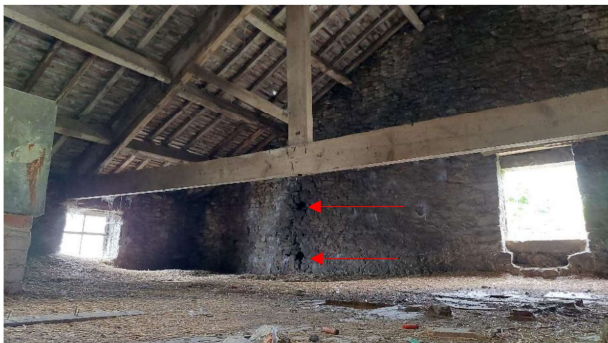
Photograph 12: Mezzanine in the eastern half of the building. Gaps in the stonework potentially provide suitable bat roosting opportunities.

Internally, due to the height of the building and the unsafe mezzanine floors all walls couldn't be fully inspected, however, using a high powered torch and binoculars enough of the walls could be inspected to provide an accurate assessment of the potential suitability of the features. Missing stonework on the eastern, western, and southern walls of the building were subject to an endoscope inspection. No bats were recorded, however, these features were suitable to support a bat roost.

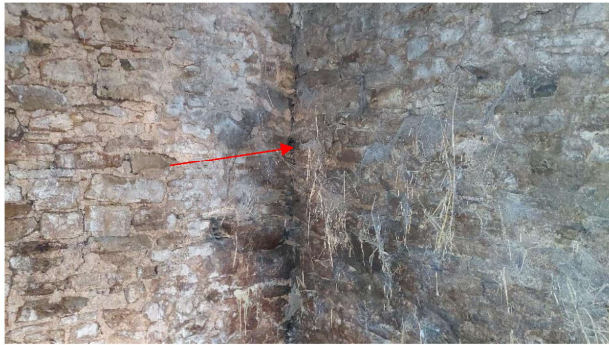
Photograph 14: Gaps in the south western corner were subject to endoscope but no bats recorded.

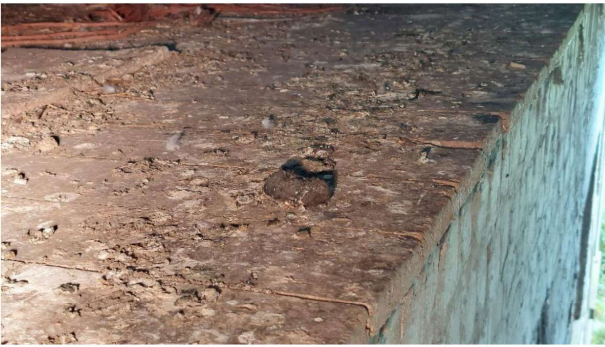
Photograph 17: Example of pellet recorded on the building's eastern mezzanine.

It should also be noted that pellets that were recorded on the larger mezzanine in the eastern half of the building. It couldn't be conclusively determined from what species they were from as the size of the pellets varied. Potential species which includes barn owl, could be little owl, kestrel etc. The pellets were estimated to be at least 6-8 months old suggesting the building isn't used regularly. No further evidence of breeding was recorded within the building.
