# **Heritage statement to support planning application**

## **for the conversion of Eveson's Barn, Simonstone**

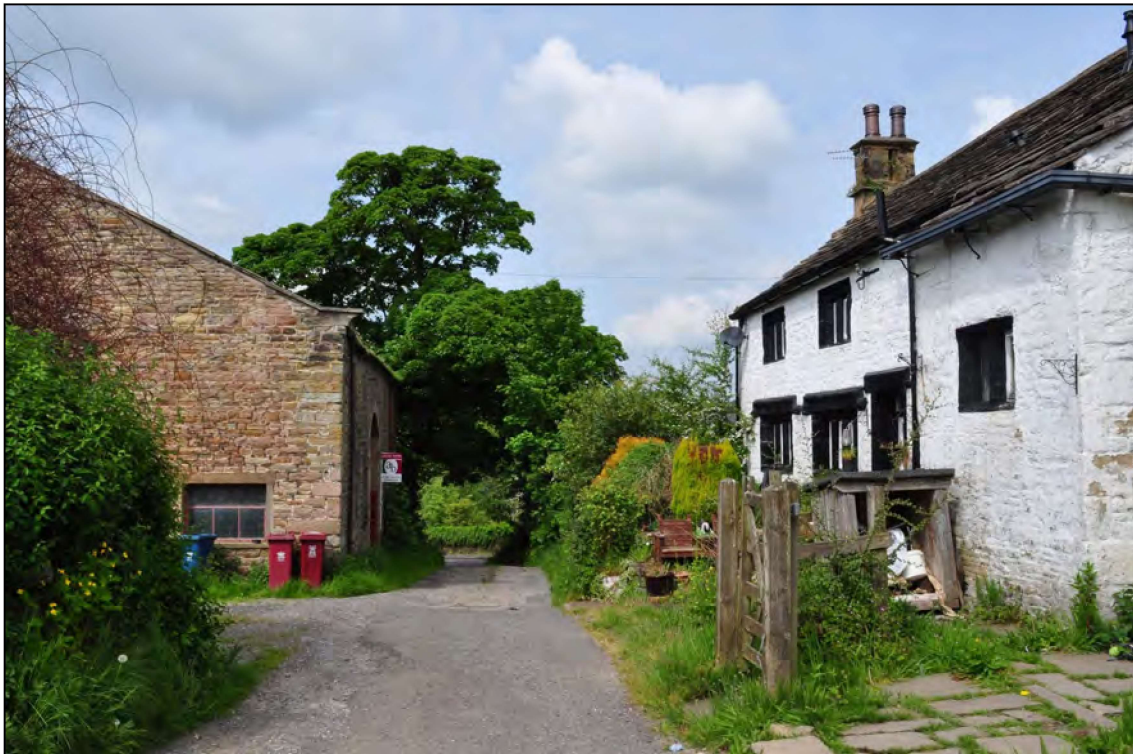
- 2.2 The listed building of "Evesons Farmhouse and Evesons Farm Cottage" (shown on some maps as Nest Cottage) stands some 8m to the north-east of the barn, on the opposite side of the track ("LB" on figure 1, and photo 1, below).

Photo 1: The barn (left) in relation to the listed building (right). Looking west, down towards Simonstone Lane

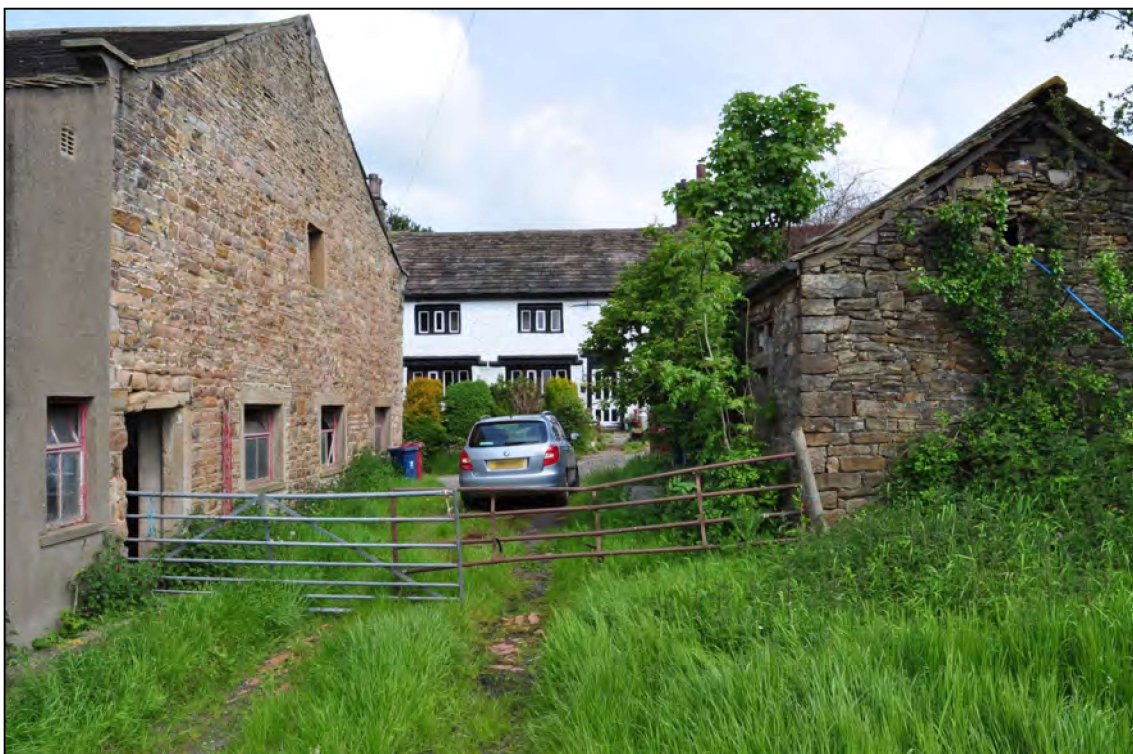
- 2.3 The barn's north side faces directly onto the track, and the east side onto a cobbled yard and a small, single-storey traditional building (photo 2). These are included within the property boundary but no works to them appear to be proposed as part of the present application. The south and west sides of the barn face onto a pasture field, and ground level slopes down from east to west, so that there are a number of different floor levels within the building.

Photo 2: East gable of barn (left), outbuilding (right), and listed building (centre)

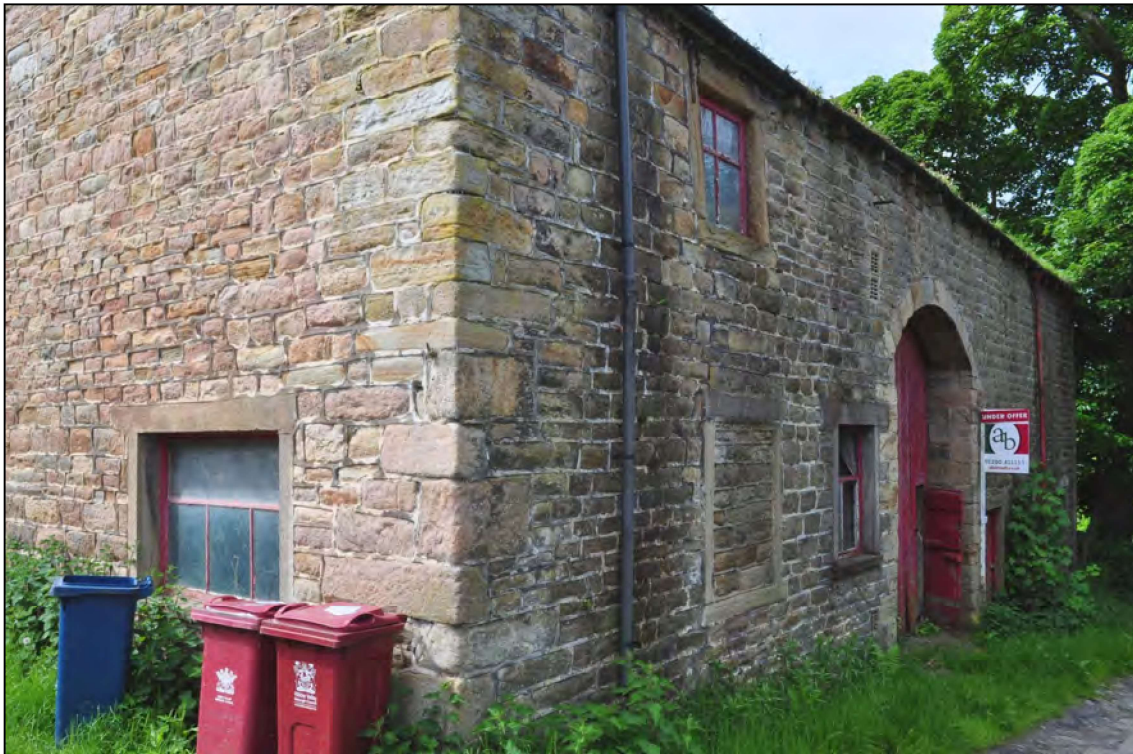
- 6.1 The building comprises a five-bay, stone-built, combination barn, likely to date from the early nineteenth century, which has a pair of brick-built, mid-twentieth century outshuts on the south side (photos 3 to 6).

Photo 3: North elevation of barn

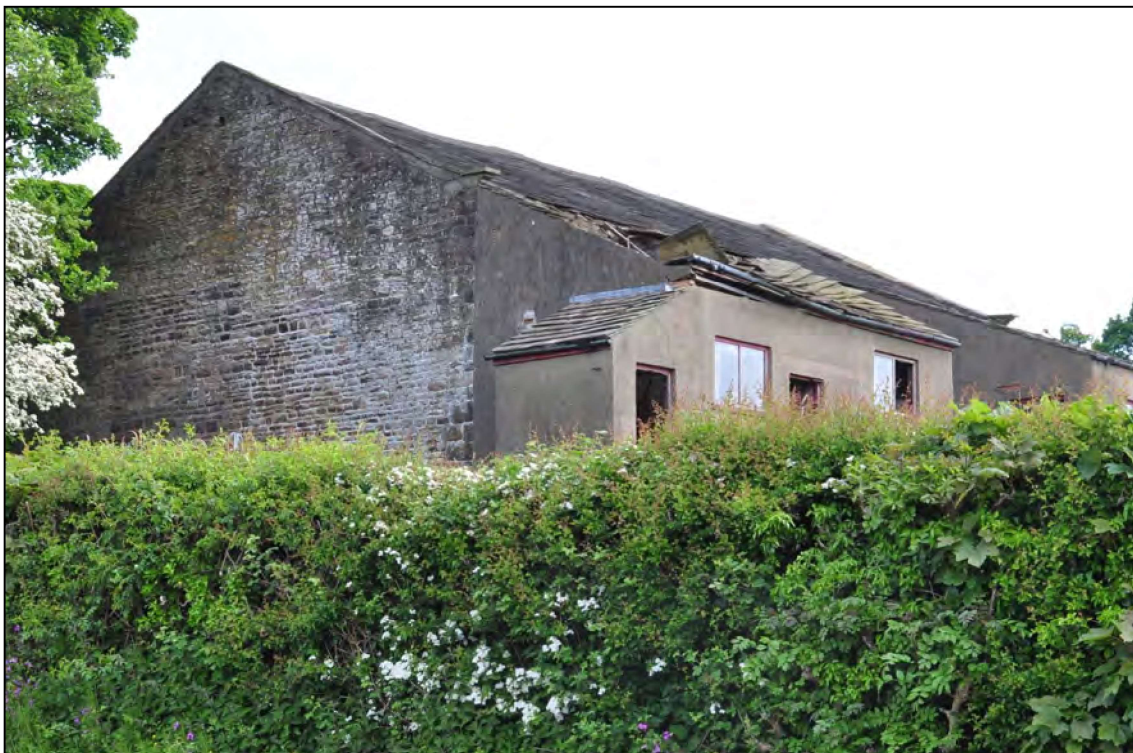
Photo 4: View of barn from Simonstone Lane, looking north-east

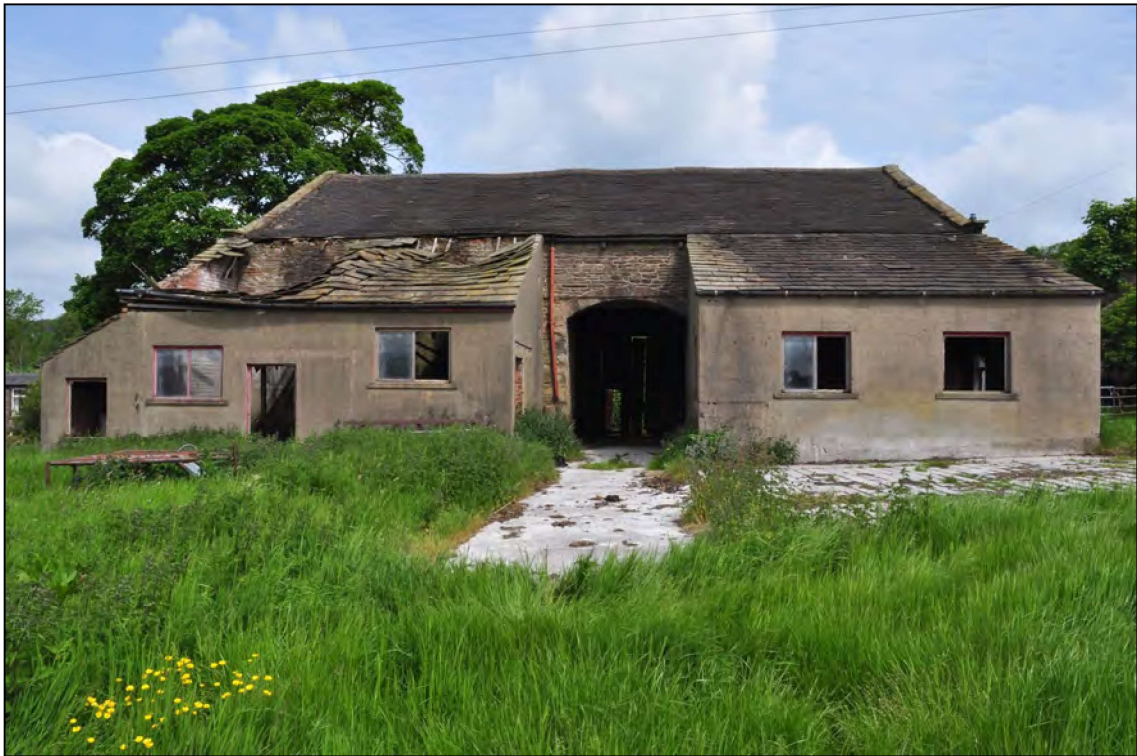
- 6.6 The barn's roof is carried on four queen-strut trusses of imported pine; the central two tie-beams are at a higher level than the outer two, and supported on piers of dressed stone (photo 10).
- 6.7 On the south side of the stone barn, two brick-built and rendered outshuts, with stone slate roofs, were added in the mid twentieth century (perhaps the 1950s), to provide additional cow housing. These have a lower solid-to-void ratio than the stone structure. There is a small projecting lean-to at the south-west corner (proposed for demolition), which forms part of these extensions. The roof of the west outshut has partly collapsed.

Photo 5: South side of barn, with mid twentieth century brick-built outshuts either side of arched cart entrance

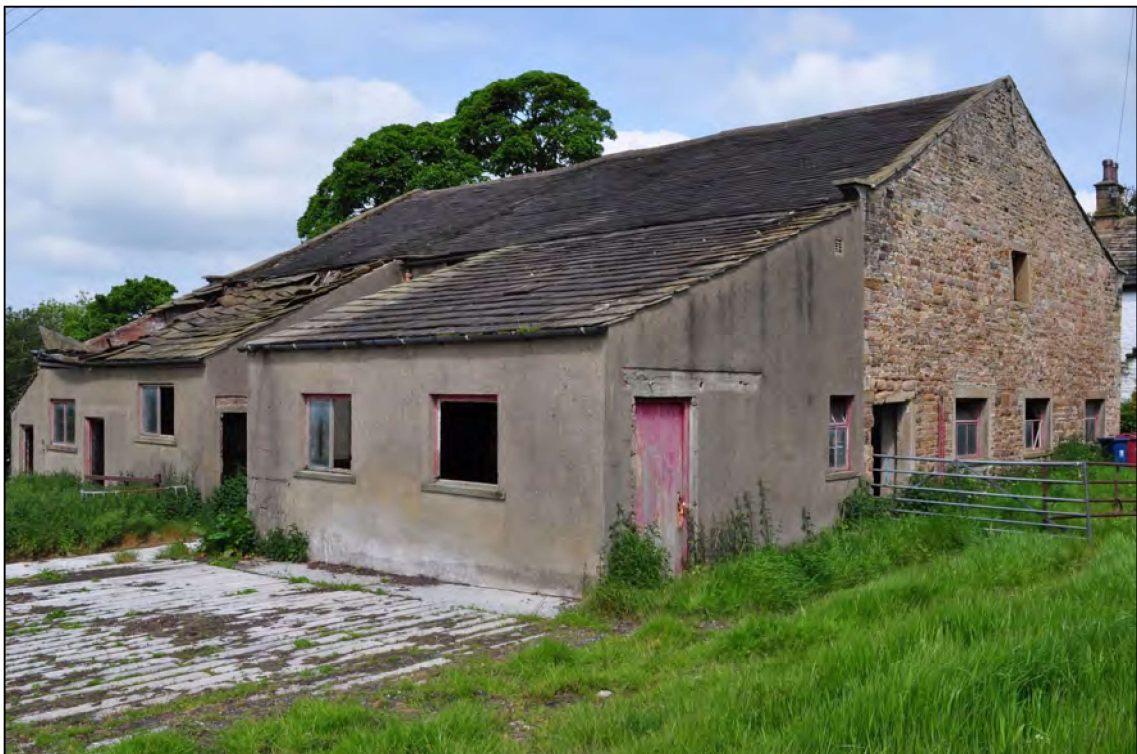
Photo 6: View of barn, looking north-west

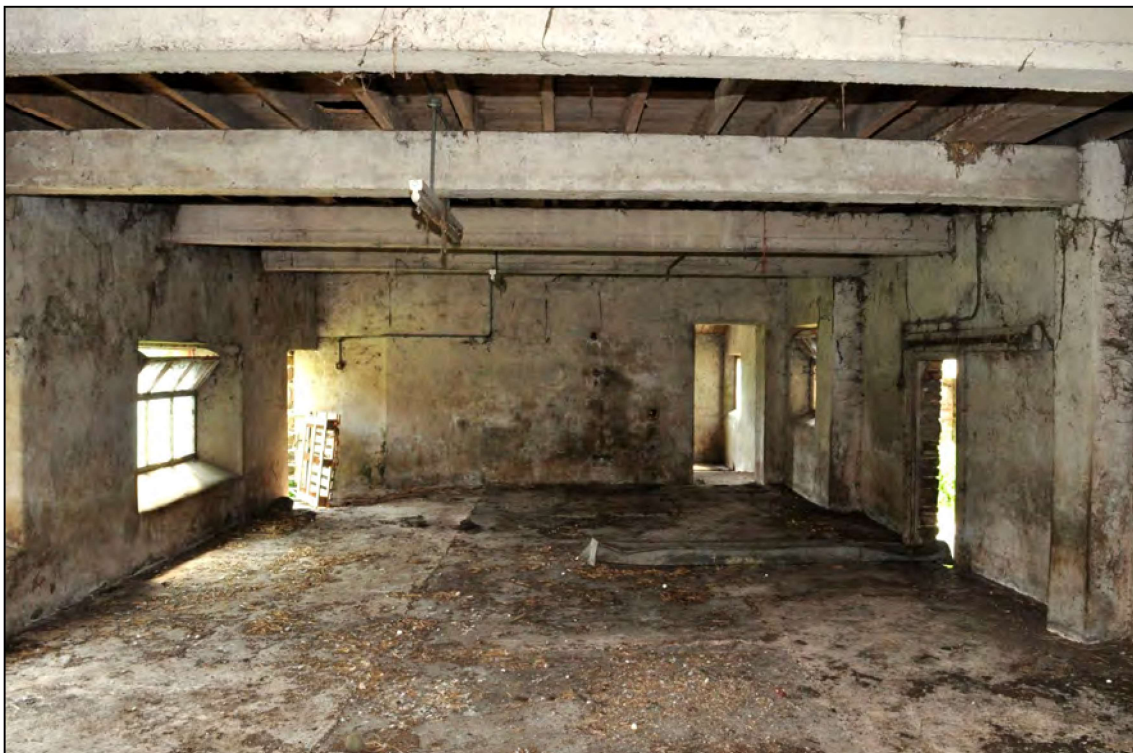
flagged floor, and is open on the west side, where there is a large, full-height space, with a modern brick wall to the north, enclosing the shippon on a slightly lower level, and supporting a hayloft over it. To the east of the threshing bay is another modern shippon with concrete floor and with hayloft over supported by concrete beams (photo 9).

Photo 9: Modern shippon in east end of barn, with concrete beams over

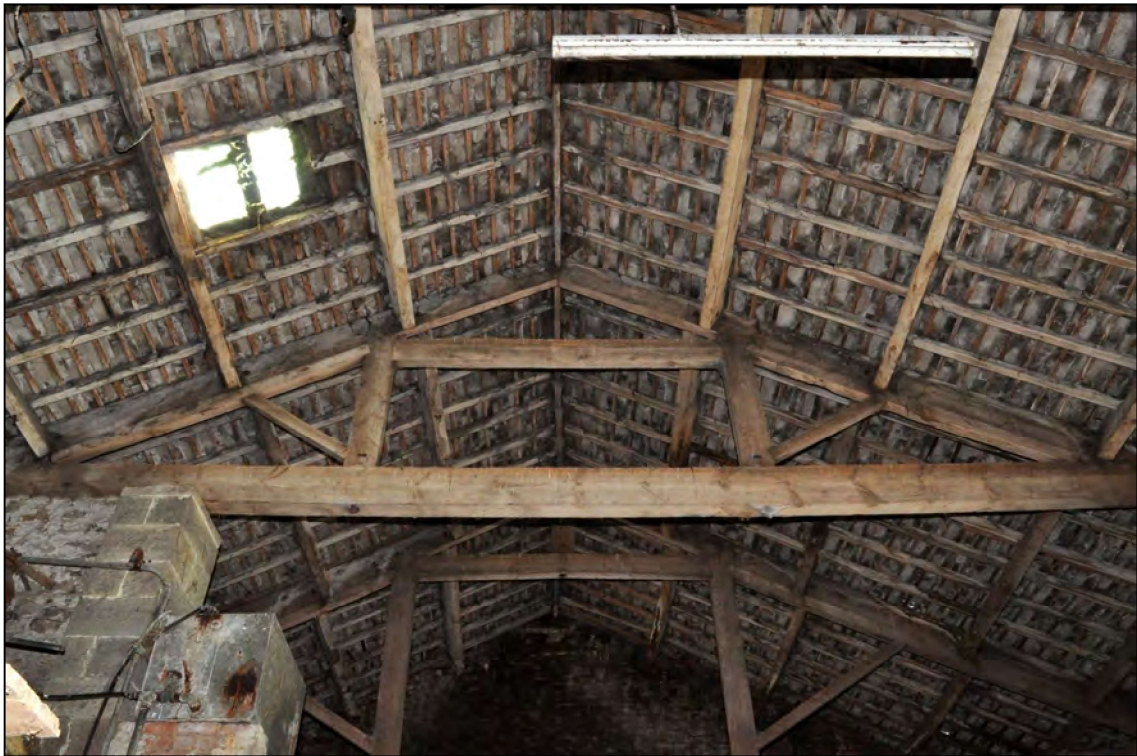
Photo 10: Roof trusses over barn
