# Heritage Statement – 18 Church Street

Ribchester, PR3 3XP

Prepared by Jamie Skuse BA (Hons)

7<sup>th</sup> August 2023

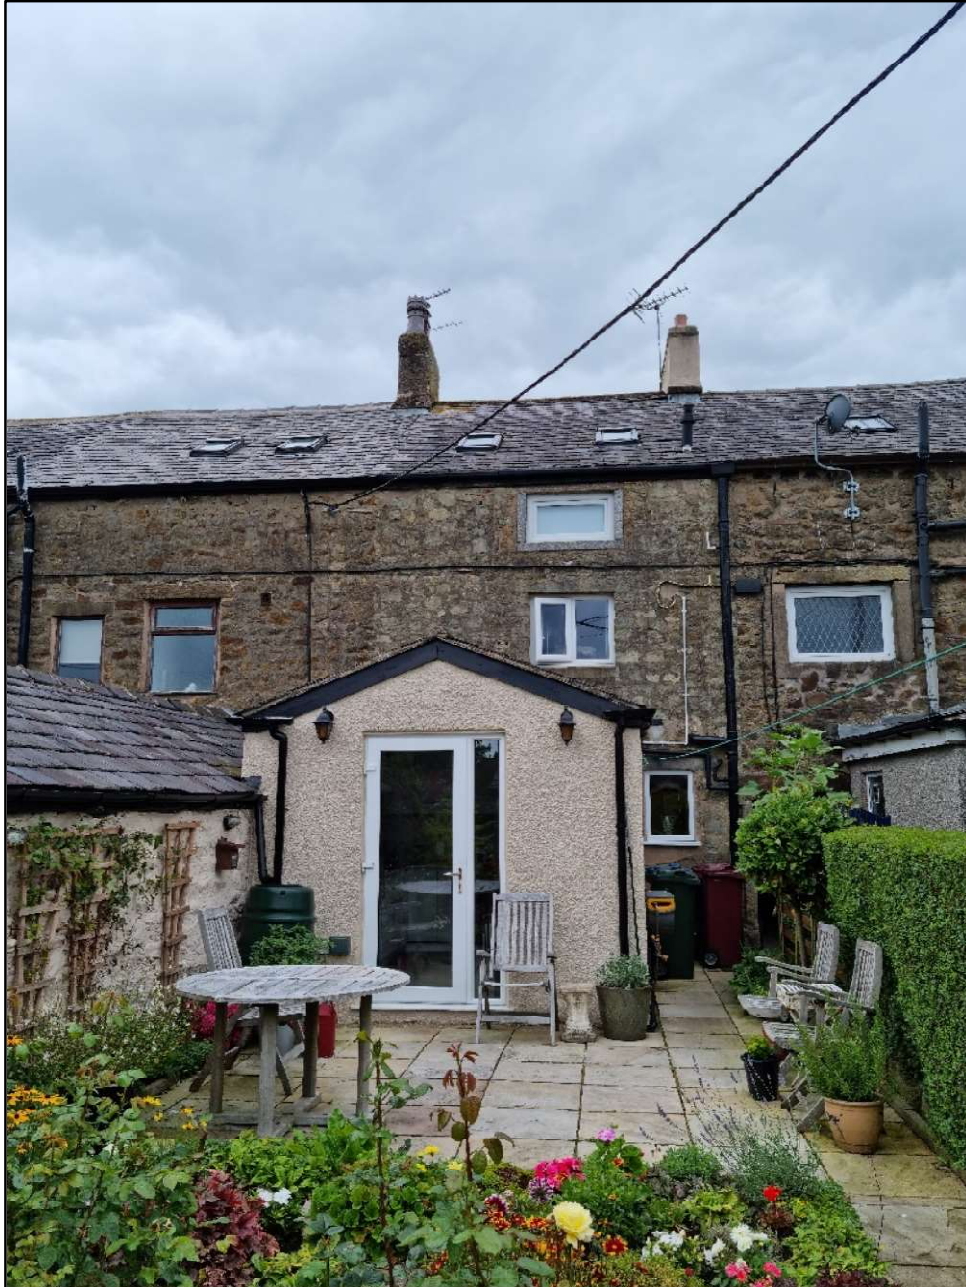
*Figure 1 The rear elevation of No 18 Church Street. The two rooflights are located between the two chimneys and are above the attic window at the top of the elevation (source - Jamie Skuse)*

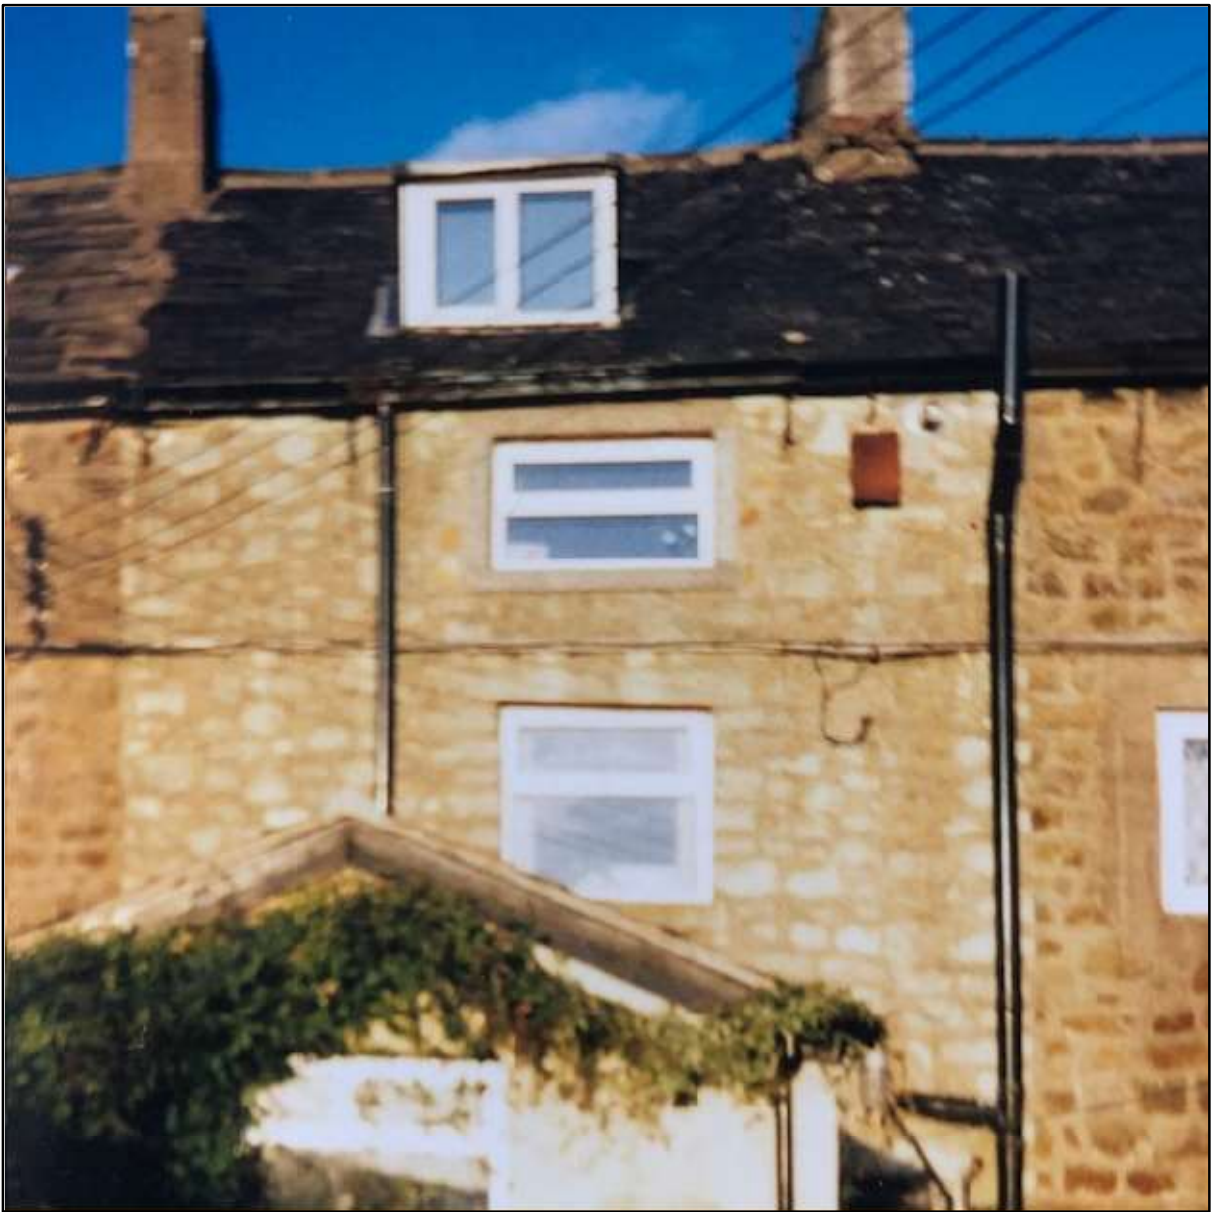
*Figure 3 A photograph of the dormer window, taken pre-2002 (source - Jackie Baker)*

- 4.4 The windows throughout the property have been replaced with modern glazing, and therefore holds no evidential value. This includes the dormer window that was removed in 2002 from the roof of the rear elevation, which was a modern installation with a PVC frame.

- 5.10 The dormer window was removed from the roof of the rear elevation in 2002. It was of a modern construction featuring a white PVC window frame attached to the wooden frame of the dormer and therefore unlikely to have held any heritage value. The date of the installation of the dormer is unknown.

- 5.11 The extra height and profile of the dormer window would have increased its visibility from the recreational space to the rear of the property and broken the roofline of the row of cottages when viewed from ground level. It is likely that the dormer window would have had a negative impact on the significance of both the heritage asset and the conservation area.

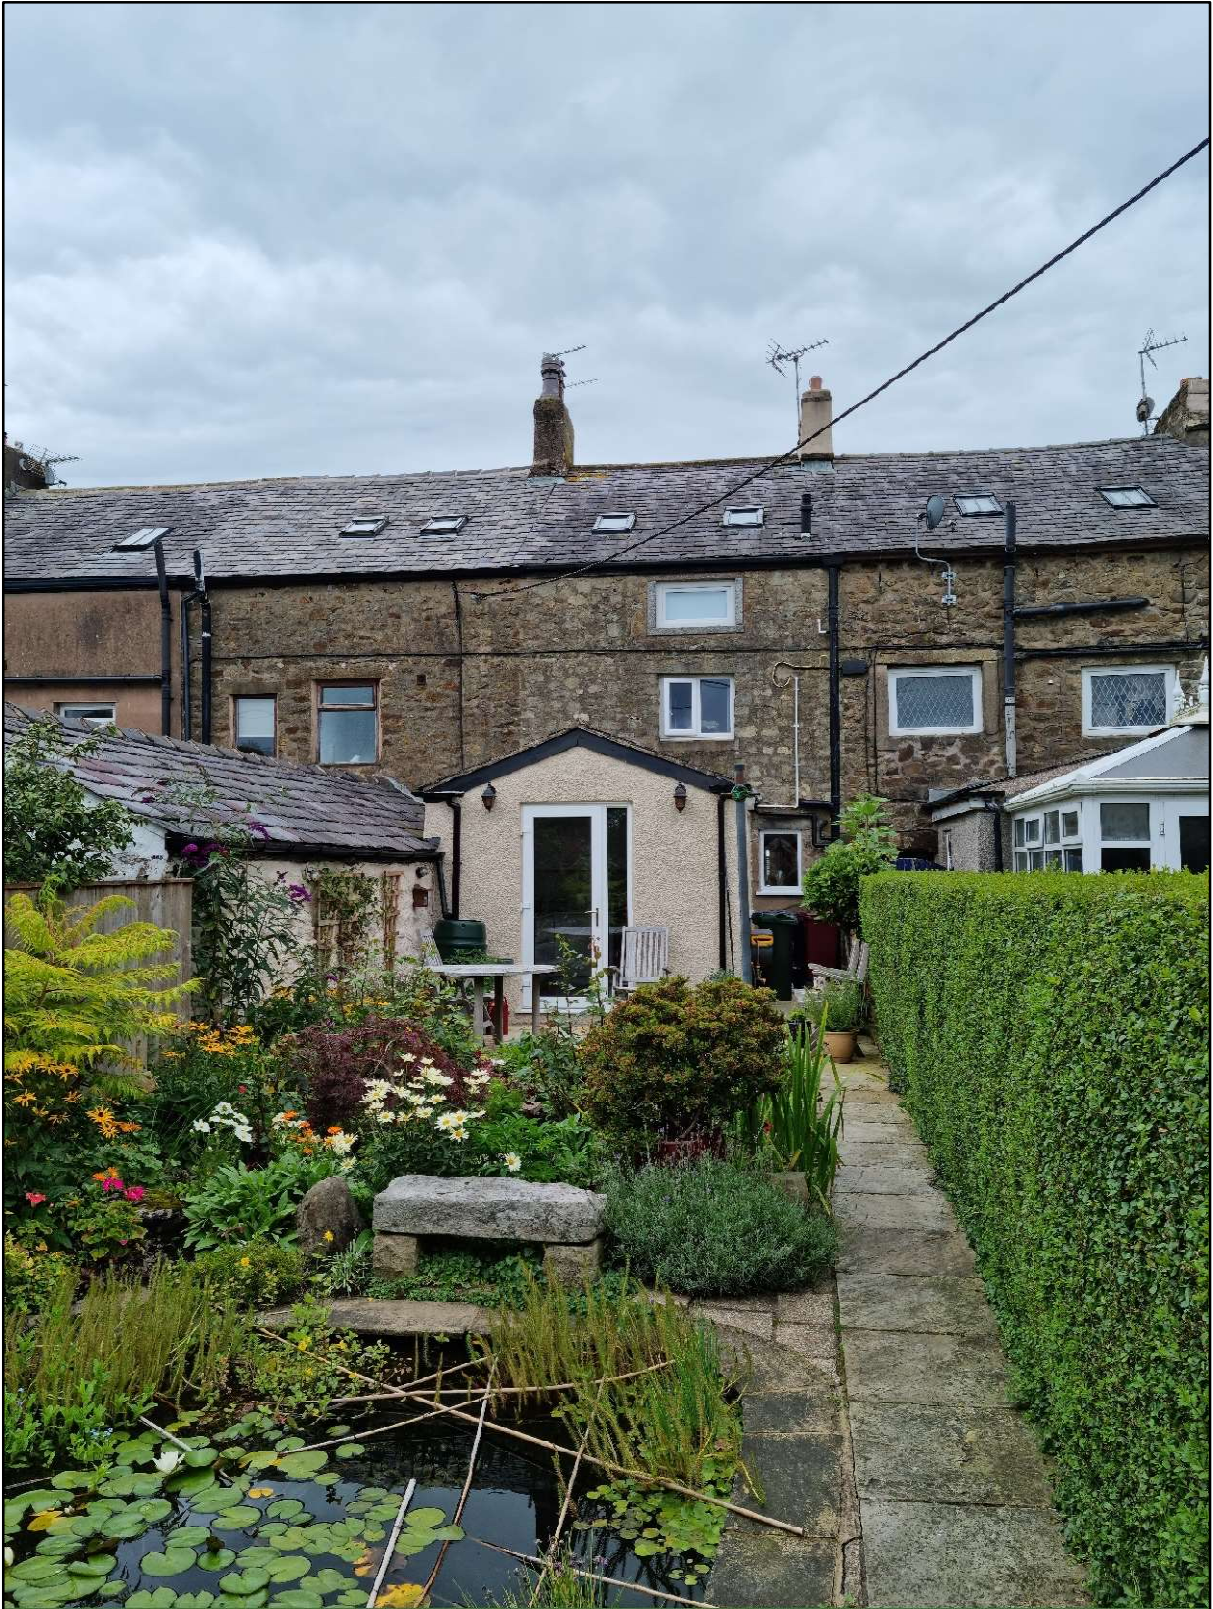
- 2.8 The building has stone slate roofing on the front elevation, and slate roofing on the rear elevation. The roof has two small dark framed Velux skylights fitted in the centre. These were installed in 2002, replacing a modern PVC framed dormer window. The windows throughout No 18 are modern PVC additions with glazing.

*Figure 4 Photograph of the rear elevation and the rooflights, taken from the rear of the garden (source - Jamie Skuse)*

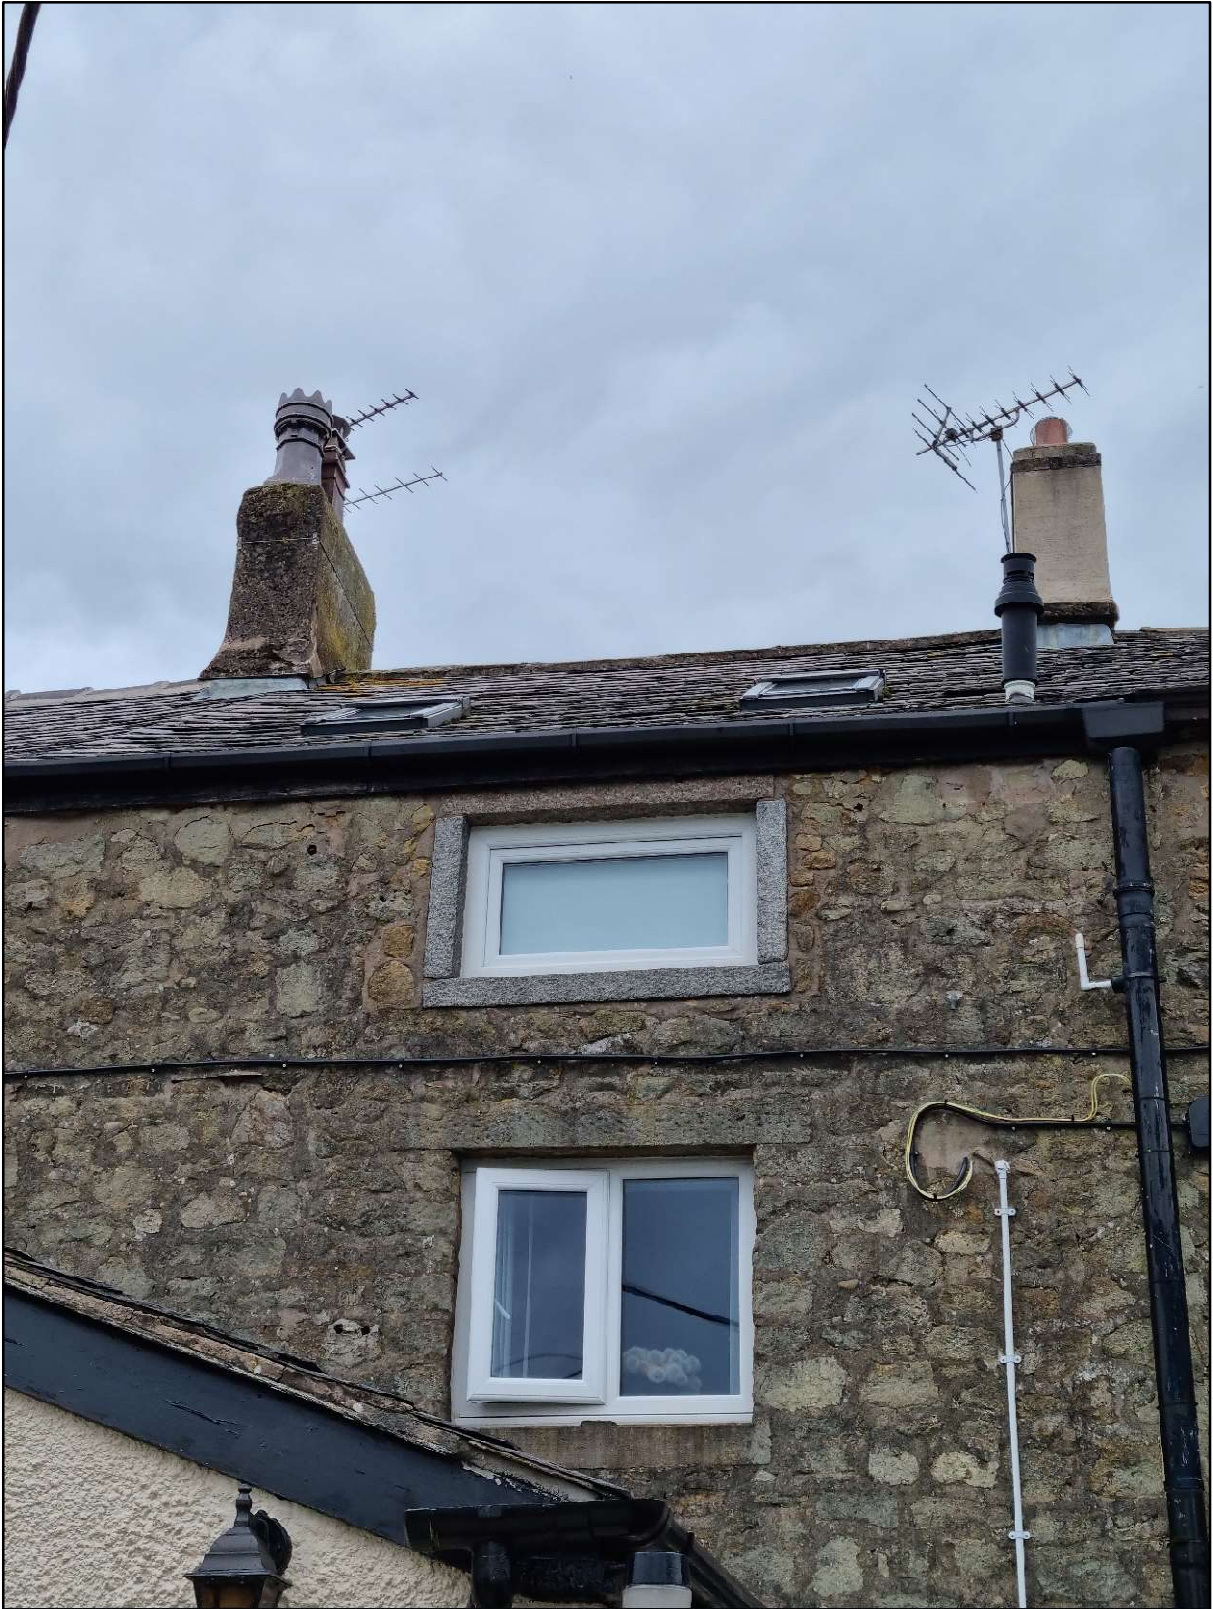
*Figure 5 Photograph taken of the roof from the position of the rear extension (source - Jamie Skuse)*

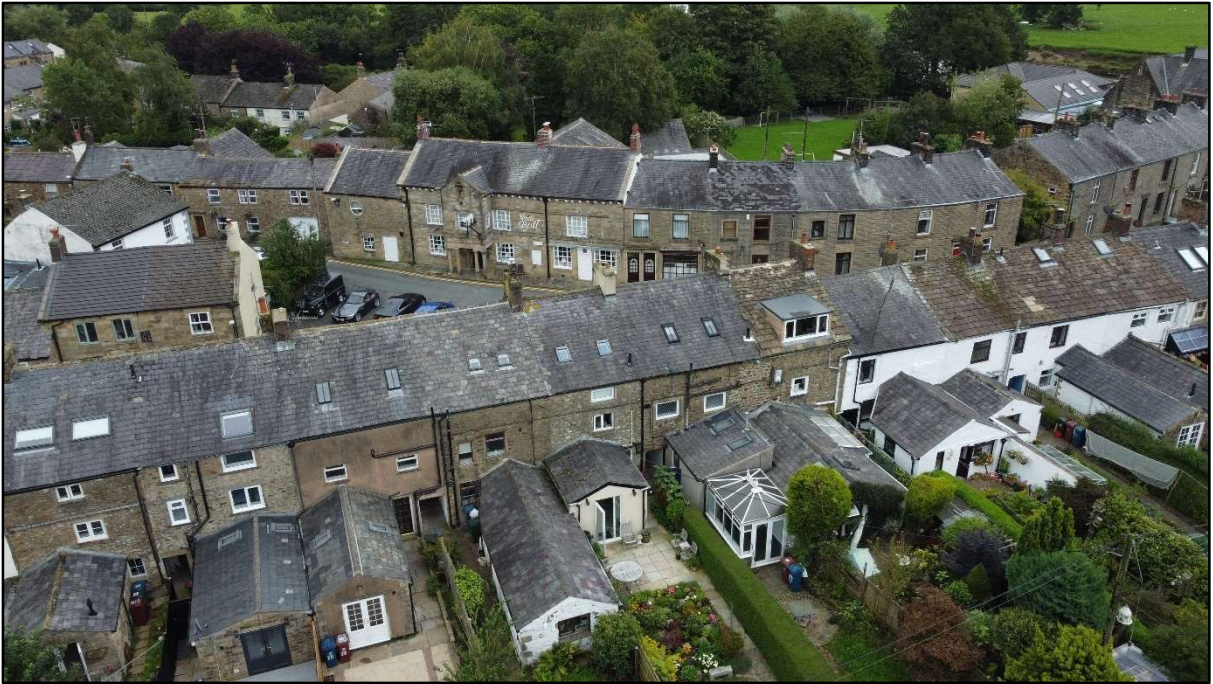
Figure 6 Photograph taken with a DJI Mini 2 drone of the roof of the heritage asset. No 18 is central in the picture, with the door to the extension open (source - Jamie Skuse)

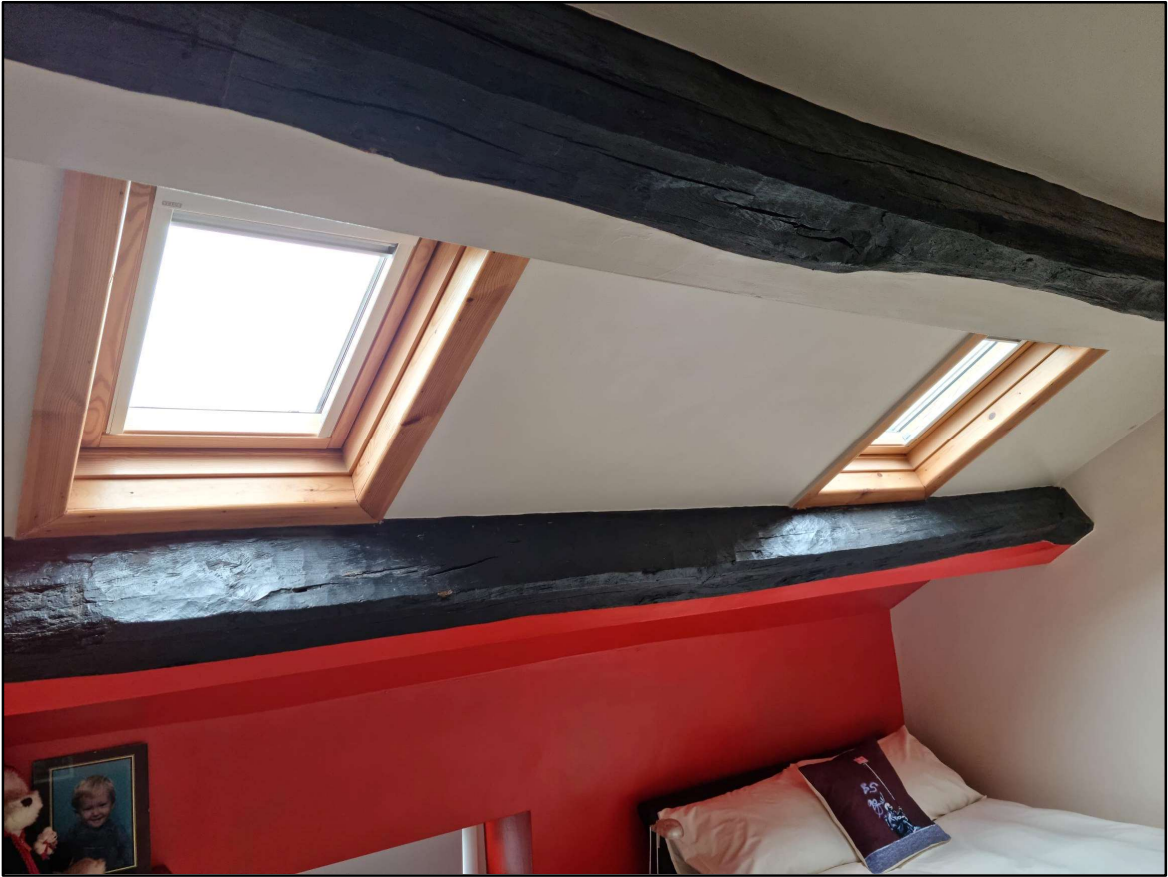
Figure 7 Photograph taken from within the attic looking at the internal view of the rooflights (source - Jamie Skuse)

- 5.12 The two roof lights that the owners of No 18 Church Street installed in place of the dormer window are fabricated by Velux and are identified by the model number GGL C02 3000 VE. The dimensions of the rooflights are 780mm x 550mm, and the frames are wooden and coloured black to better match the slate roof on which they sit. The windows are double glazed. A manufacturers sheet is attached to the appendix which details the performance data of the roof lights.

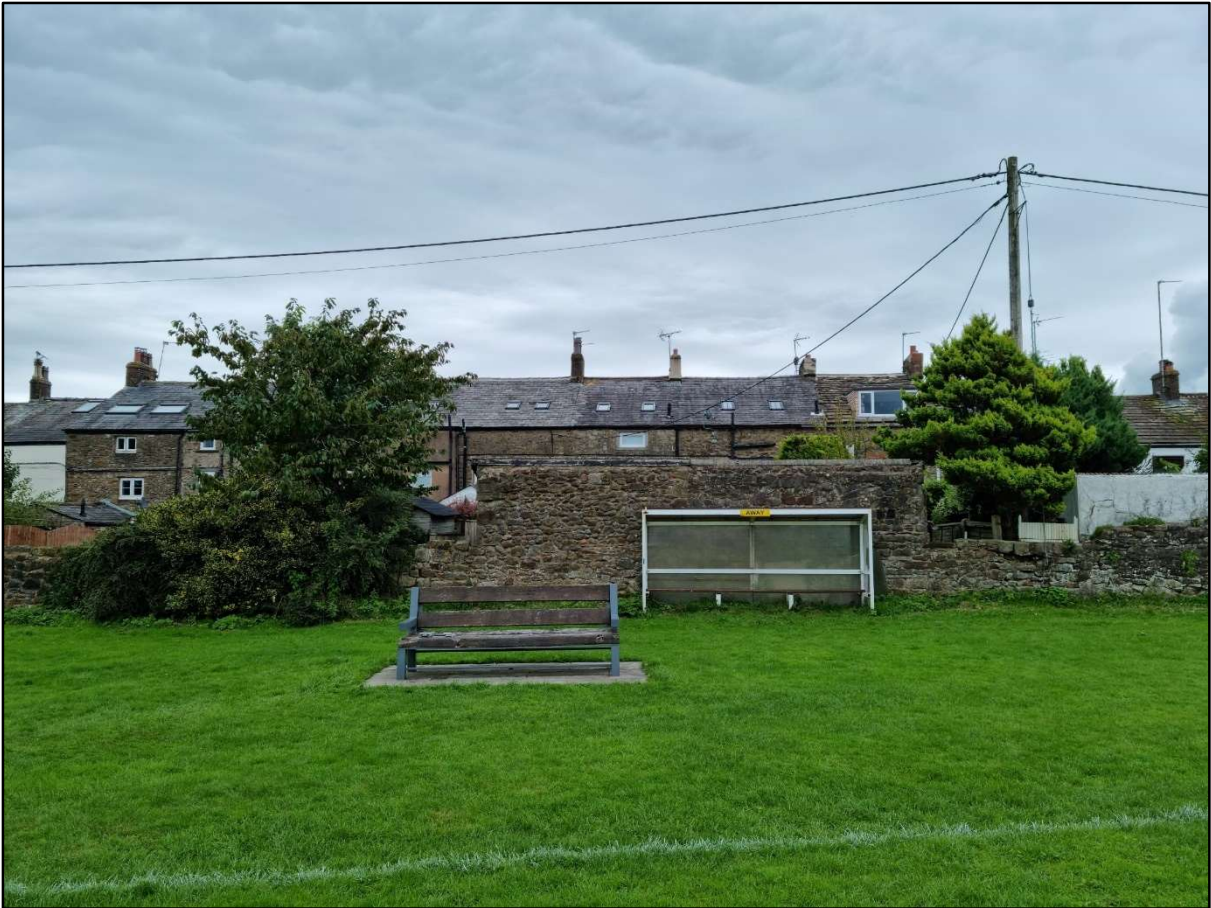
*Figure 8 Photograph taken from the recreational space to the rear of the property. Sightlines are hindered by the foliage and the stone shed at the rear of the property (source - Jamie Skuse)*

- 5.15 The rear elevation of No 18 Church Street is the less prominent aspect, facing towards the connected recreational area to the south west. This recreational space marks the south-west boundary of the conservation area, and is the only space within it with sightlines of No 18’s rear elevation roof. Sightlines of the roof from the recreational space are limited due to intermittent foliage and a stone shed at the rear of the asset’s garden.
