**Bat Survey Report and Method Statement  
European Protected Species (Bats)**

**Reasonable Avoidance and Mitigation Measures**

**Outbuildings at Parsonage Farm,  
Church Street,  
Ribchester,  
PR3 3ZR**

**21.06.2023**

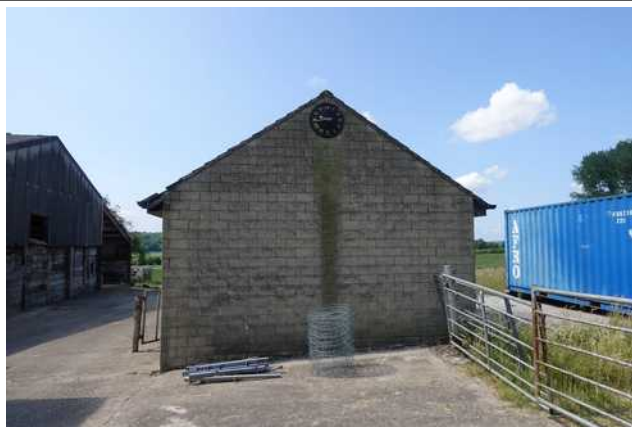
*Outbuilding 1 North Gable End*

A single storey stone faced block built outbuilding with a double pitched slate roof. External walls are generally well pointed with no obvious cracks, gaps or crevices, however internally gaps are present at wall tops.

Roof slates are generally close fitting with no lifted, slipped or missing slates present. Gaps in pointing are present on gable ends allowing access below slates. Roof slates are lined with a bituminous roofing felt.

The building was assessed as offering moderate bat roosting potential.

It is proposed that the installation of integrated bat boxes into the northern and southern gable ends is an appropriate level of roost compensation for the loss of a non breeding Common Pipistrelle roost.

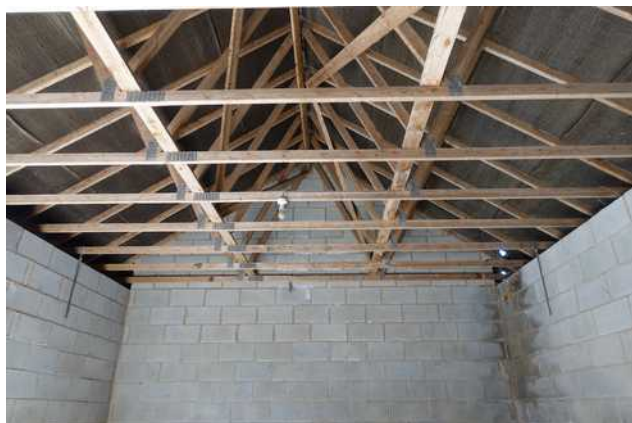
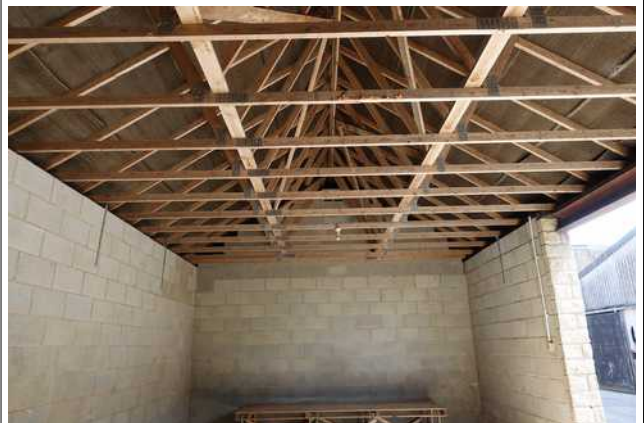
*Outbuilding Internal*

Scattered droppings were observed within the south western bay of outbuilding 1. Droppings were consistent with pipistrelle bats emerging from and returning to roost within the building.

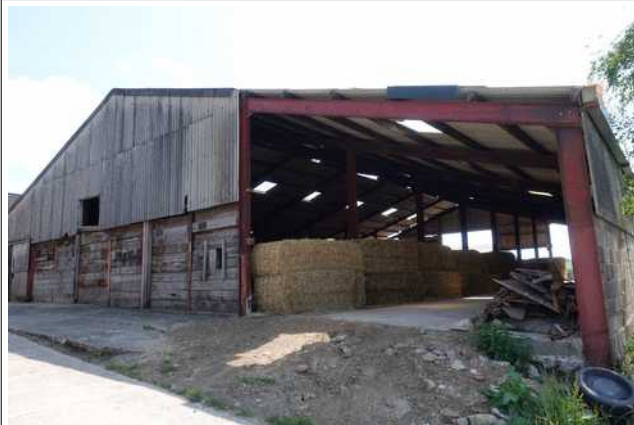
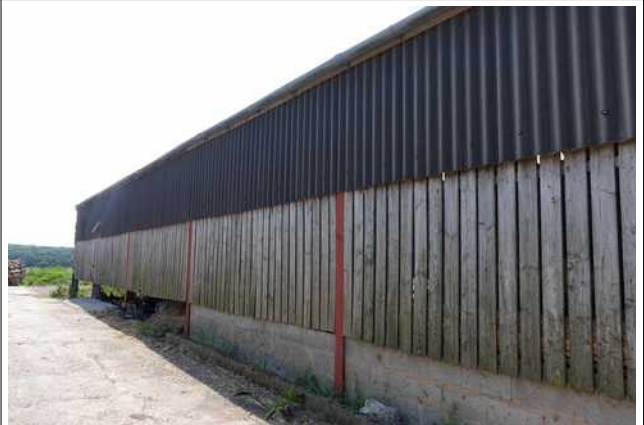
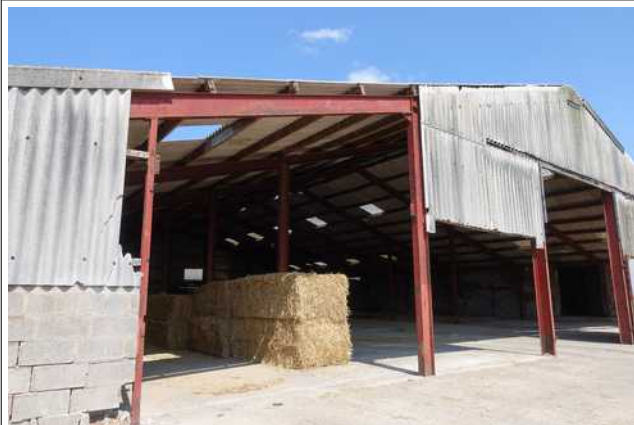
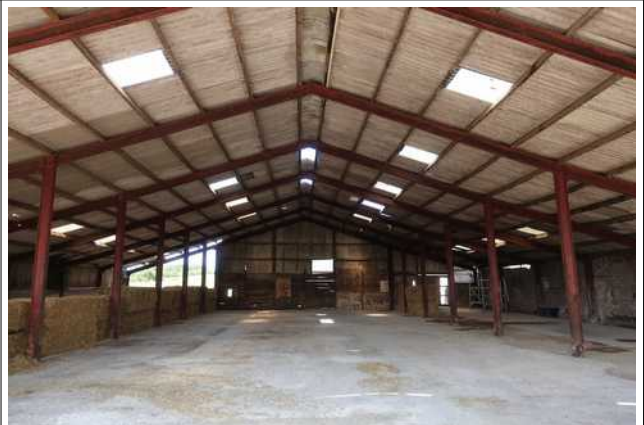
Outbuilding consists of a steel portal barn with single skin timber and corrugated metal external walls. Then building has a double pitched single skin corrugated fibreboard roof.

The building was assessed as offering negligible bat roosting potential.

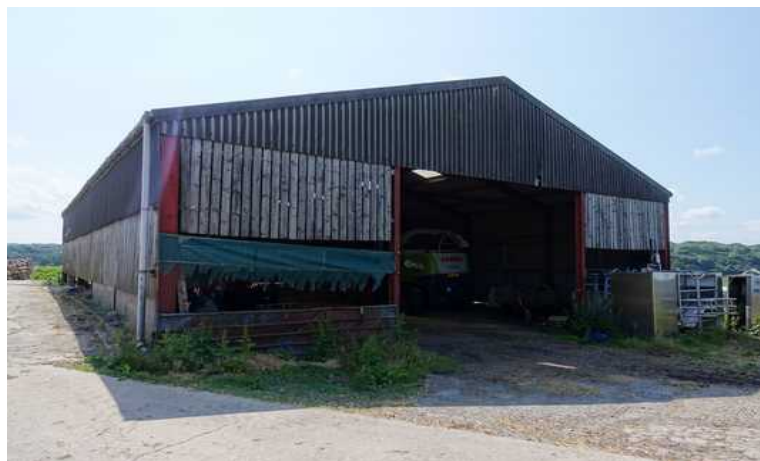
*Outbuilding 3 Northern Gable*

Outbuilding 3 consists of a steel portal barn with single skin timber and corrugated metal external walls. Then building has a double pitched single skin corrugated fibreboard roof.

The building was assessed as offering negligible bat roosting potential.

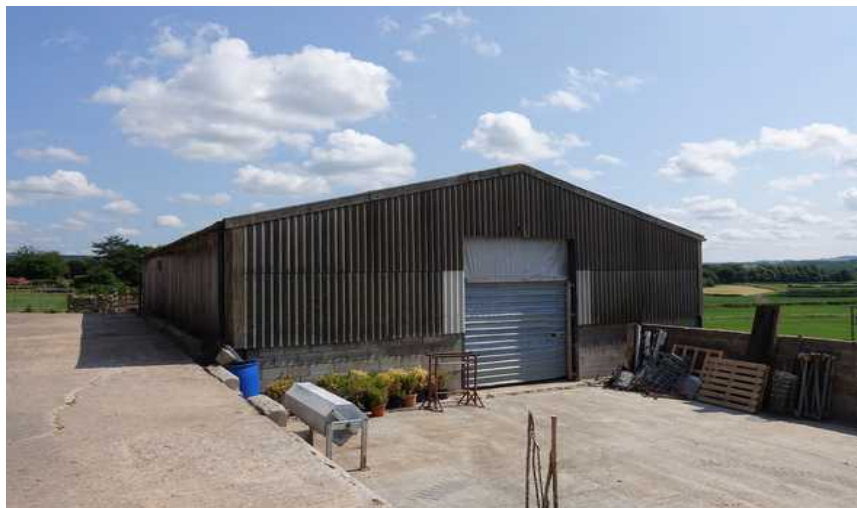
Outbuilding 4 consists of a steel portal barn with single skin concrete block, timber and corrugated fibreboard external walls. The building has a double pitched single skin corrugated fibreboard roof.

The building was assessed as offering negligible bat roosting potential.

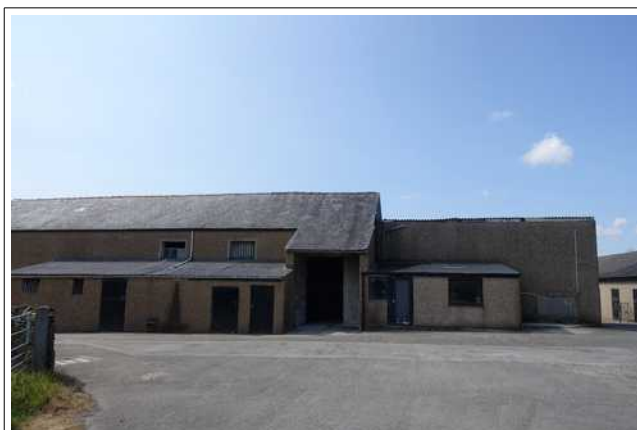
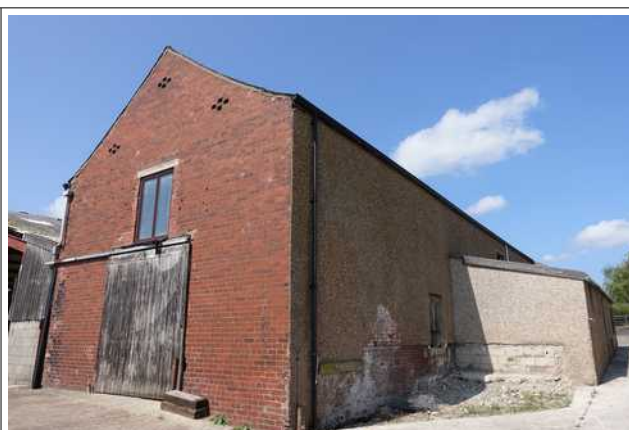
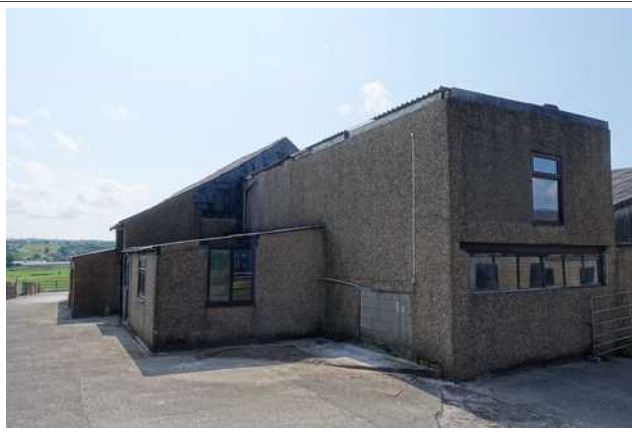
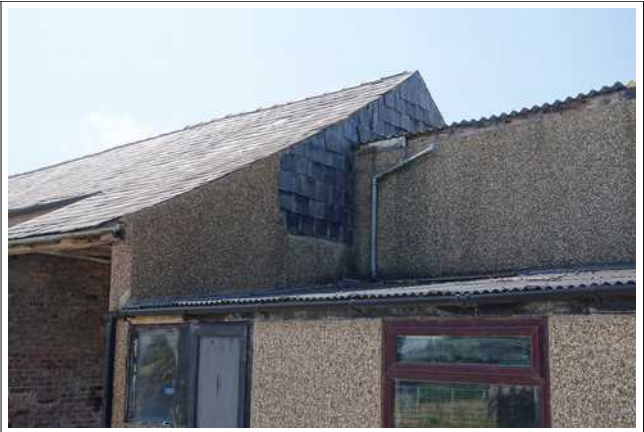
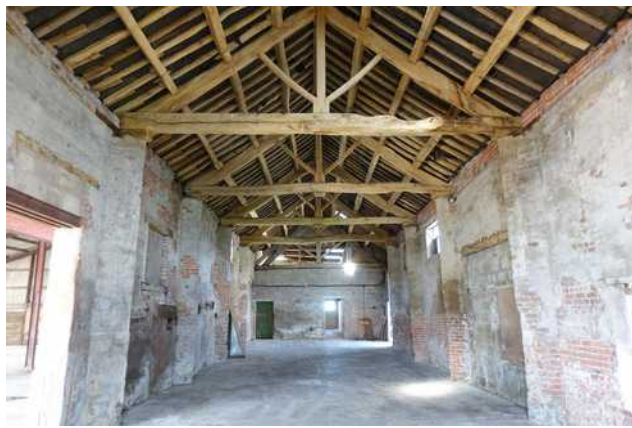
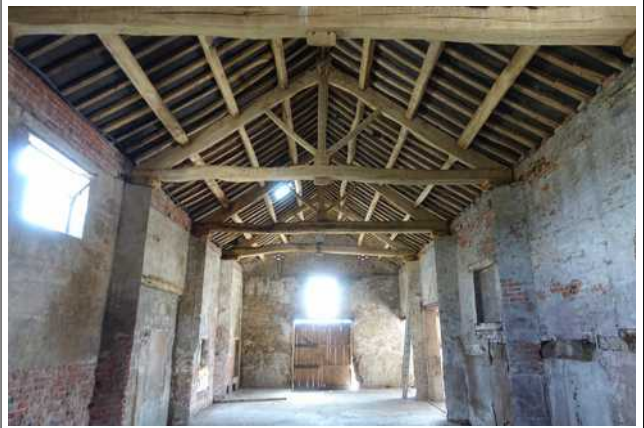
Barn 1 is a brick built two storey barn with single storey extensions to the north and eastern facades. The building has a double pitched slate roof, extensions have single pitched unlined corrugated fibreboard roofs.

External walls are well pointed and partially rendered and pebble dashed with some gaps and crevices present. Gable ends are pointed and sealed. Gaps were recorded on internal walls and all tops within the barn are exposed.

Roof timbers are hand cut and gaps and crevices are present within joints, some cracks were noted within beams. Roof slates are lined with a bituminous roofing felt in good general condition.

The building was assessed as offering moderate roosting potential.

Removal of roof slates, where necessary, on Barn 1 will be carried out by hand and under supervision.

A visit by the batworker prior to roof works commencing will confirm absence of bats in the affected areas.

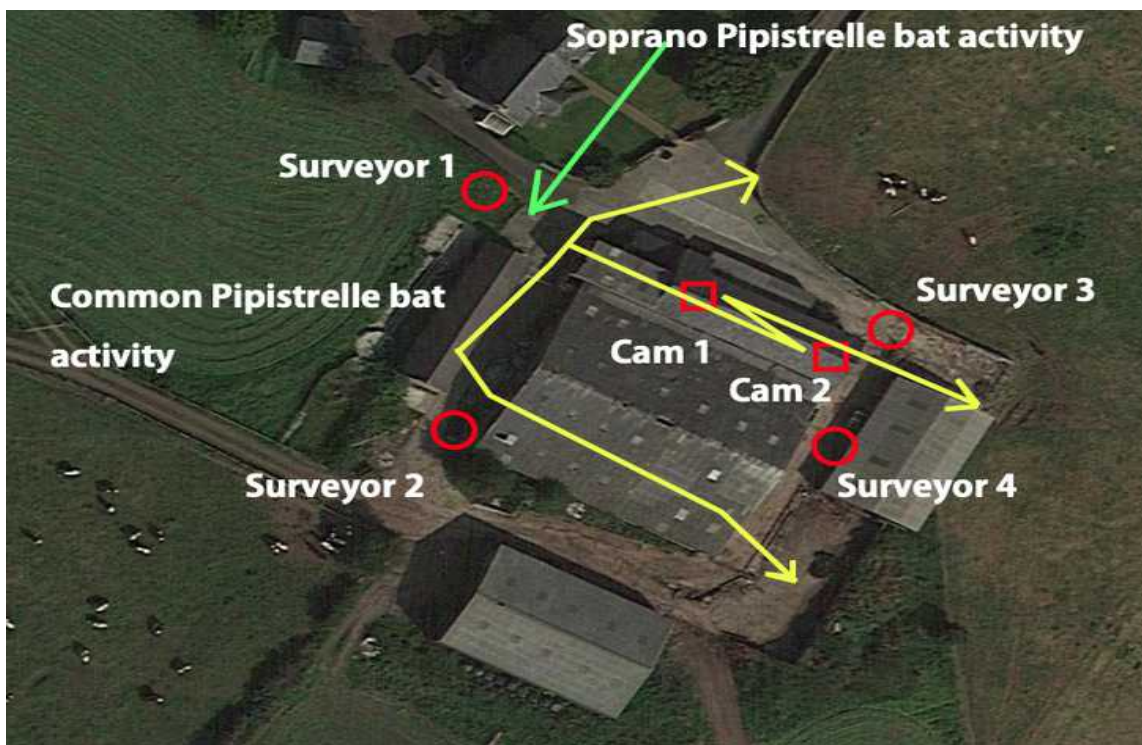
*Emergence Surveys summary*

21 Common pipistrelle bats were recorded emerging from Outbuilding 1 and flying into Barn 1 and Outbuilding 2 to forage before dispersing into the wider landscape.

14 Common pipistrelle bats were recorded emerging from Outbuilding 1 and flying into Barn 1 and Outbuilding 2 to forage before dispersing into the wider landscape.

26 Common pipistrelle bats were recorded emerging from Outbuilding 1 and flying into Barn 1 and Outbuilding 2 to forage before dispersing into the wider landscape.
