**BAT SURVEY AT -  
1 HAWTHORNE PLACE  
CLITHEROE**

**DATE AND TIME OF VISIT  
4<sup>th</sup> Aug 2023 5.30pm**

### **TYPE OF BUILDING**

End terrace period property with a single storey rear out shot.

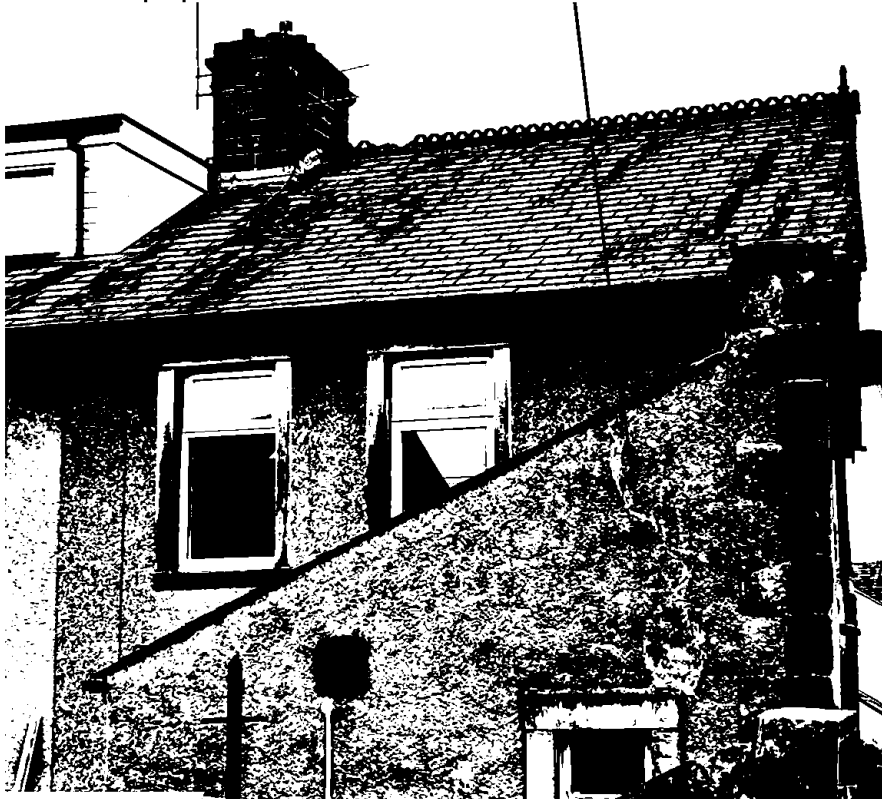
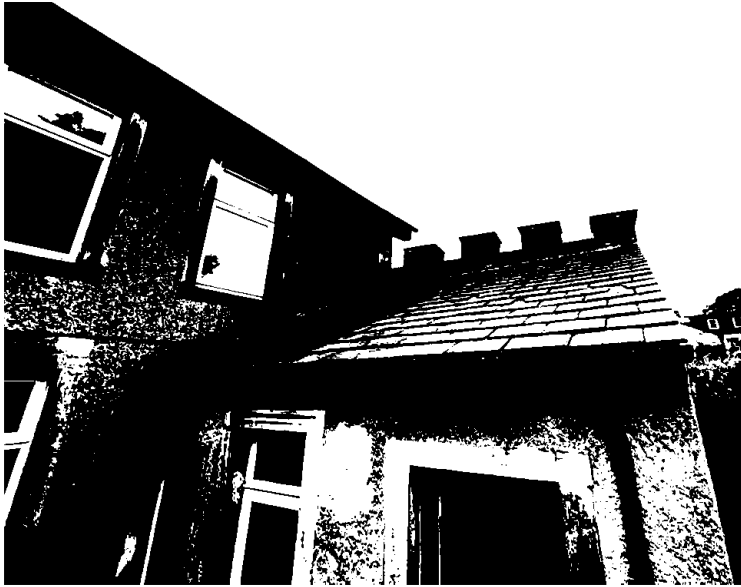
Location of proposed extension on the rear elevation.

North east elevation of the out shot  
Existing detached garage. front elevation

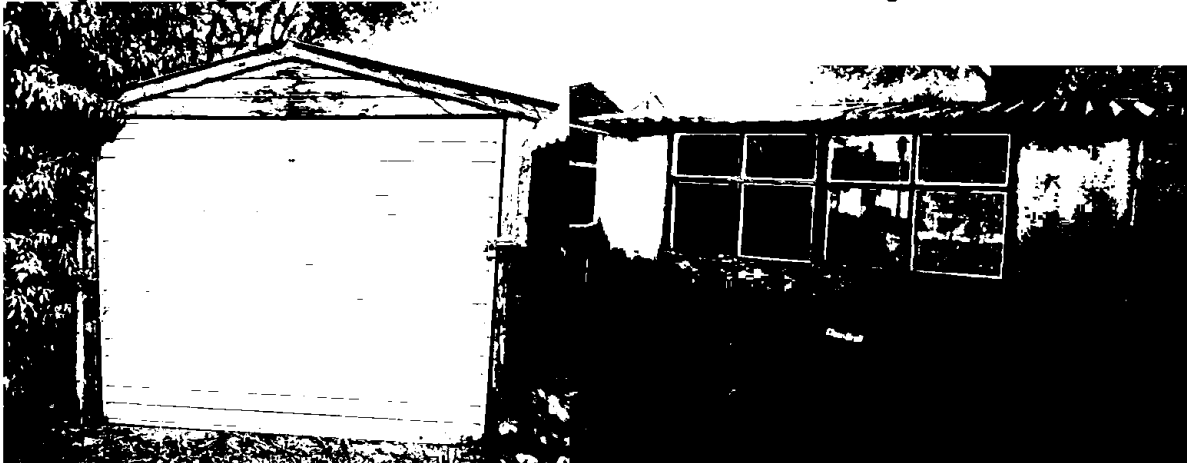
Shed elevation to the garden

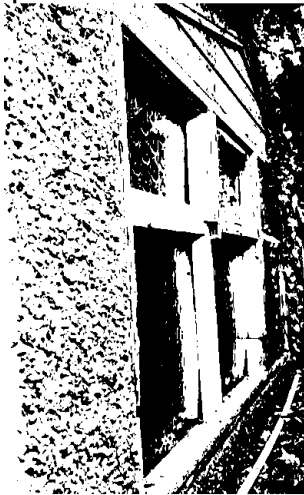
The garage walls are prefabricated concrete with a rough cast render finish. timber boarding to the apex to the front and rear.

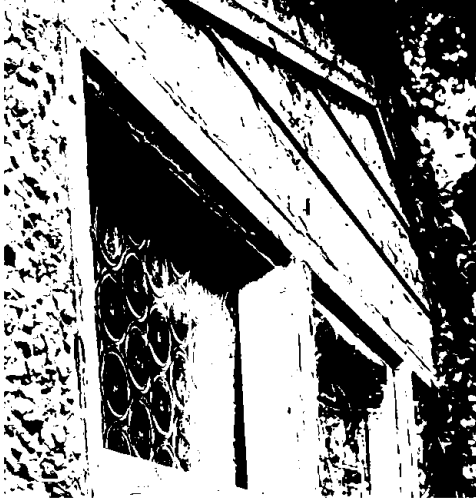
The garage walls are in reasonable condition with no cracks or crevices suitable for bat ingress. The timber boarding is in aged condition, this said there was no rot present nor any gaps with the potential for bat ingress.

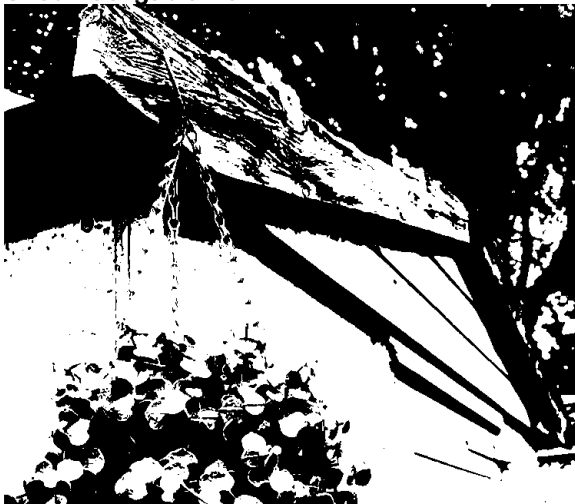
Shed East gable wall

The garden shed has a section of timber boarding to the north east apex which does have a gap behind, it was possible to inspect closely with an endoscope. The recess behind the boarding was shallow, the result was negative, no current or historic presence of bats was evident.

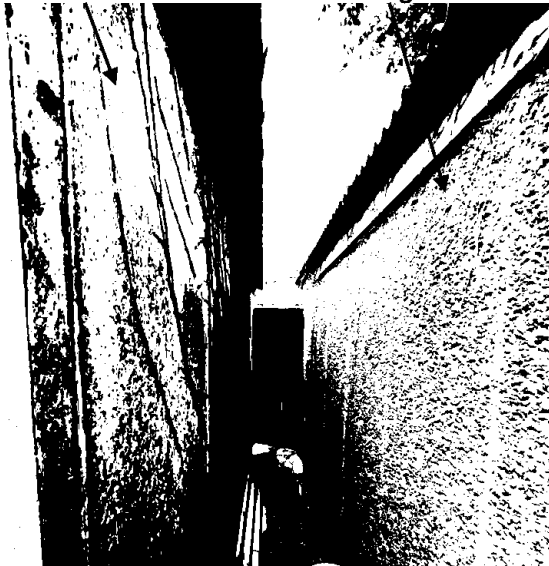
Shed wall

Garage wall

The walls do not provide any potential roost habitat for bats

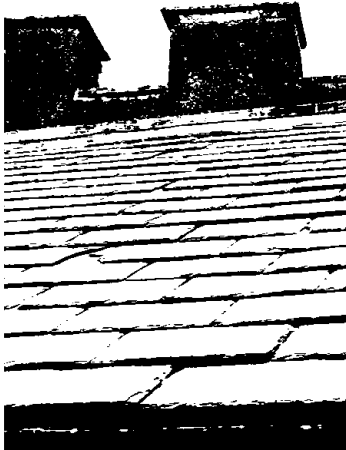
The out shot roof is mono pitched against a castellated wall with a slate finish and timber fascia fixed flush to the wall. Lead flashing is present to the house and castellated wall.

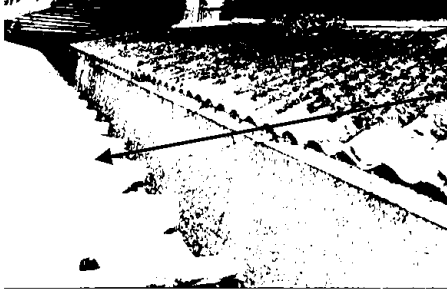
The garage roof is corrugated fibre cement sheet. The shed roof is profile steel sheet

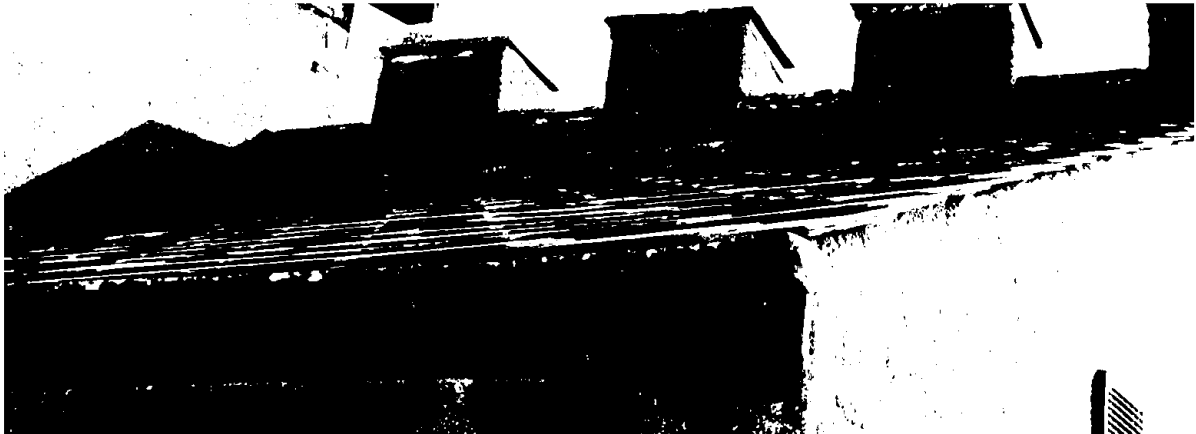
The roof slates are tight fitting with no gaps or slipped slates. There are no gaps present behind the fascias and the lead flashings are in good tight fitting condition. The slates at the verge are very tight fitting and do not have any gaps suitable for bat ingress.

The roof structure does not provide any cracks or crevices with the potential to provide bat roost habitat.

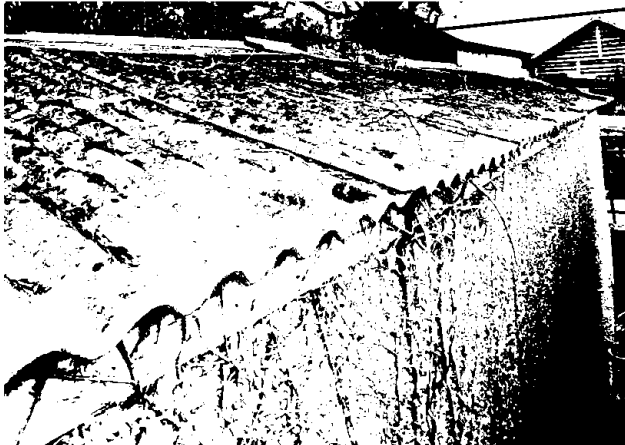
The garage roof was in reasonable condition with significant moss coverage. The sheets are tight fitting and the eaves are sealed. The metal ridge is in poor condition with some gaps .

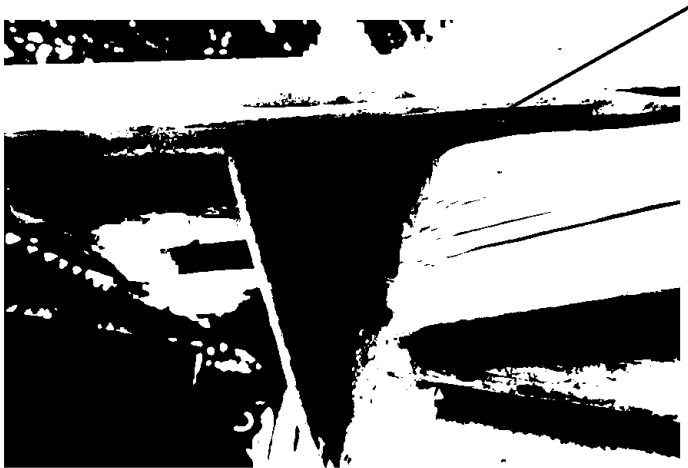
The shed steel roof sheets are in good condition with no access points , the exception being a gap in the eaves trip to the south west corner . An endoscope was used to inspect the small void, no bats were found to be present and no signs of any historic presence was found.

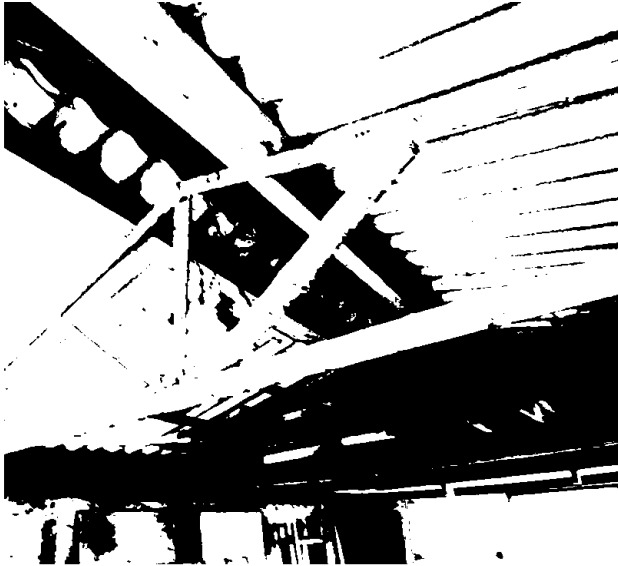
The garage roof has no enclosed roof void, the steel trusses, timber purlins and the roof sheets are fully visible . Very close inspection of all the structure was carried out. The structure was found not to provide any high value roost potential for bats nor were any bats found to be present or evidence of historic presence. Signs of current or historic bat presence was not found.
