# **Preliminary Bat Roost Assessment & breeding birds survey**

**Site: 12 Calder Ave, Billington, BB7 9NQ**

15<sup>th</sup> September 2023

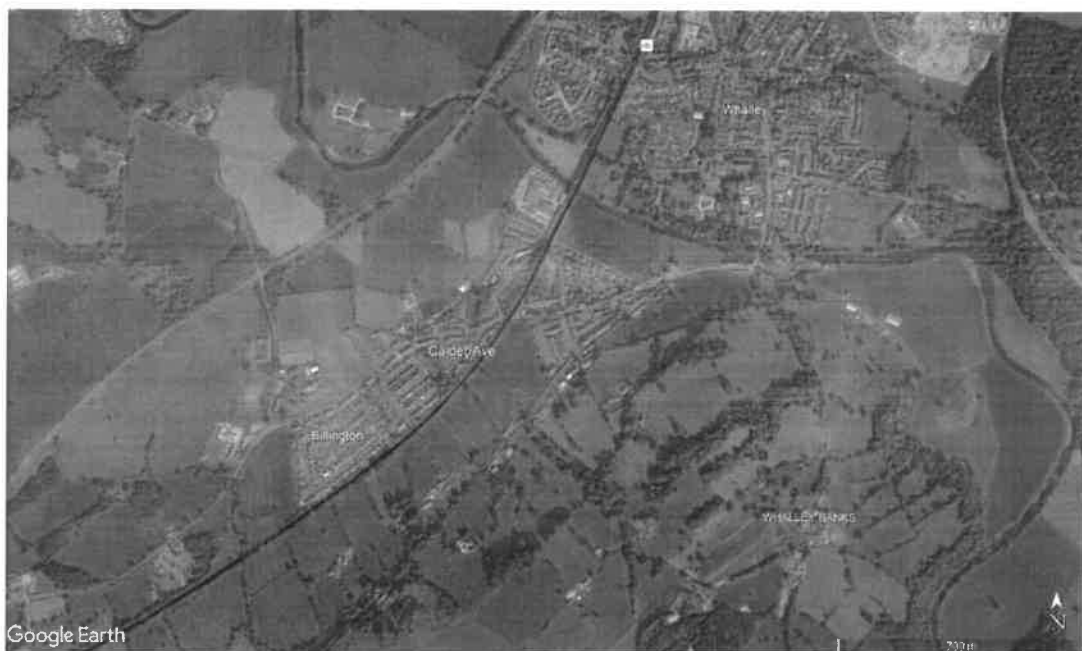
The Site is located in a residential estate, in Billington Village. Broadleaf woodland is located at 400m to the south, with the river Calder at 730m to the north. These features along with the wider rural landscape of pasture and meadows with hedges, and small areas of deciduous woodland form suitable commuting and foraging habitat for bats.

Figure 1: Aerial photo of site, showing surrounding landscape structure

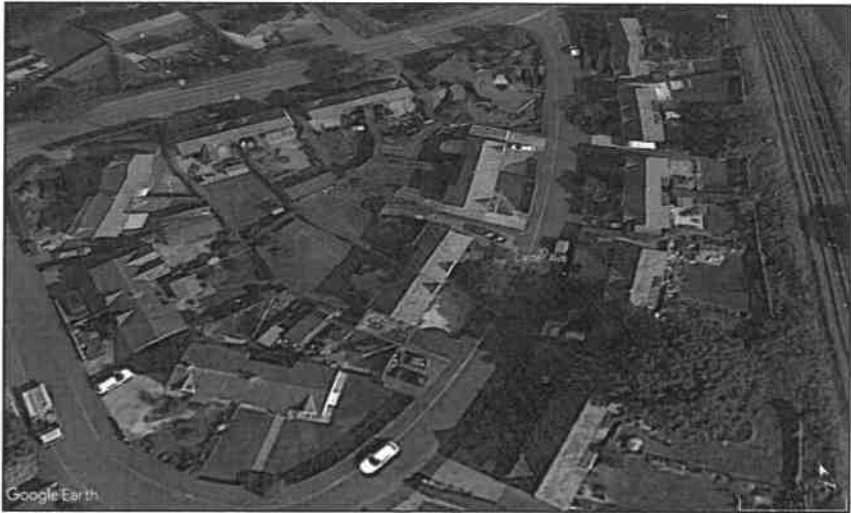
<p>Photo 1: Overview of the complex roof structure.</p>
<p><b>Potential roosting features:</b> Main dwelling: All roofline materials, windows and doors were uPVC and in an excellent state of repair, with no gaps to the wall or cracks that could be used by bats for roosting. Roofing materials were all in an excellent state of repair, with no lifted or cracked tiles forming potential gaps for crevice dwelling bats.</p> <p>No potential bat roosting features (PRF's).</p>

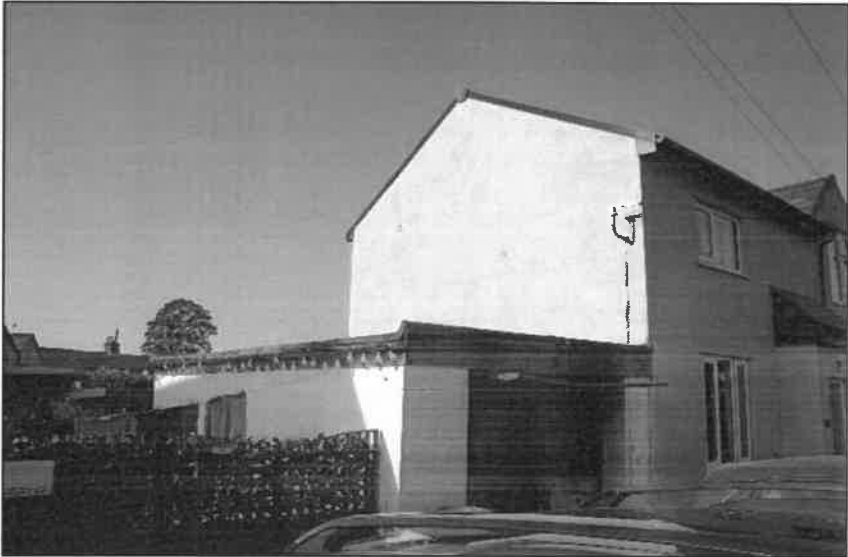
<p>Photo 2: Southwest and southeast elevations of the house.</p>

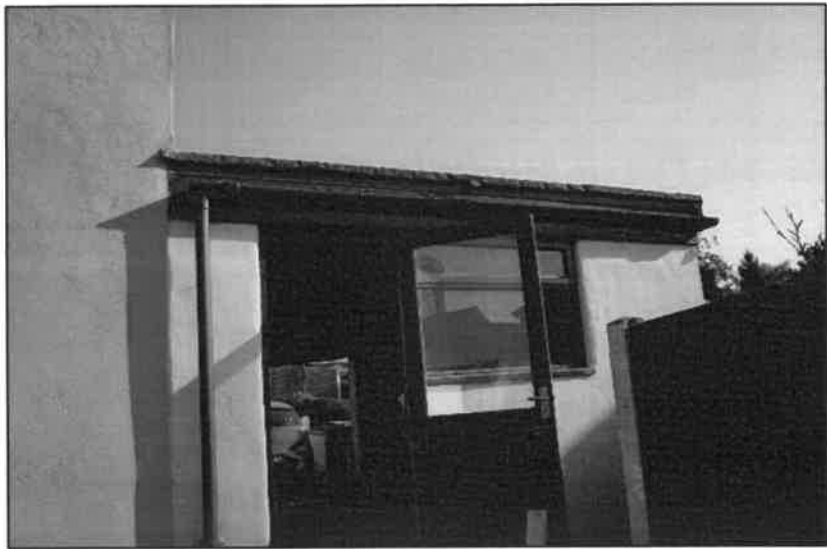
A single storey, flat roofed garage attached to the southwest elevation, and running the full length of the gable end.

The door and window frame were timber and close fitting with no gaps to the brickwork or lintels.

Roof fascia boards were also timber, and although there was the occasional gap these were either open above to the elements or covered in cobwebs.

Photo 3: Northwest elevation of the garage.

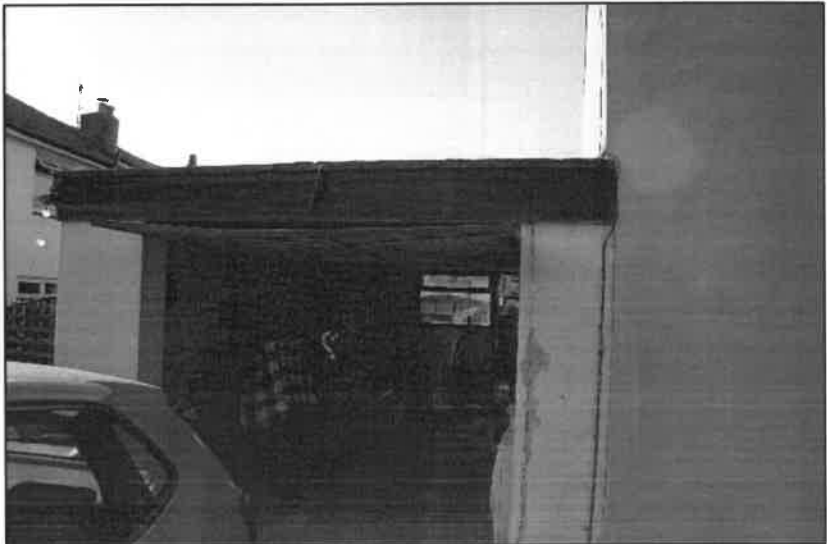
The garage doors was an 'up-and-over' door with a gap along the top which could potentially allow access to the interior of the garage.

The roof felt was in a good state of repair. Any slight gaps were inspected by endoscope; but were considered too short to be suitable for bats to roost under at max. 1.5cm depth.

Photo 4: Southeast elevation of the garage.

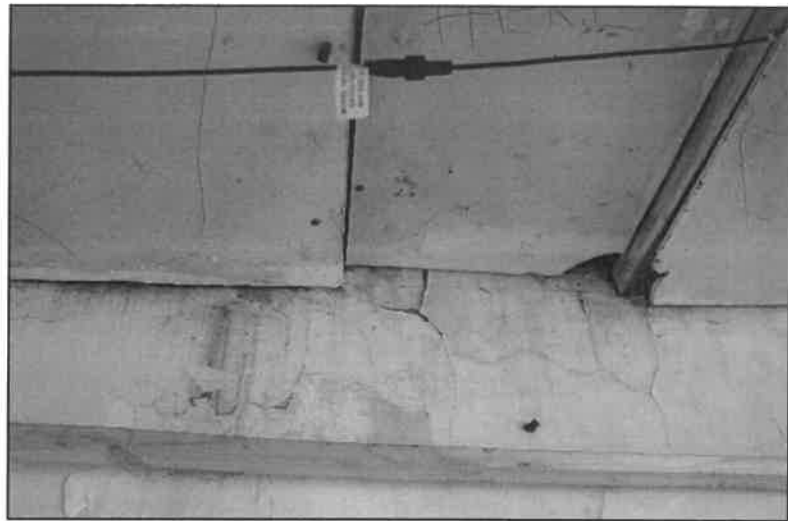
**Internally** the garage was underdrawn by a flat sheet material, similar to plasterboard. There were some gaps at the corners, and a large opening in the centre of the ceiling.

All gaps were closely inspected by endoscope, but no evidence of them being used by bats was found.

No droppings present on any surfaces.

Photo 5: Example of gap in the ceiling boards.
