**Bat Survey Report and Method Statement
European Protected Species (Bats)**

Reasonable Avoidance and Mitigation Measures

**Mill Race Cottage,
Dilworth Bottoms,
Ribchester,
PR3 3ZB**

01.09.2023

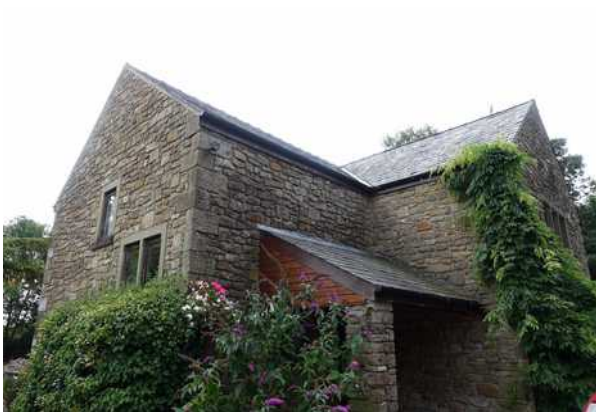
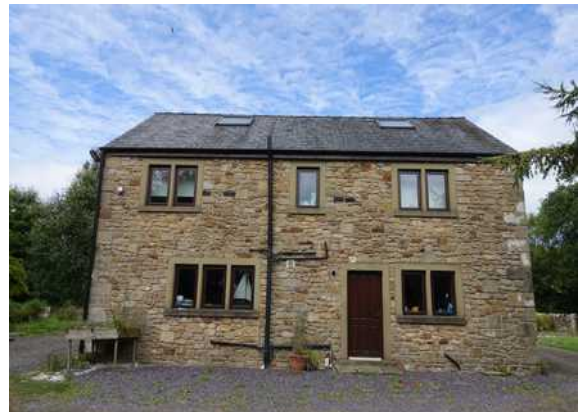
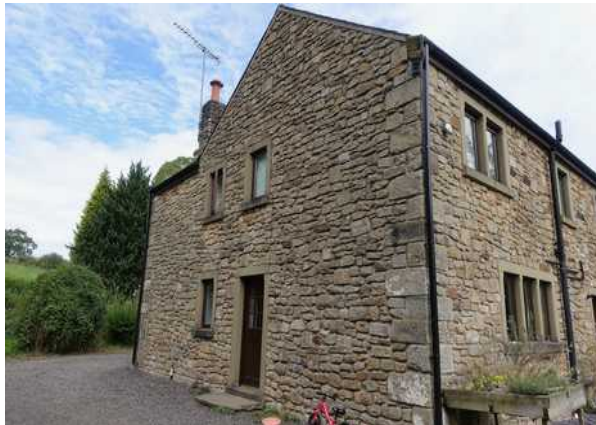
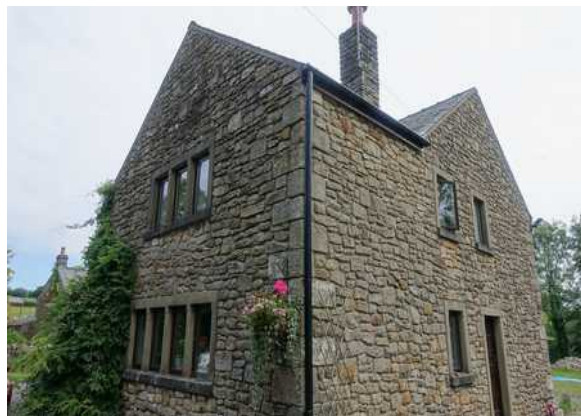
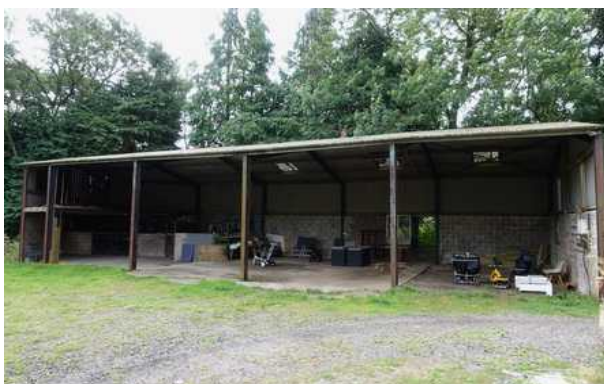
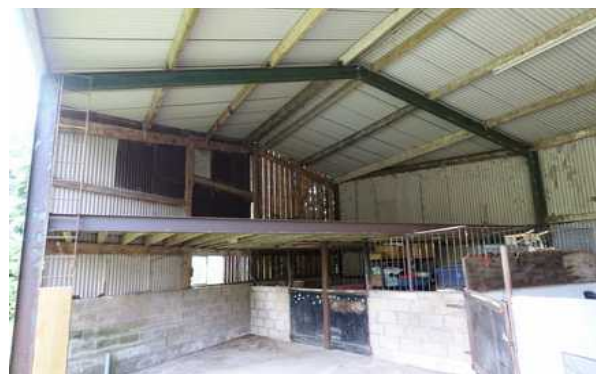
The property consists of a detached modern stone built two storey house with a double pitch and valley slate roof, a single storey porch is present to the frontage. The property has a open fronted portal style corrugated metal and block outbuilding present to the west of the main house. External walls are generally well pointed with no obvious cracks, gaps or crevices suitable for roosting bats.

Roof slates are close fitting with no obvious missing, lifted or slipped slates present. Ridge tiles are pointed and well sealed. Some gaps were present behind fascia boarding.

The main house was assessed as offering low bat roost potential, the portal style outbuilding offers negligible potential due to a lack of cavities or crevices.
