**Re: Proposed development at 4 Branch Road, Mellor Brook, BB2 7NU**

Thank you for your request for a bat survey.

We understand that the proposal is for first floor extensions; one to the north (side) elevation and one south (rear) elevation.

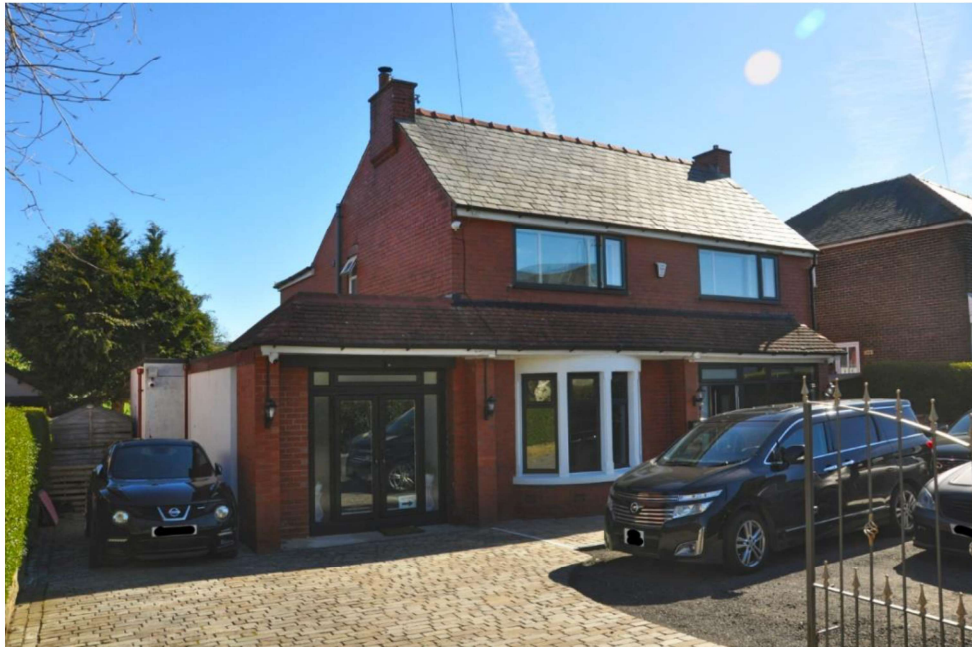
***Image showing west (front) elevation at 4 Branch Road***

Low potential – very small number of potential access gaps associated with soffit (west elevation) and natural fit of the slate roof coverings.

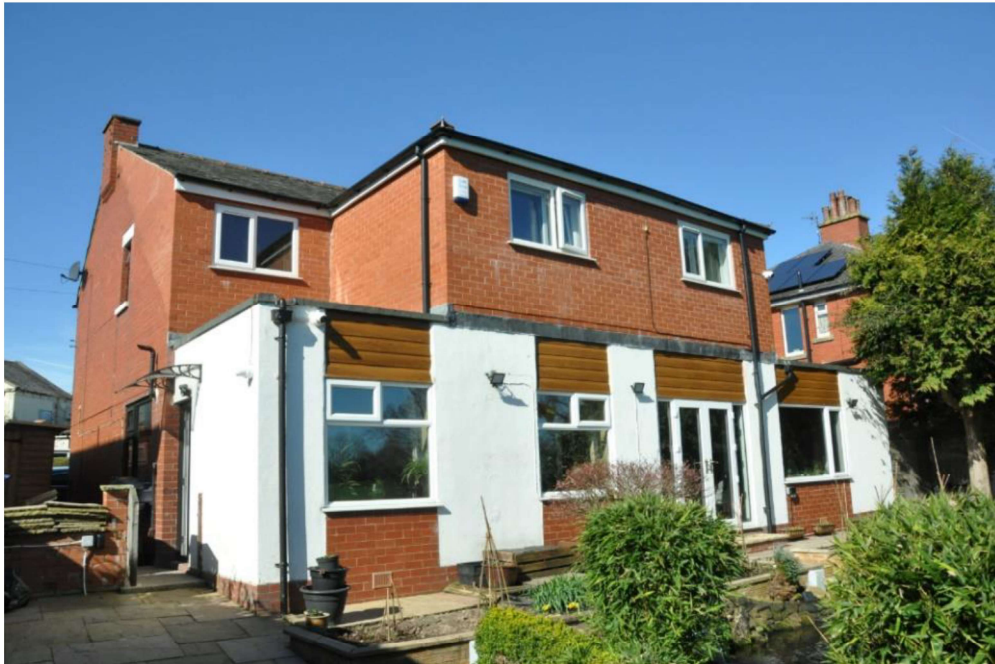
***Image showing east (rear) elevation at 4 Branch Road***

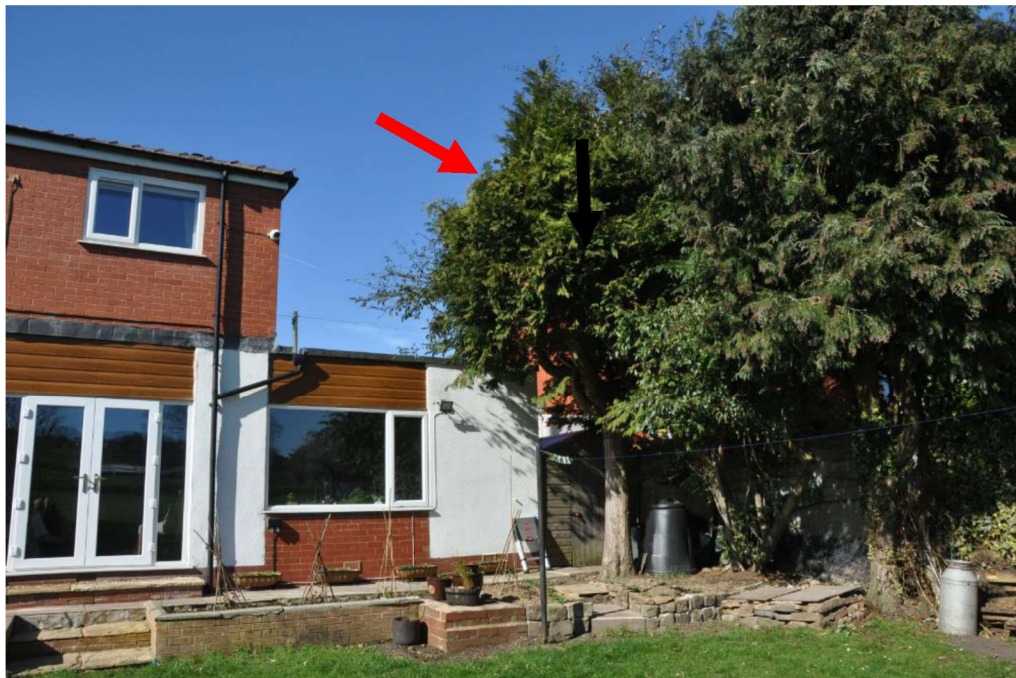
There is high potential for nesting birds to utilise the boundary vegetation including Leylandii trees, ivy and privet hedges during the bird nesting season (February to September). This vegetation is close enough to the proposed development site to be potentially subject to disturbance during the proposed works.

***Image showing rear garden with boundary vegetation (example of potential bird nesting area indicated by red arrow) in close proximity to proposed first floor extension i.e. above the flat roof***

| Protected species | Impacts, Issues & Rationale | Action Required |
|---|---|---|
| Nesting birds | <p>There are potential impacts (disturbance, damage and destruction) to nesting birds, nests and eggs as a result of the proposed works.</p> <p>It is advised that there is high potential for birds to be nesting within the adjacent garden vegetation during the bird nesting season (February to September).</p> <p>Under the Wildlife and Countryside Act 1981 (as amended), wild birds are protected from being killed, injured or captured, while their nests and eggs are protected from being damaged, destroyed or taken.</p> <p>There is no provision under the Wildlife and Countryside Act 1981 (as amended) for licensing the disturbance of nesting birds or the destruction of nests which are in use for the purpose of development.</p> <p>If enforcement action were taken the developer would need to rely on the 'incidental result of an otherwise lawful operation' defence if it were not possible to avoid an offence being committed. This defence can only be tested in court and it is therefore important to ensure all possible mechanisms for avoiding an offence are considered.</p> | <p><b>Advice (mitigation):</b> It is advised that the most appropriate way to address the risk to nesting birds is:</p> <p>Avoid disturbance to the building and garden vegetation during the nesting season.</p> <p>Or</p> <p>If works cannot be delayed, the proposed work area should be carefully checked, immediately prior to works commencing. Checks should be carried out by a suitably experienced ecologist. If the risk of nesting birds remains, then monitoring for nesting bird activity should continue for the duration of works. <b>Prior to any work commencing (checks) and throughout works in nesting season (monitoring).</b></p> <p><b>Advice (mitigation):</b> If works are to be undertaken during the nesting season, all people working at the proposed development site should attend a toolbox talk delivered by an appropriately experienced person, to be made aware of the likelihood of encountering nesting birds and how to identify them, the legal protection of nesting birds and their own responsibilities as regards implementation of precautionary measures. <b>Prior to any work commencing.</b></p> <p><b>Advice (mitigation):</b> If birds are found to be nesting within or in close proximity to the work area during proposed works, it will be necessary to stop and establish an exclusion area. The extent of the exclusion area, which should be determined by a suitably experienced ecologist, will depend on the bird species and the nature of the proposed works. <b>At all times.</b></p> |

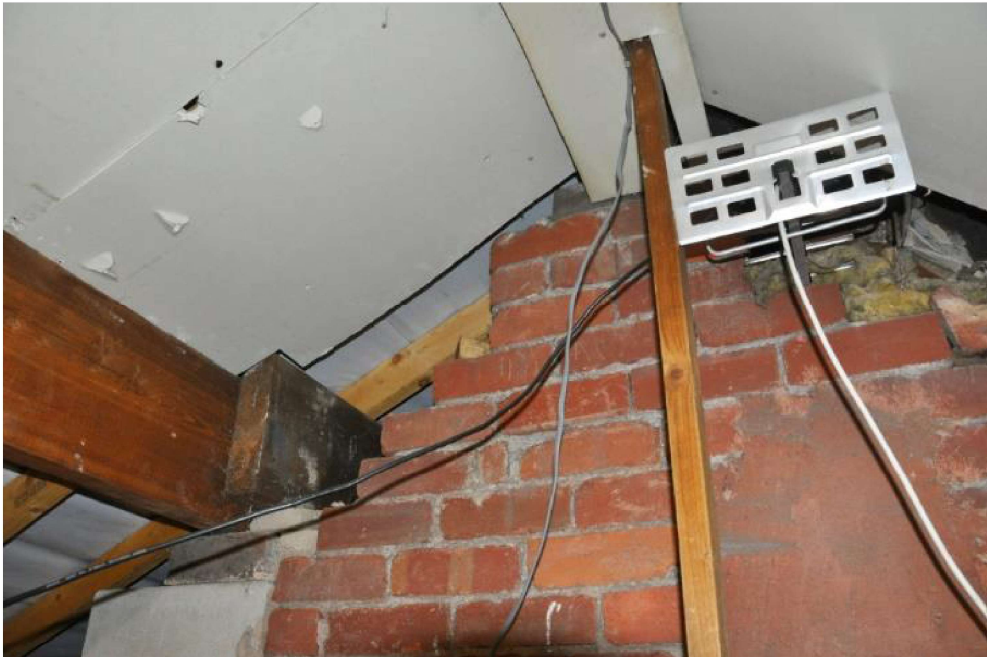
There is a large roof void, spilt in two sections by an internal brick wall. The roof void section to the north is underlined with plaster boards and there are boards throughout the floor which is used for storage. The roof void section to the south is part underlined with modern roof membrane (eastern aspect) and unlined on the western aspect. There is deep rock wool on the floor.

***Image showing roof void with dividing brick wall, plaster boards and modern roof membrane roof liner***

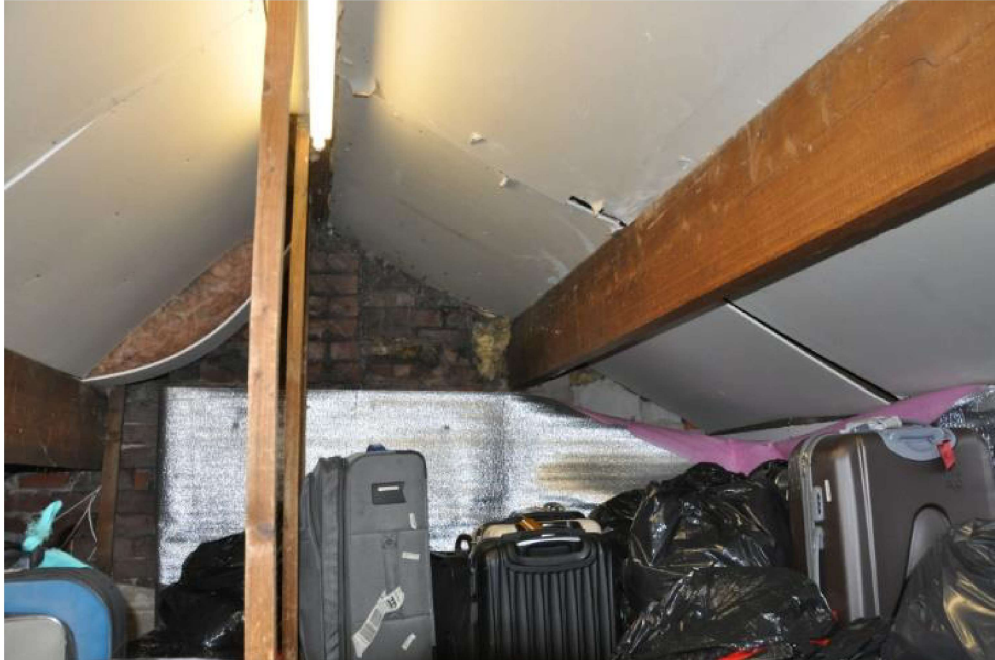
***Image showing roof void used for storage***
