**BAT SURVEY AT -**

THE HAWTHORNS  
RIMINGTON LANE  
RIMINGTON

REFERENCE NO. 6179

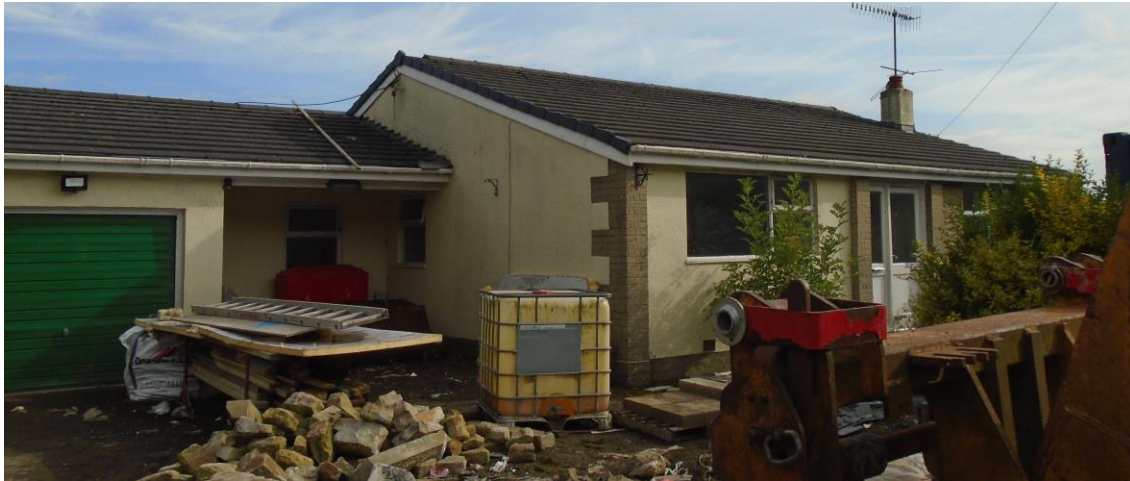
The property is a detached Bungalow with attached garage. Possibly dating from the 70s

In accordance with previous approvals the demolition was started a few years ago. machinery and materials are on site.

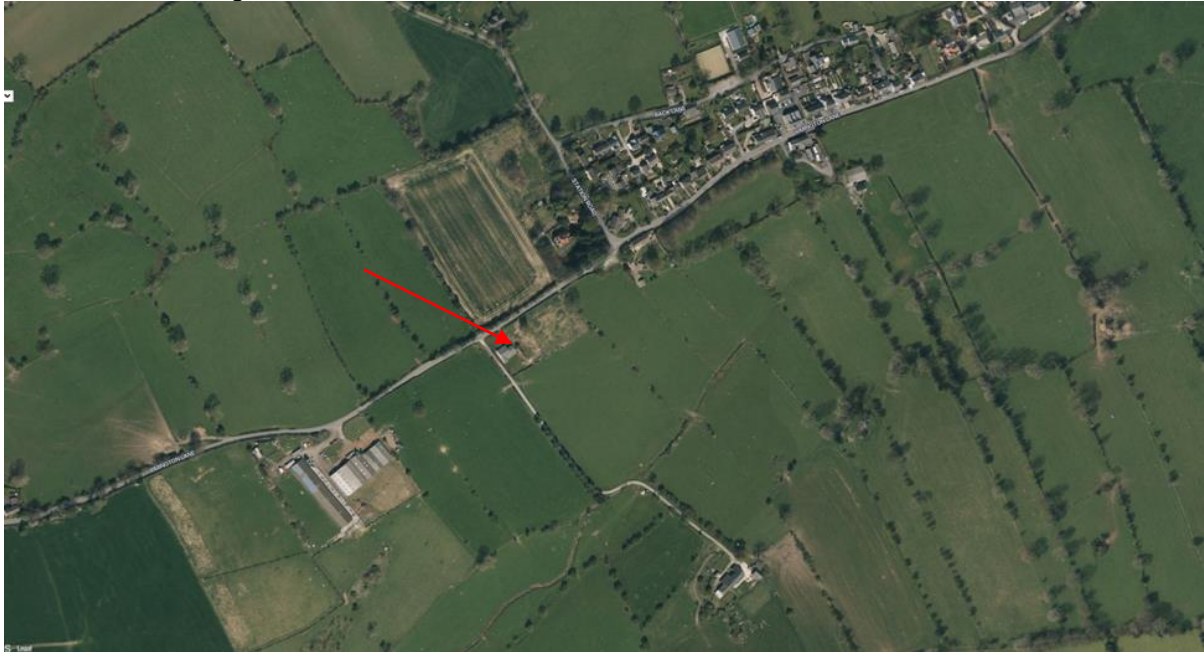
### **LOCATION SD 802455 151m elevation**

The house is located adjacent to Rimington Lane surrounded by garden and agricultural land on the outskirts of the village.

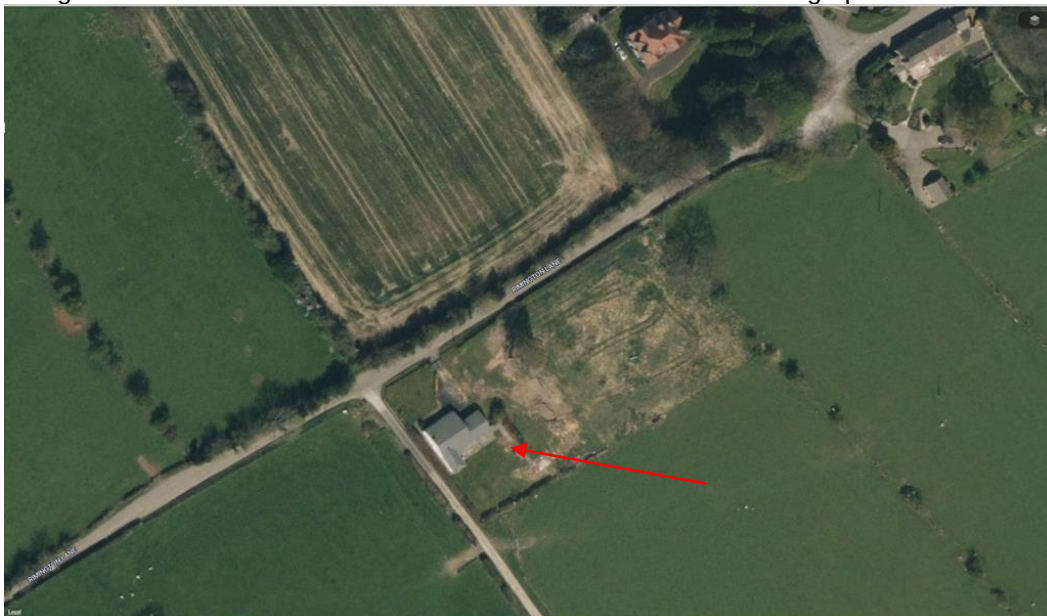
The garden boundaries to the side are Beech hedge the south west being approx 2m from the building, and there are mature trees lining the other boundaries.

The garden area is currently full of machinery and building materials.

The greater location is considered to have a reasonable level of forage potential.

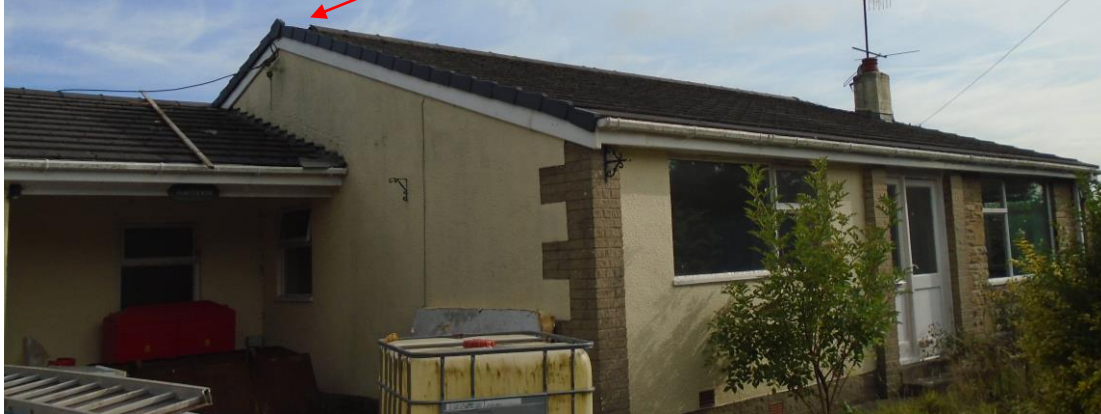
The roof was been replaced 6-7 years ago The tile roof is in reasonable condition with no access points, the exception being a missing ridge tile to the main roof.

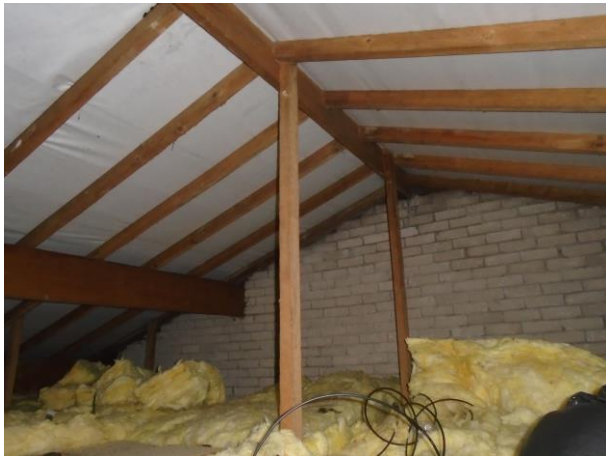
The roof space is used for storage the purlins rafters and felt are in excellent condition with no cracks or crevices suitable for bats.

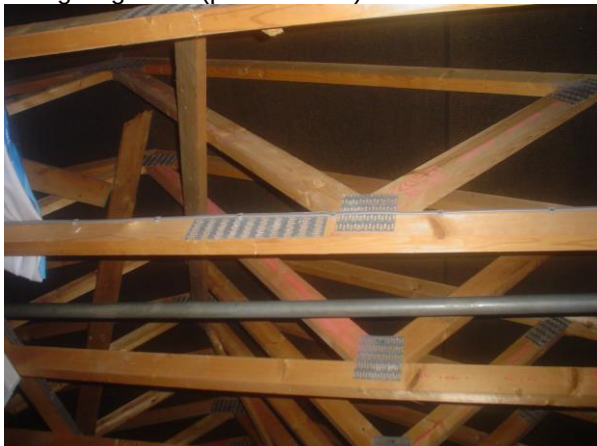
The garage roof (photo below) is trussed with no ceiling.

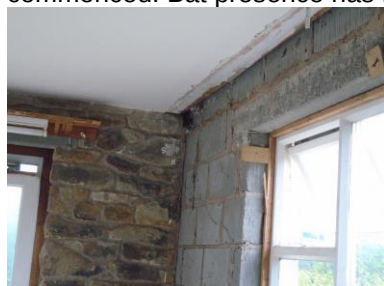
In line with a previous approved planning application on this site, stripping out of the building had commenced. Bat presence has not been found internally.
