**BAT SURVEY AT -  
84 WHALLEY ROAD  
CLITHEROE**

**2023 UPDATE**

REFERENCE NO. 6410

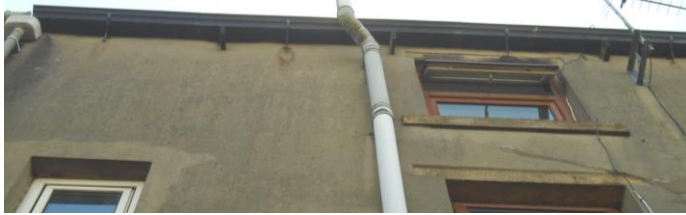
House

The house walls are stone with a smooth render finish and stone sills and heads. The garage walls are prefabricated concrete with a pebble dash finish externally.

The render on the walls of the house is in excellent condition with no possible access points.

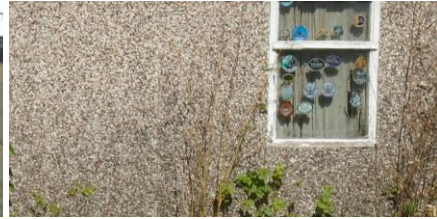
Garage walls

The garage walls are in perfect condition with no possible access points.

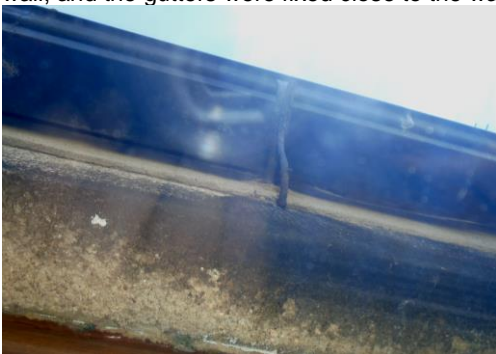
The main roof was examined from the ground with the aid of binoculars and the eaves from the second floor windows. The slates were in excellent condition and very tight fitting, the ridge tiles were well pointed. The eaves were closely inspected from the second floor windows, the slates were very tight fitting at the abutment with the wall, and the gutters were fixed close to the wall. No access points in the roof were found.

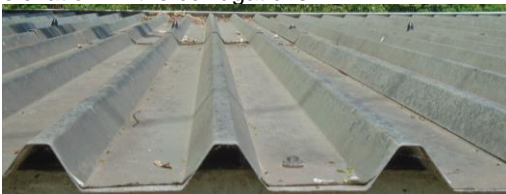
The Garage roof sheets were very tight fitting and in good condition, access points were formed in the rear elevation in the corrugations.

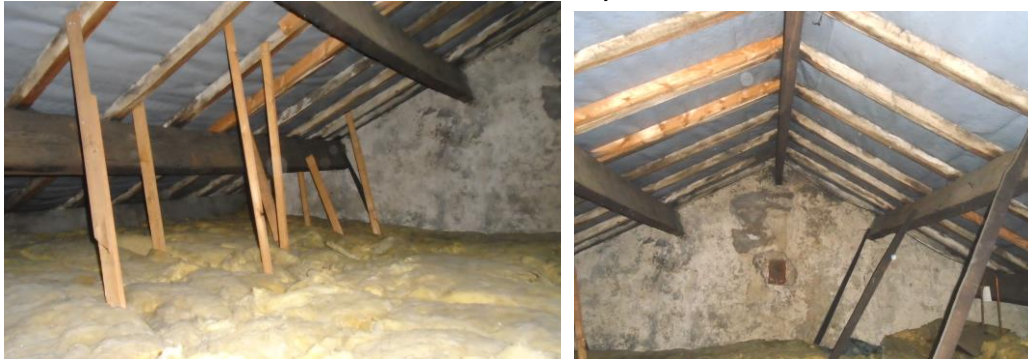
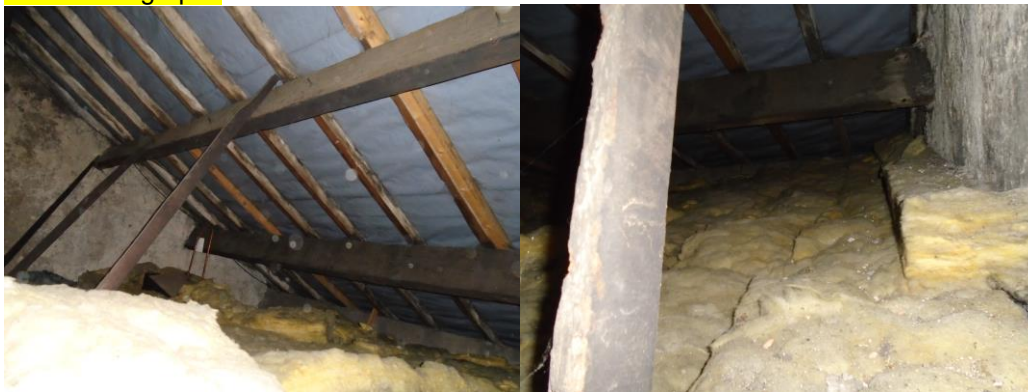
**2023 Photographs**

The house roof void was accessible, the timber purlins and rafters were in reasonable condition with no areas of rot or cracks/crevices. The underlay is very new indicating the house has been re-roofed relatively recently.

The insulation quilt is very clean with no droppings or insect remains. The space did not provide any potential roost habitat and no evidence of current or historic use by bats could be found.

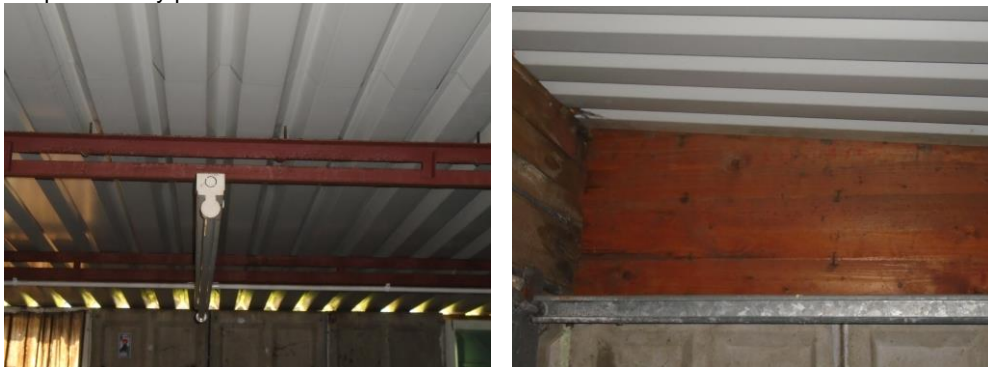
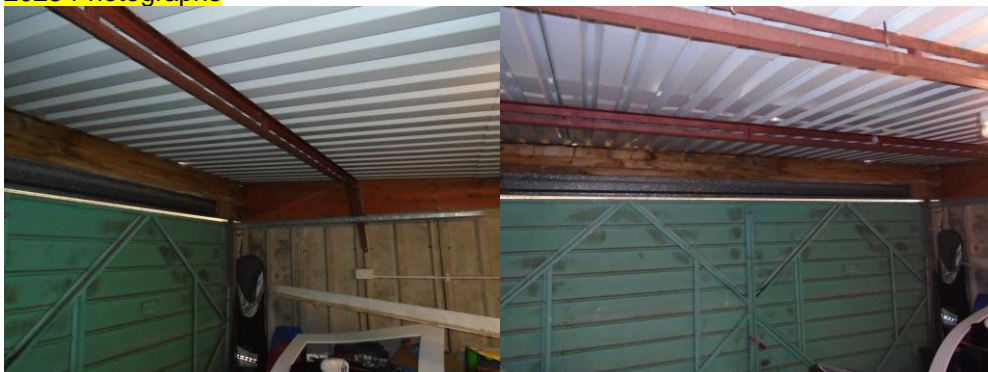
**2023 Photographs**

The garage roof did not have an enclosed void, the sheets were fixed directly to steel purlins. The structure did not provide any potential roost habitat.

**Roof space and garage remains unchanged no bats present.**
