# TEEWOOD FARM BARN, WADDINGTON, CLITHEROE, LANCASHIRE

Historic Building Survey

September 2023

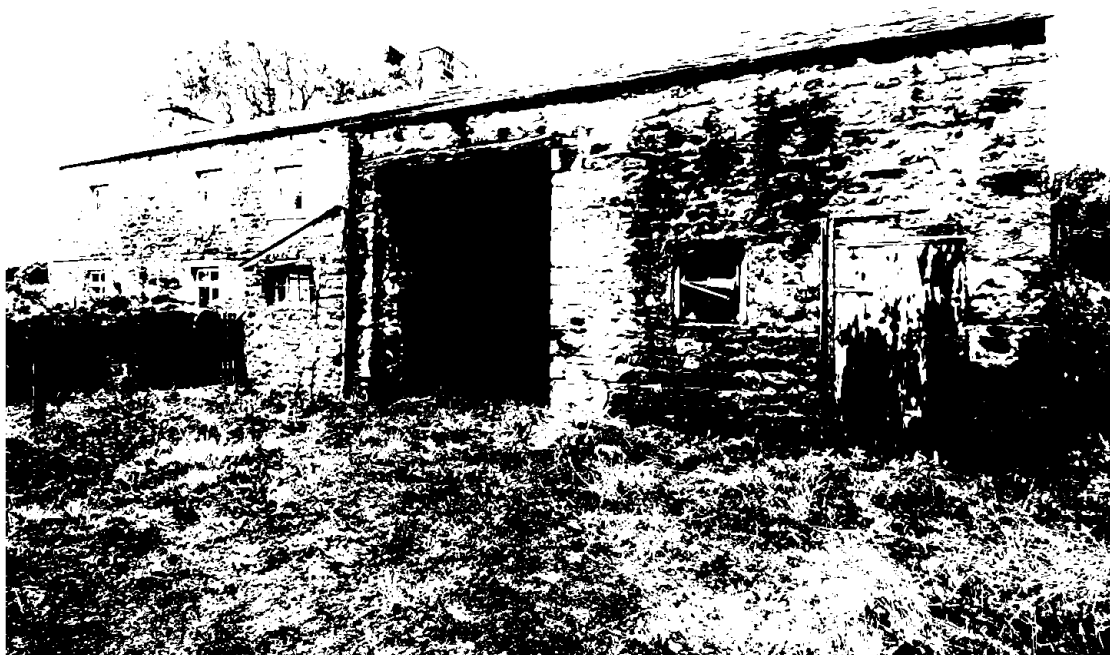
The south-facing wall was constructed of blocks and slabs of local coarse-grained sandstone, in irregular courses, with larger rectangular blocks defining the quoins at the wall corners and cart entry. However, within bay 1, where the elevation was set back to match the farmhouse elevation, there were some irregular blocks of local limestone. It was noted that the wall had been raised above the original eaves at some point, by about 0.80m, probably to match the height of the farmhouse. This was evident from the presence of a 'lift' of sandstone blocks with a more rectangular finish.

Plate 1. Barn B, south elevation, with farmhouse to left, viewed from south-east.

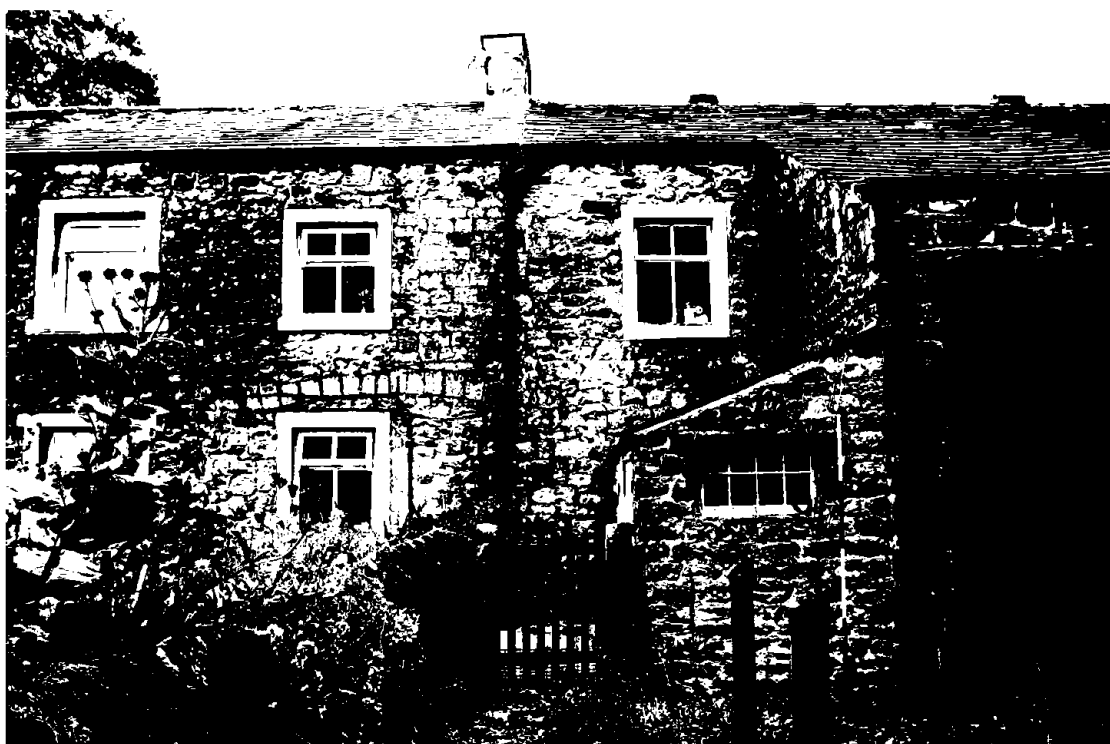
Plate 2. Barn B, south elevation, showing relationship with farmhouse. Property boundary indicated by downspout.

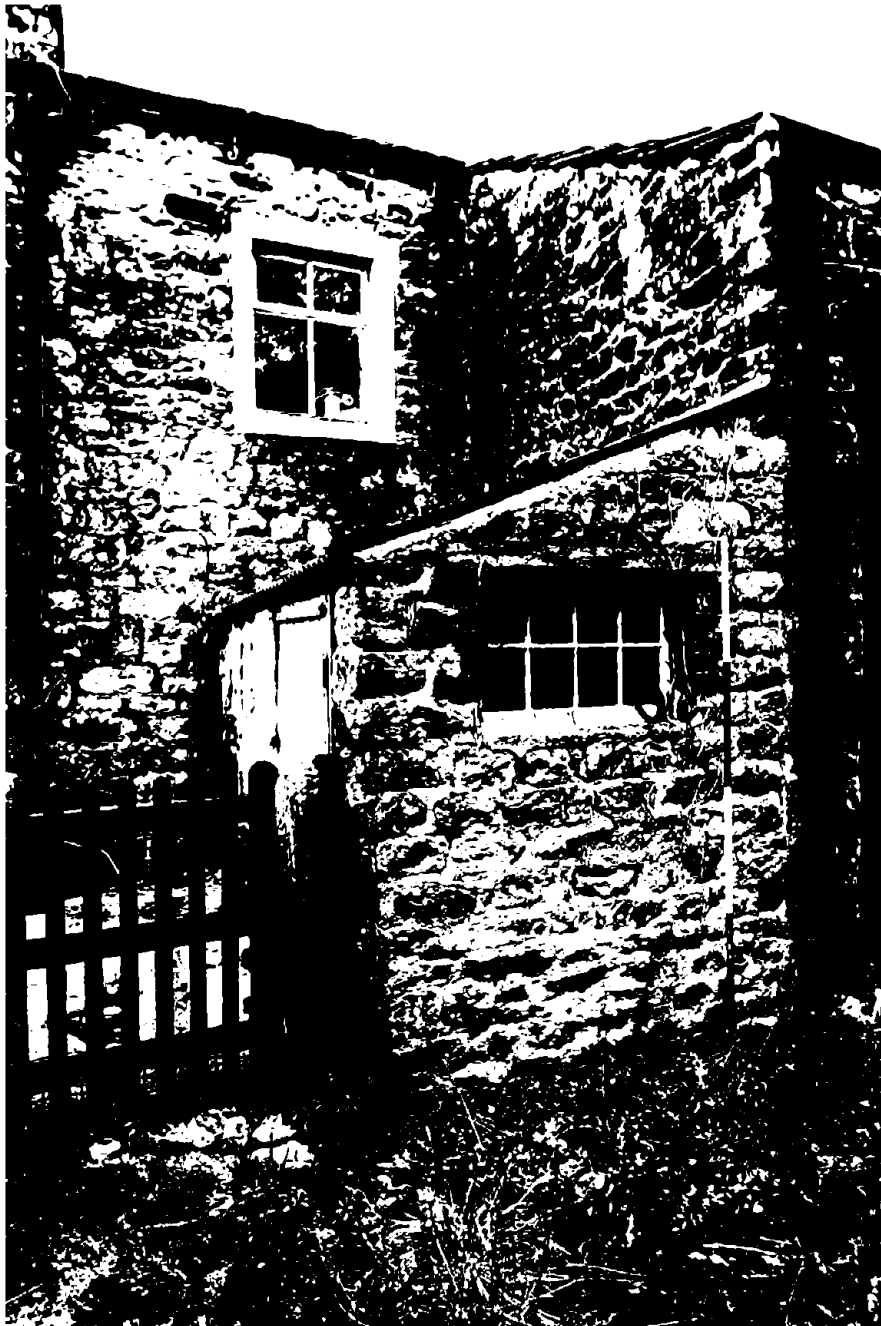
Within Bay 1, the elevation was offset between the farmhouse and the barn porch. At ground floor level, a small outshut had been constructed, possibly as a coalshed, with a front wall of sandstone blocks, and a small eight-light window. It had a timber west wall with timber plank door, and a corrugated iron mono-pitched roof. Above here was a large four-light sash window, which was similar to those in the farmhouse. It was probably inserted when the barn eaves were raised.

Plate 3. Barn B, south elevation, bay 1, viewed from south-west.

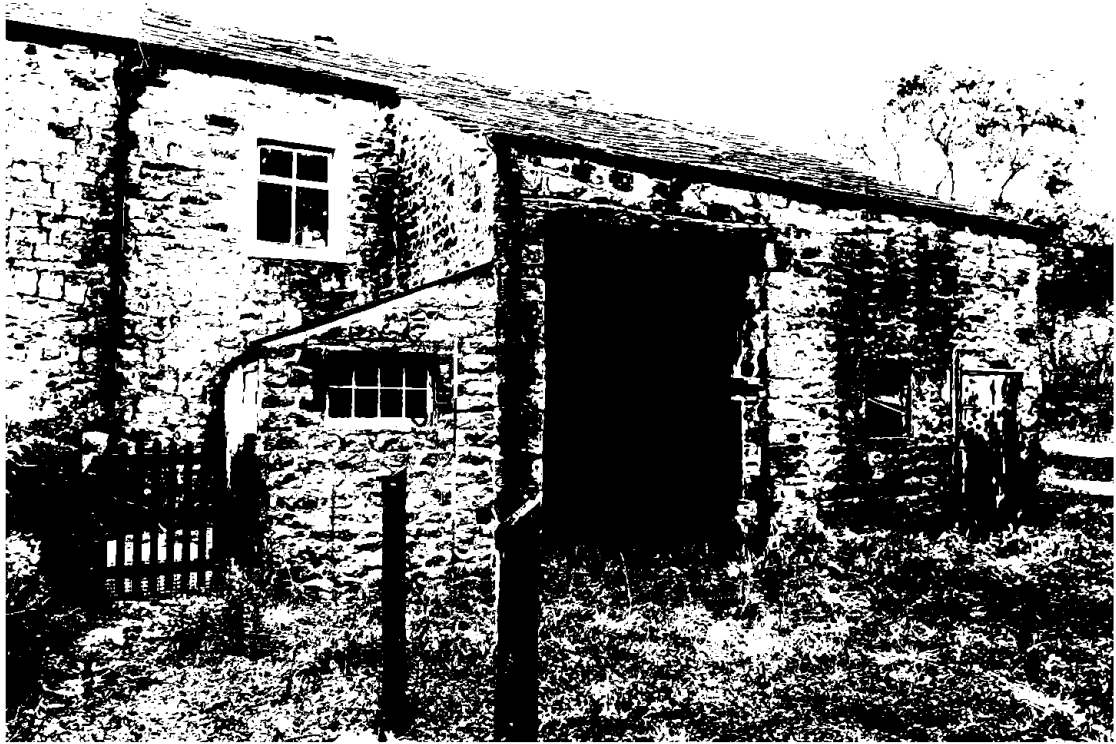
Bay 2 comprised the barn porch, in the form of a large cart doorway, with sandstone quoin surrounds and a lintel comprising a pair of thick timber beams. It is uncertain whether this opening was raised along with the eaves; as a lower eaves position would not have compromised the available lintel height.

Within bay 3, there was a small ?original four-light window (left), with monolithic sandstone surrounds; and a probably inserted doorway (right), with a crude plywood door. Over bays 2 and 3, it was clear that the eaves were raised.

Plate 4. Barn B, south elevation, viewed from south-west.

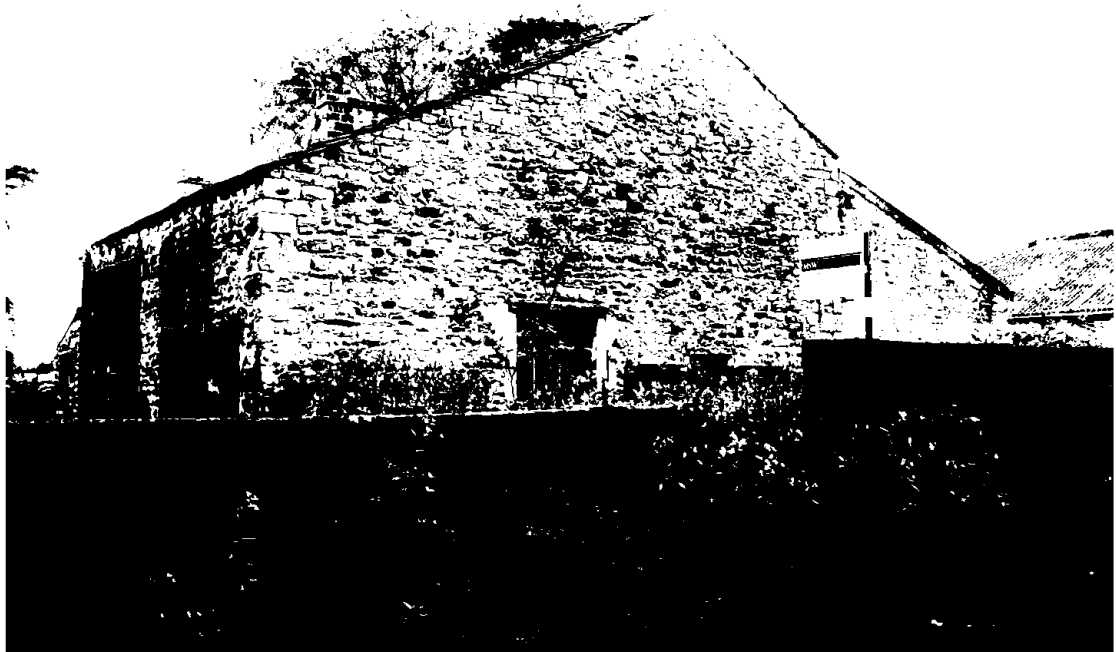
This gable elevation faced onto Slaidburn Road, between the two were concrete slabs and block walls, related to demolished C20 structures. The original gable is asymmetrical due to the integral outshut on the left (south). In construction, it is similar to the south elevation, although the raised section is more obvious, as it comprises ashlar sandstone set in neater courses than the original fabric. Large sandstone quoins demarcate the original extent.

Plate 5. Barn B, east elevation, viewed from Slaidburn Road, from south-east.

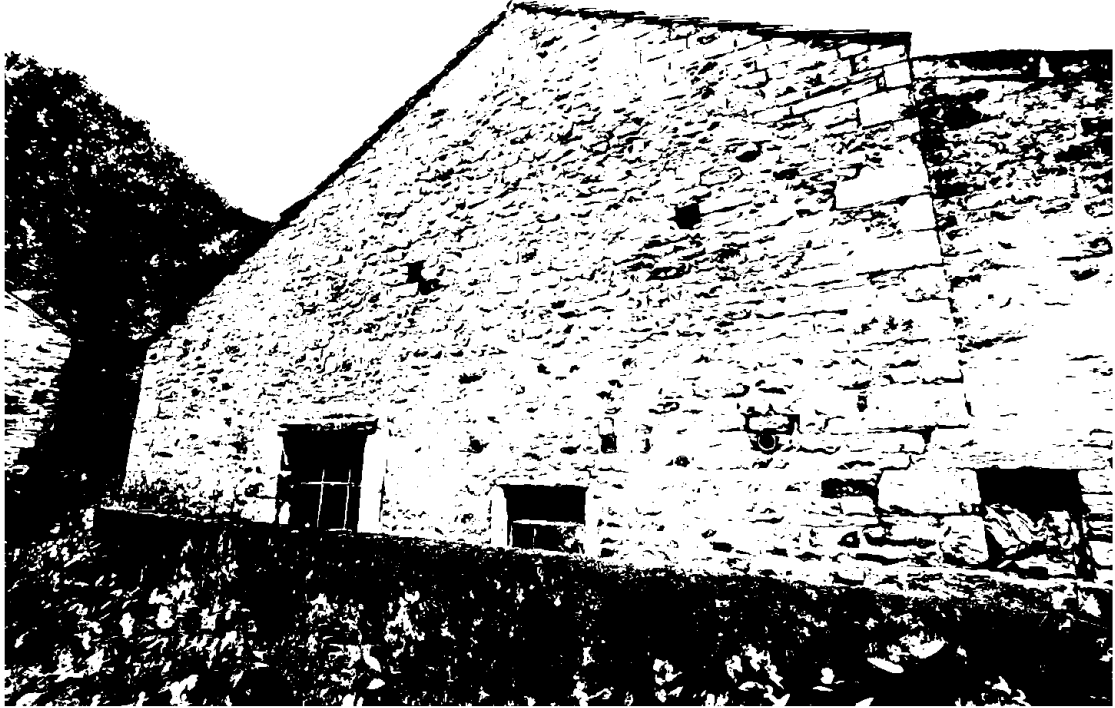
To the north, this elevation seems to have been extended twice, firstly to create an earlier outshut, the roofline of which extended that of the original barn before the gable was raised. The second extension, creating a larger outshut, post-dated the raising of the gable. These two phases of outshut can be differentiated by the quality of stonework – as in the original gable, the later work was of a higher quality, with more regular coursing and ashlar-dressed sandstone blocks. Set against the straight joint of the original gable was a small window, now internally blocked.

Plate 6. Barn B, east elevation, viewed from north-east.

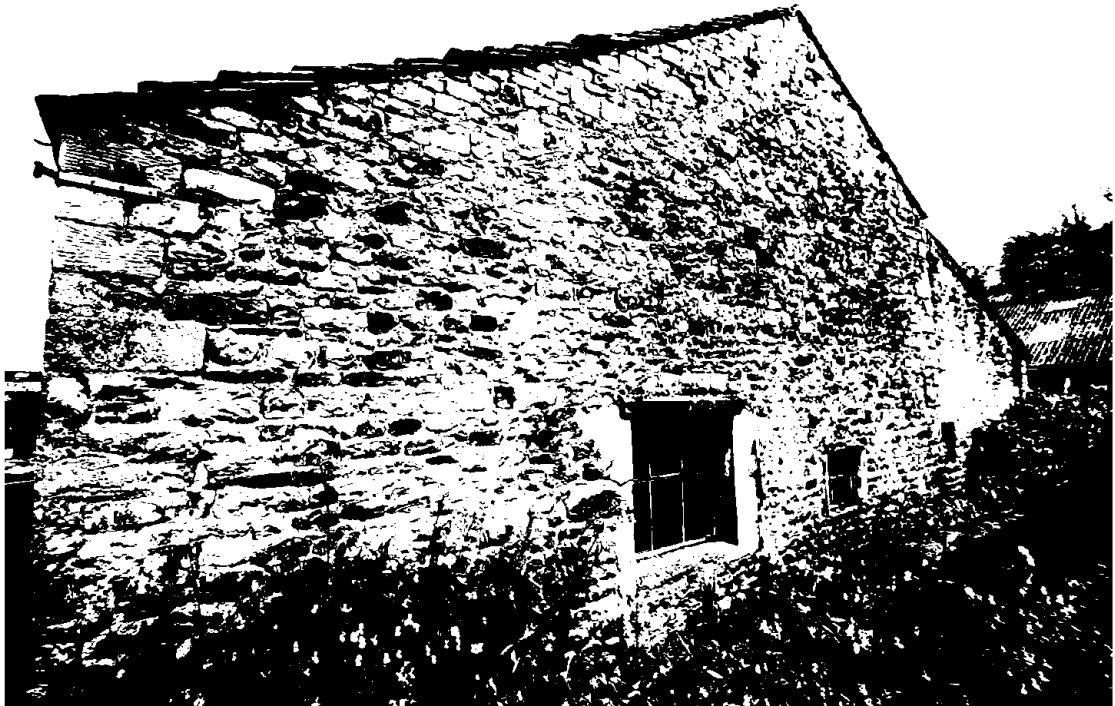
Just above this window level were three inserted sections of ceramic pipe, probably intended as ventilation for the internal shippon. At first floor level was a pair of apertures best described as owl holes, and in the absence of any breather slits at this level in any of the elevations, these could also have functioned as ventilation to the main hayloft.

Plate 7. Barn B, east elevation, viewed from south-east.

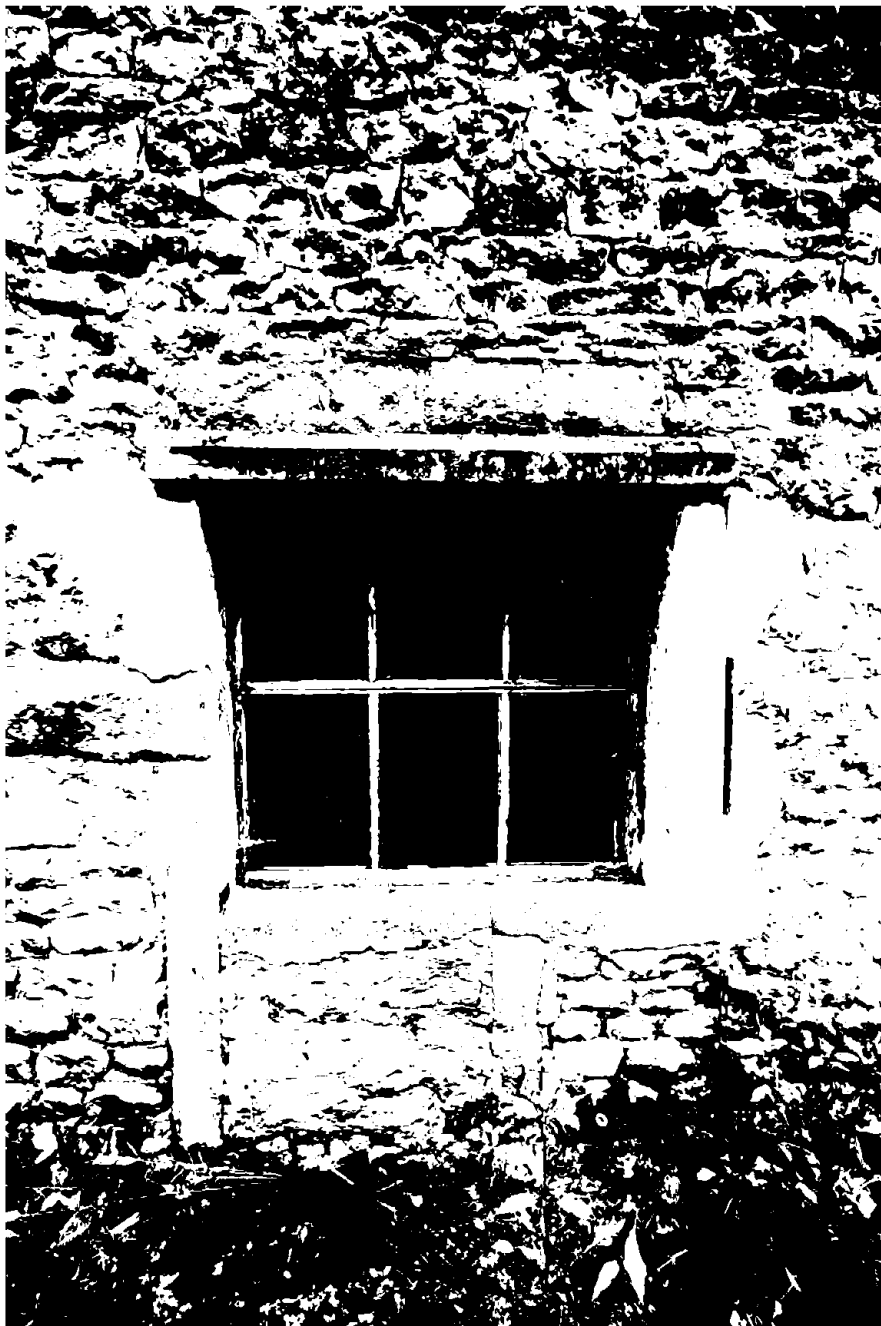
At ground floor level, there is a large six-light window, which has been inserted to replace an original doorway. The lower part of the latter still remains, now blocked with sandstone, and evidently with monolithic surrounds. To the right of this was a small four-light window, with crude monolithic sandstone surrounds.

Plate 8. Barn B, east elevation, blocked doorway replaced by window, viewed from east.

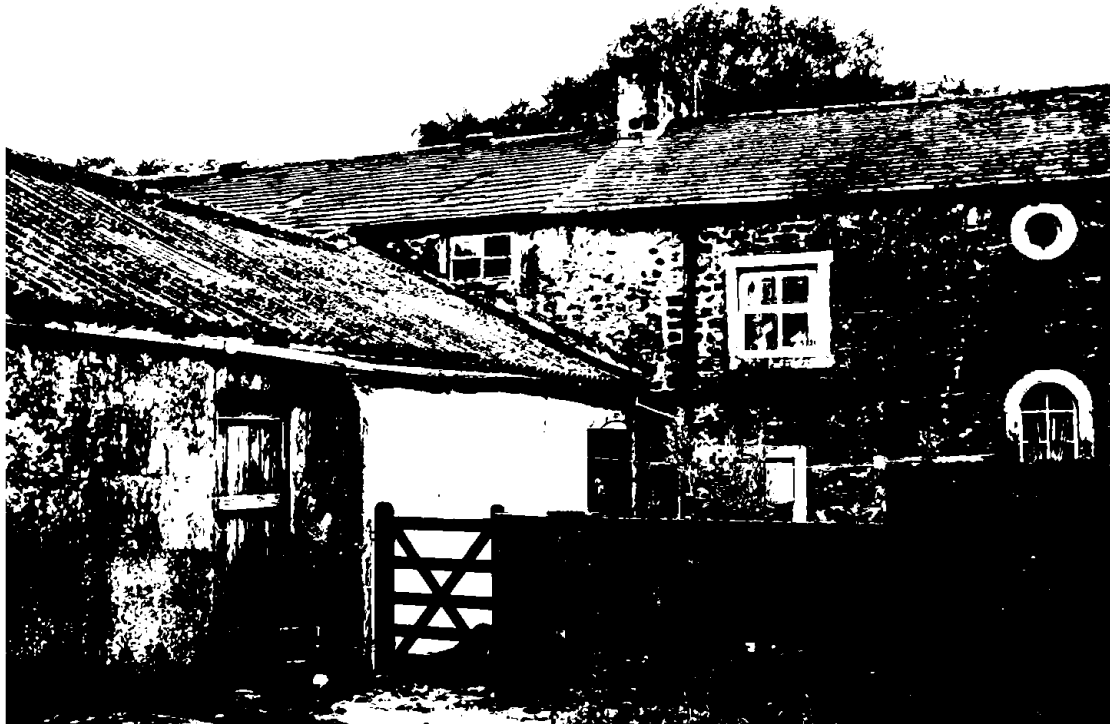
This long elevation seems to have been most altered by later changes. It had been rendered over following the construction of later buildings, which had wholly contained this elevation. The only visible feature of interest was the doorway into bay 2, which had been reduced both in width and height, although the evidence for this reduction was only seen on the inside of the barn.

Plate 9. Barn B, north elevation, property boundary with farmhouse is indicated by change in roof covering between Welsh slate over farmhouse and stone slabs over barn.

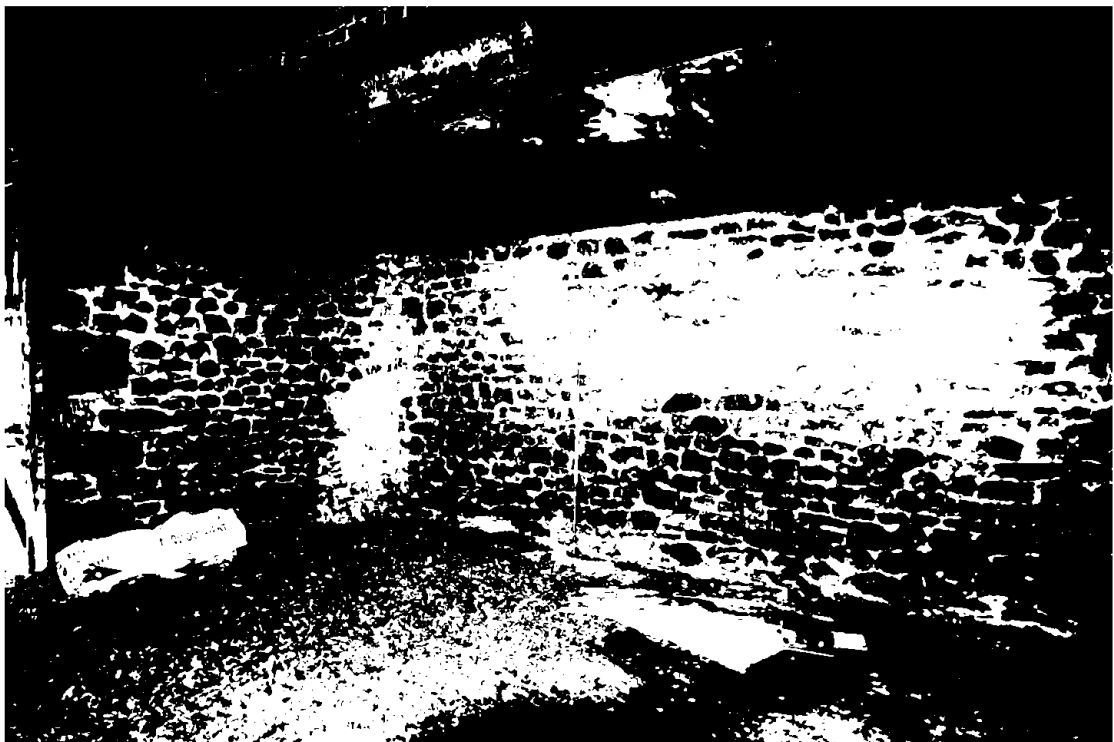
A substantial steel I-section had been inserted between bays 1 and 2, and a machine-made brick wall constructed off this, to encapsulate the timber king-post roof truss over. The wall was blank, with no openings. From the beam soffit, a (timber?) floor had been constructed to span across to the west wall of bay 1; the soffit was clad in plasterboard, and there was no access through this floor. At the time of the survey (2023), this upper room was sealed, with no access from the farmhouse, and this space is to be integrated into the new development.

Plate 13. Barn B, bay 1, viewed from north-east.

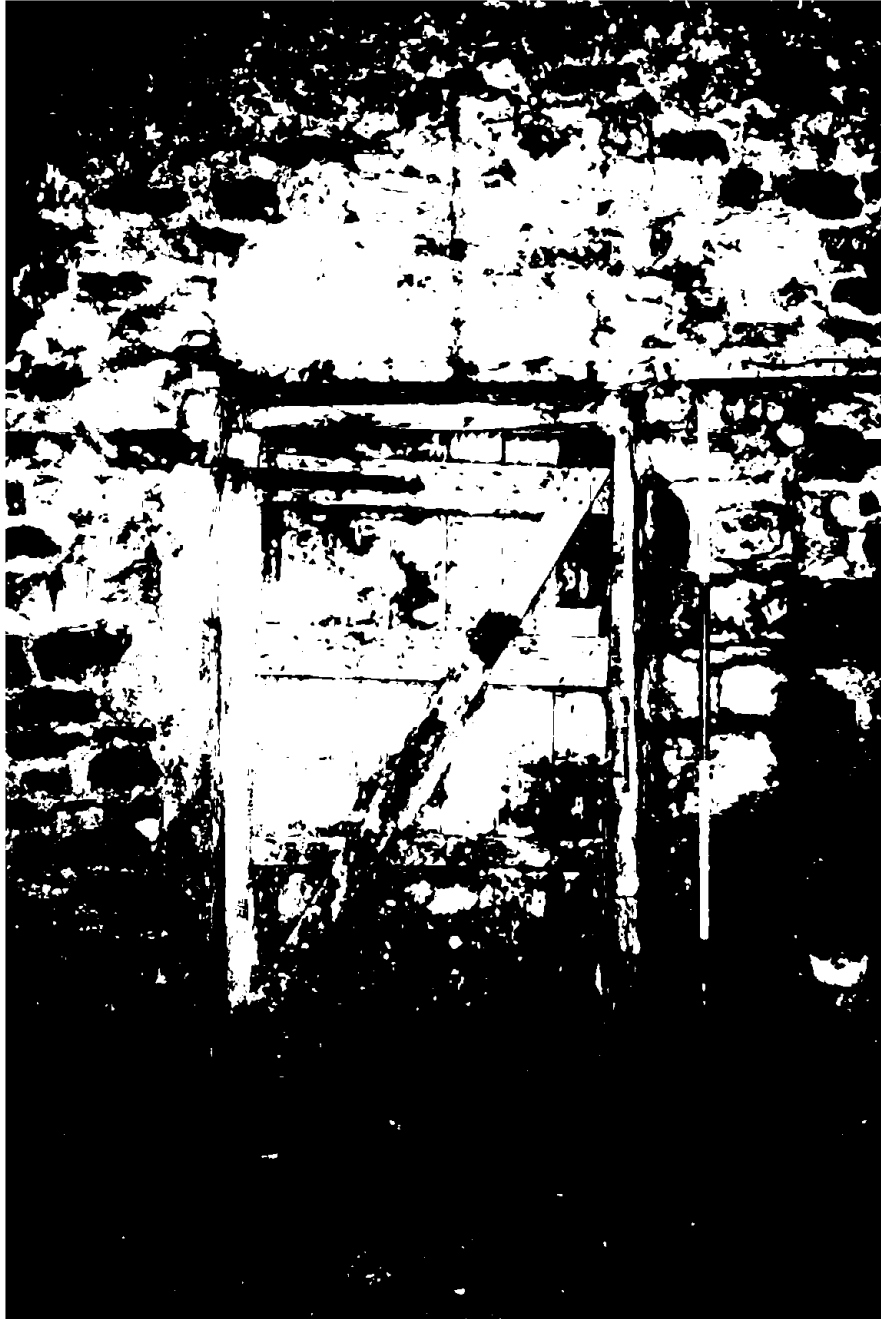
Within the barn proper, this bay was open to the roof. Central to the north wall was a partially blocked doorway, which had originally measured 2.3m high by 1.6m wide. On the east side, the bay was defined by a timber plank partition,

Plate 15. Barn B, bay 2, partially blocked doorway in north wall, viewed from south.

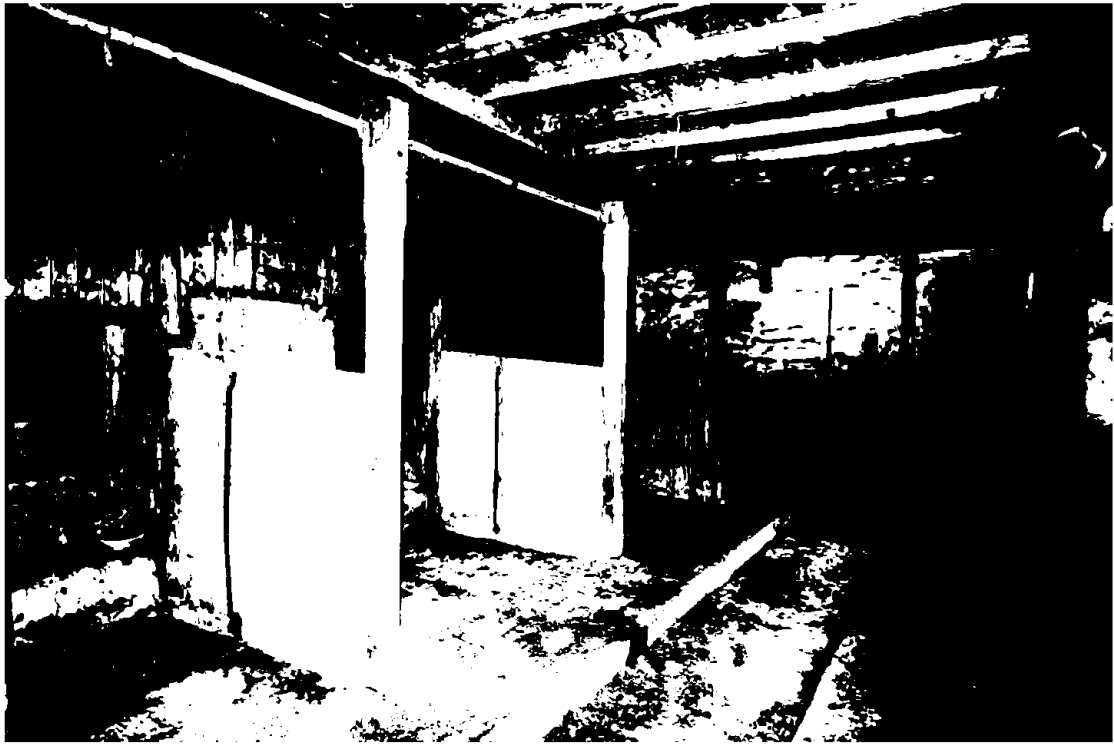
At ground floor level, bay 3 comprised a single open space, the internal wall between the outshut and the barn proper having been removed, the wall over being carried upon a pair of I-section iron beams, 130mm wide. The west part of this greater space had been set out with five pairs of boskins. The dividing partitions comprised pairs of vertical timber posts, with chamfers and plain stops. These posts had clearly been reused, as all had been extended vertically by the addition of short identical sections, attached by mortice & tenon joints.

The posts were linked by solid sections, possibly of Carboniferous flagstone, but these had been rendered over, obscuring the internal panels. Vertical tie-posts of wrought-iron had been bolted into these panels, indicating how the pairs of cattle were secured within the boskins. The water feed pipes and troughs were still present. At the 'tail' side of the boskins, a concrete lined channel provided drainage for manure; an aperture at the north end (uphill) of the drain contained a water tap. This channel would have discharged through the probable inserted doorway in the south external wall of the outshut.

Plate 19. Barn B, bay 3, showing range of boskins, viewed from south-east.

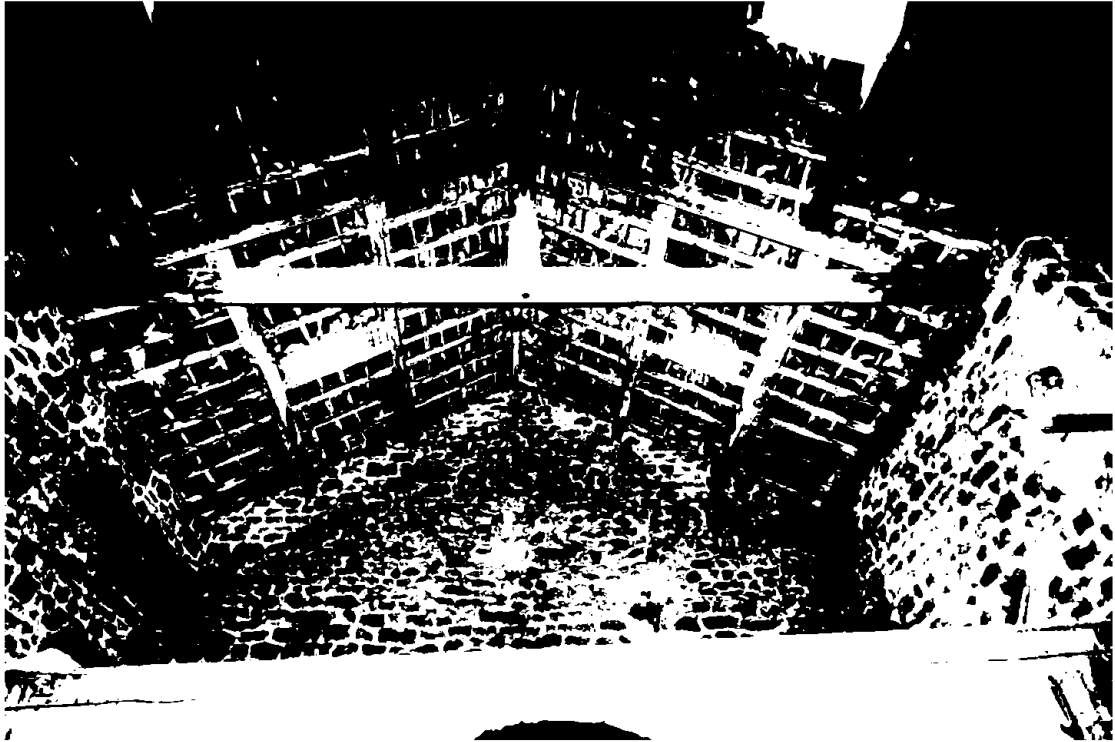
The main hayloft was not accessible, but over this was visible the roof truss which defined bays 2 and 3. It comprised a substantial timber king-post truss, supporting two purlins per pitch, and a ridge piece. All of these components were of machine cut softwood, probably Baltic pine, but no Baltic timber marks could be discerned. The tie-beam was linked to the king post and to the principal rafters by wrought-iron iron bolts; but there were no compression struts, which was perhaps surprising, given the weight of the roof covering. Common rafters and lathes for attachment of roofing slabs completed the assemblage.

Plate 25. Barn B, roof structure over bays 2 and 3, viewed from west.

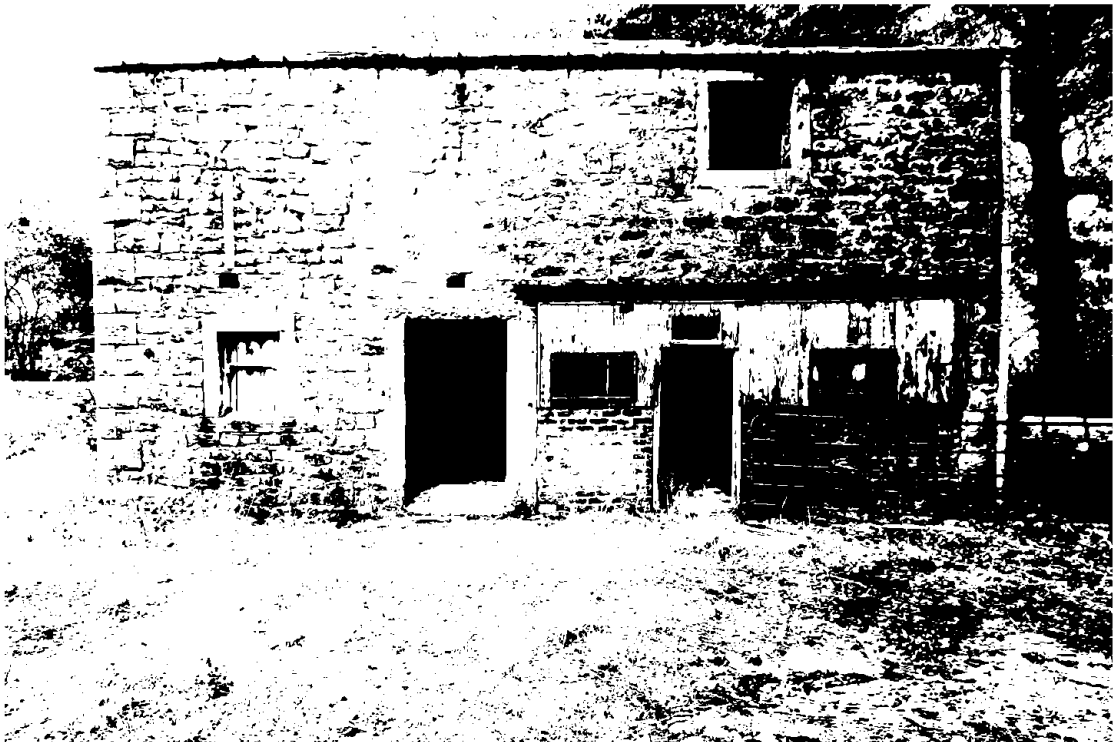
This was the principal elevation, facing into the farmyard. Within bay 1, on the south side, the ground floor was wholly taken up by a broad cart entrance. This was defined by a pair of iron I-section beams, carrying the wall over. The beams were supported at the central point by a cast-iron column, which was no longer visible from the exterior. Subsequently, the lower part of the opening had been infilled in brick, with a timber plank screen over, the whole infill being punctuated by an offset pedestrian entrance (to avoid the iron column), and a pair of small three light windows to either side. Above this, at loft level, was a rectangular pitching eye, with monolithic ashlar cut sandstone surround. This had a pair of wrought-iron strap hinges on gudgeons, indicative of an outward-opening wooden shutter.

Within bay 2 was a possibly inserted doorway at ground floor level, contiguous with the cart doorway as described above. This had neatly-cut monolithic gritstone pillars as architraves, although the rock-faced limestone lintel may have replaced an earlier timber one. To the left (north) of the doorway was an original; two-light sash window, with neatly-cut monolithic gritstone surrounds. Above both the window and the doorway were cast-iron grid ventilators, evidently providing air flow to the internal shippon.

Plate 32. Barn A, west elevation, viewed from west.

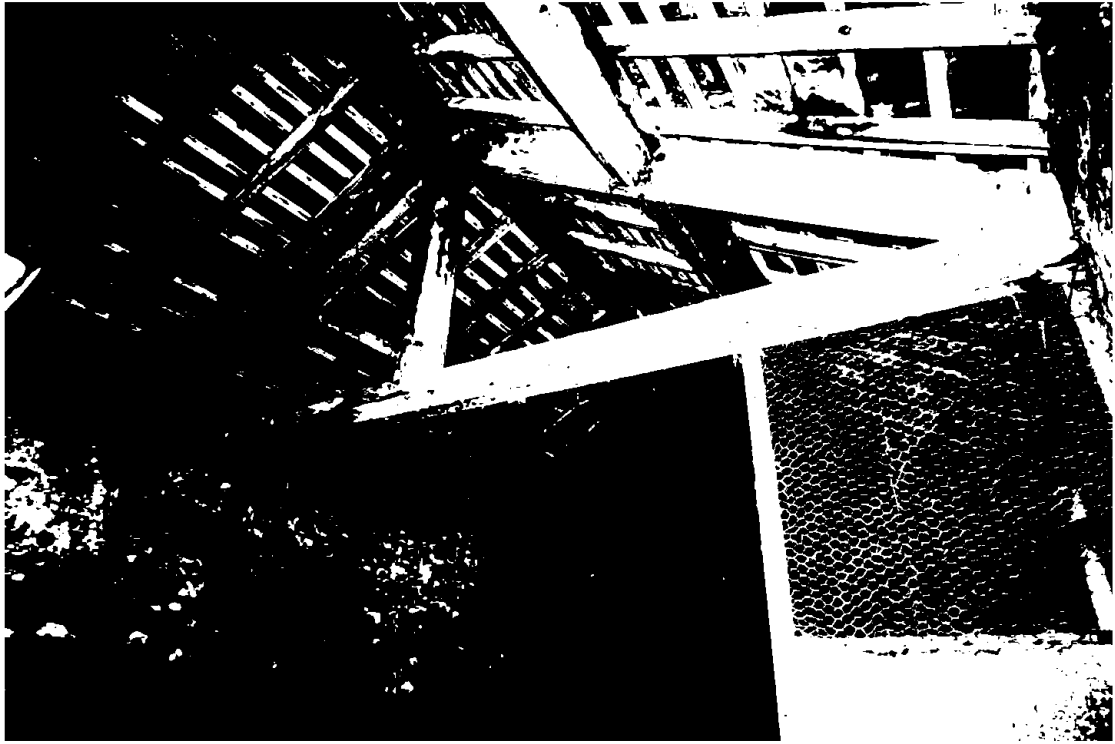
The roof structure was carried upon a single, central timber king-post truss. The king post and principal rafters were affixed to the tie-beam by wrought-iron tie bars. Raking struts had extended to connect tie-beams to principal rafters, but the one on the west side was no longer present. The king post was deeply jowled at its upper end, supporting a large scantling ridge piece, and there was a single purlin per pitch. Common rafters and lathes to affix roof slates completed the assemblage. All of the roof timbers were of mechanically sawn softwood, and no Baltic timber marks were noted, so given the time frame, it is possible that the provenance was either the Baltic states or North America.

Plate 41. Barn A, roof structure at loft level, viewed from bay 2, viewed from north-west.
