Bat Survey Report and Method Statement European Protected Species (Bats)

**New Springs Barn,
Saccary Fold,
Saccary Lane,
Mellor, BB1 9DL**

08.03.2024

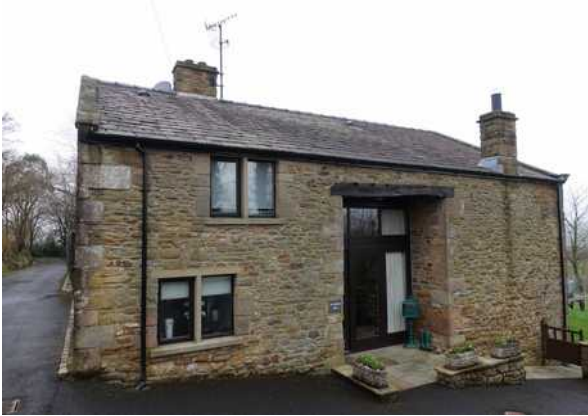
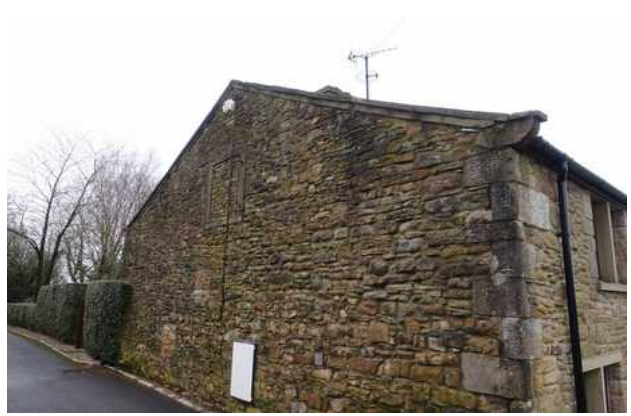
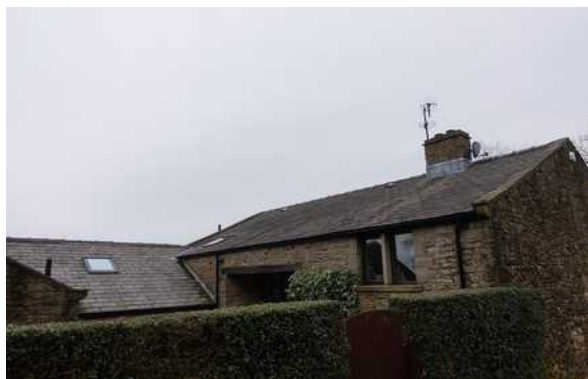
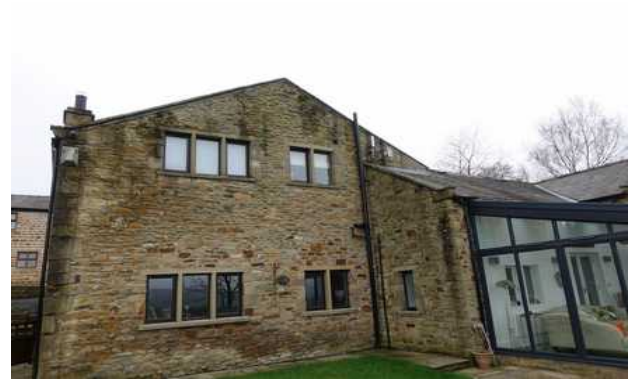
The property is a traditional stone built barn conversion with a double pitched slate roof, the building has single storey extensions to the southern gable.

External walls are generally well pointed with no obvious cracks, gaps or crevices present. The gables are pointed and sealed. Fascia boarding is generally close fitting.

Roof slates are close fitting with no obvious lifted, slipped or missing slates present. The ridge is sealed.

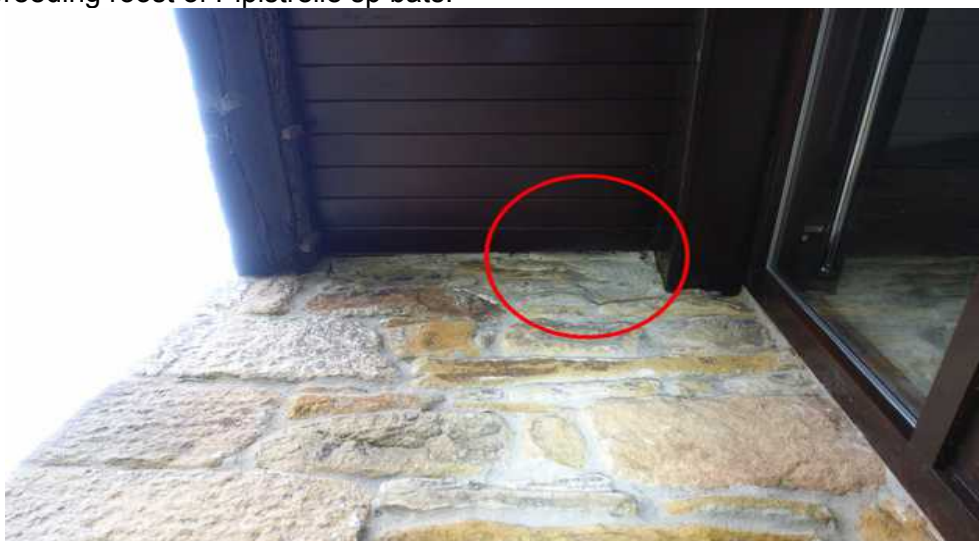
A gap in the underdrawn porch was observed with droppings adhering to the wall consistent with a small non breeding roost of Pipistrelle sp bats.

Location of roost within porch area.

Scaffolding should be positioned to ensure a clear flight line from the porch to surrounding habitat.
