**Bat Survey Report (preliminary day-time survey):  
Agricultural building at Scott House,  
Greenmoor Lane,  
Knowle Green,  
Preston,  
PR3 2YR**

OS grid reference:  
SD 6392 3716

**Survey Date: 7/11/23**

**Report Date: 8/11/23**

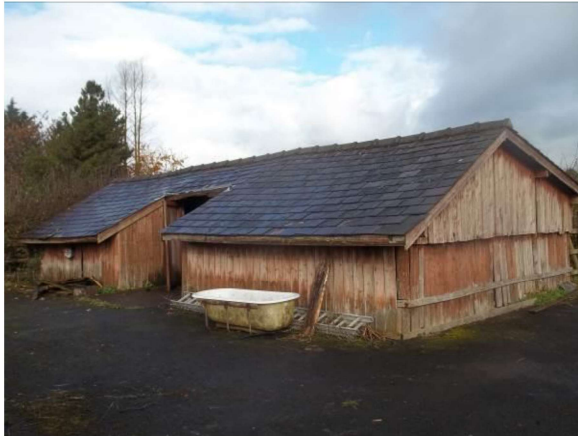
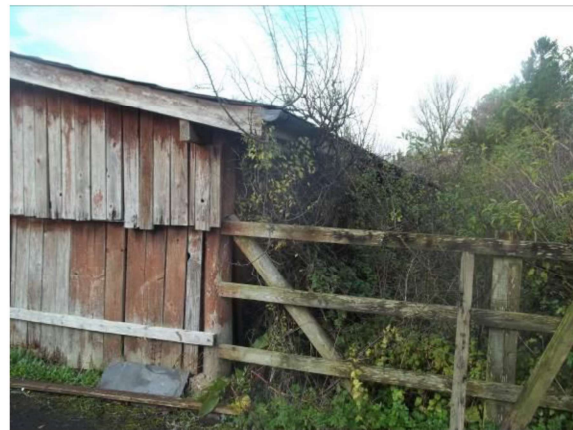
Front (south-west) and rear elevations

This is a single-storey, wooden structure with a slate roof:

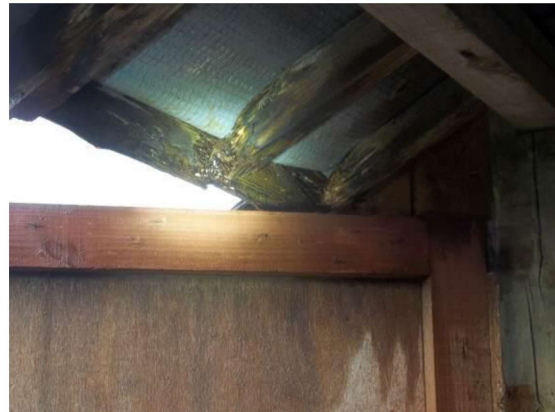
The building is a simple structure of wood, in deteriorating condition:

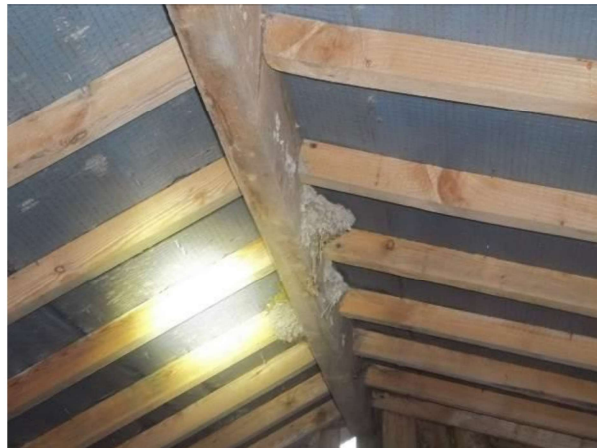
There is a ridge beam present, and the slate roof is lined with plastic Monoperm:

The plastic lining material to the roof is not particularly bat-friendly as they are likely to have difficulty clinging to it, but to a limited degree bats can enter between it and the slates externally and could tuck between slates or under the ridge.

If the building is to be re-roofed with same type of slates as currently, it would be a wise precaution to line the roof with a breathable membrane that has been shown to be safe if bats roost in association with it. Currently the only one to have passed the necessary 'pilling test' is TLX batsafe. <https://www.tlxinsulation.co.uk/tlx-batsafe/Batsafetesting.aspx>. Bats may still be able to get between slates if any are not close-fitting enough to prevent them. Alternatively, traditional Type 1F bitumastic felt is bat-friendly.

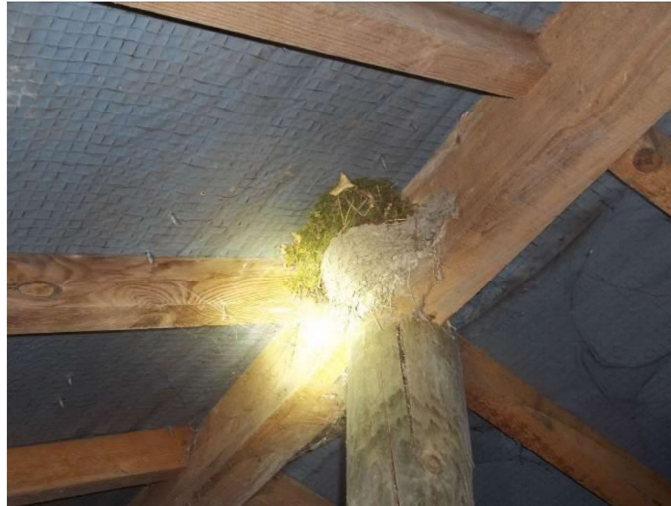
Multiple swallows' nests were present. Two have since been used by other passerine species:

There were no obvious signs of recent swallow droppings to confirm use in 2023.

When the building is converted it should be ensured the roof provides a beam structure similar to that present at the moment so swallows can return to nest if necessary. It should be ensured access in flight is still available to them. This is necessary to allow bats access to internal boxes too.

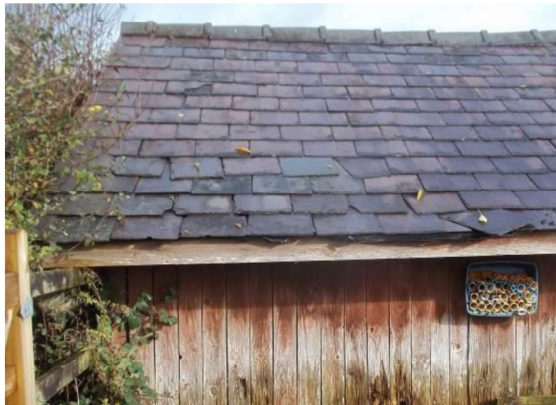
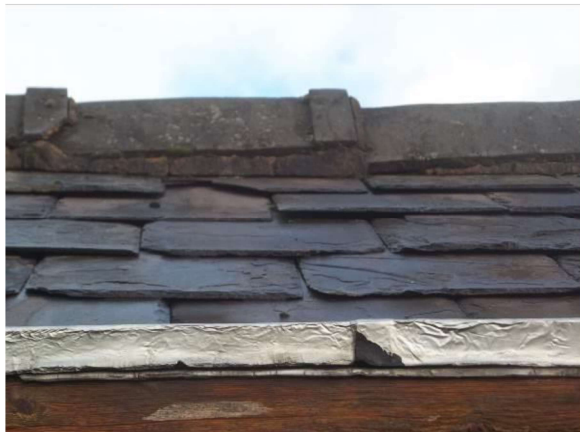
Externally in places there are a few uneven slates where bats could enter to roost between slates or between slates and lining material, and some limited access under the ridge tiles:

I am provisionally assessing the risk of bats roosting here as low, pending the result of a bat emergence survey. It is quite possible that a bat will roost here at times, but the likelihood of confirming roosting even if multiple activity surveys are undertaken is quite low. However, a dusk-emergence-survey should be undertaken to better evaluate the situation.

However, loss of bat roosting potential when the work is done can easily be compensated-for by means of bat boxes, which can be attached to the gable walls both externally and internally. This would accord with the biodiversity objectives of the National Planning Policy Framework.

Boxes internally will have better stability of conditions. I recommend a Greenwood's small, hollow bat box on each internal gable wall and a Greenwood's small, single crevice bat box on each external gable wall. They should be fixed towards the gable apices. (<https://www.greenwoodsecohabitats.co.uk/shop>).

Have a dusk-emergence-survey undertaken in 2024 in favourable weather conditions.

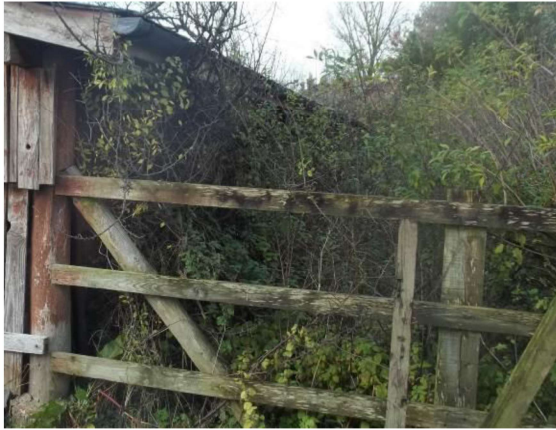
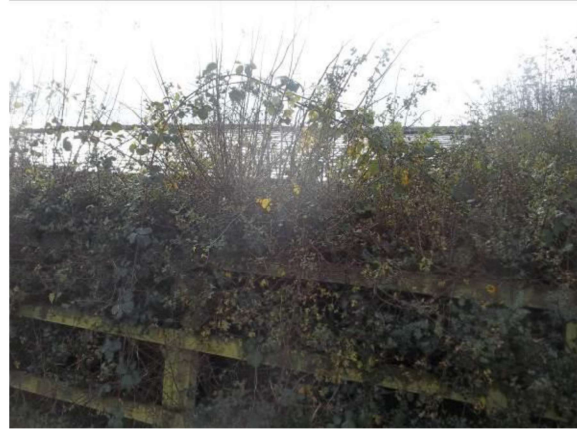
A hedge along the fence-line on the north-east side (rear) of the building, and dense shrubbery between it and the building, both obscure the view of the building and provide nesting habitat for birds; possibly including birds of conservation concern such as the dunnock and house sparrow:

This will also provide a feeding habitat for bats.

Some clearance of overgrown vegetation to the rear of the building will be necessary to facilitate the project. I usually require existing vegetation to be retained until after the bat survey work has been completed, but in this case I'm happy that clearing vegetation between the north-eastern boundary hedge and the building can be done before the next bird nesting season without it being likely to impact any use of the building by bats significantly. Retention of the hedges on the north-eastern and north-western boundaries will ensure that nesting habitat for species such as the dunnock and house sparrow is still available.
