## ECOLOGY TECHNICAL NOTE

| <b>SITE NAME &amp; ADDRESS</b> | Land off Elker Lane, Billington (Grid reference SD 7177 3556) |
| <b>DEVELOPMENT PROPOSAL</b> | Continuing Care Retirement Facility |
| <b>ECOLOGY ASSESSMENT TYPE</b> | <b>BIODIVERSITY NET GAIN</b> |

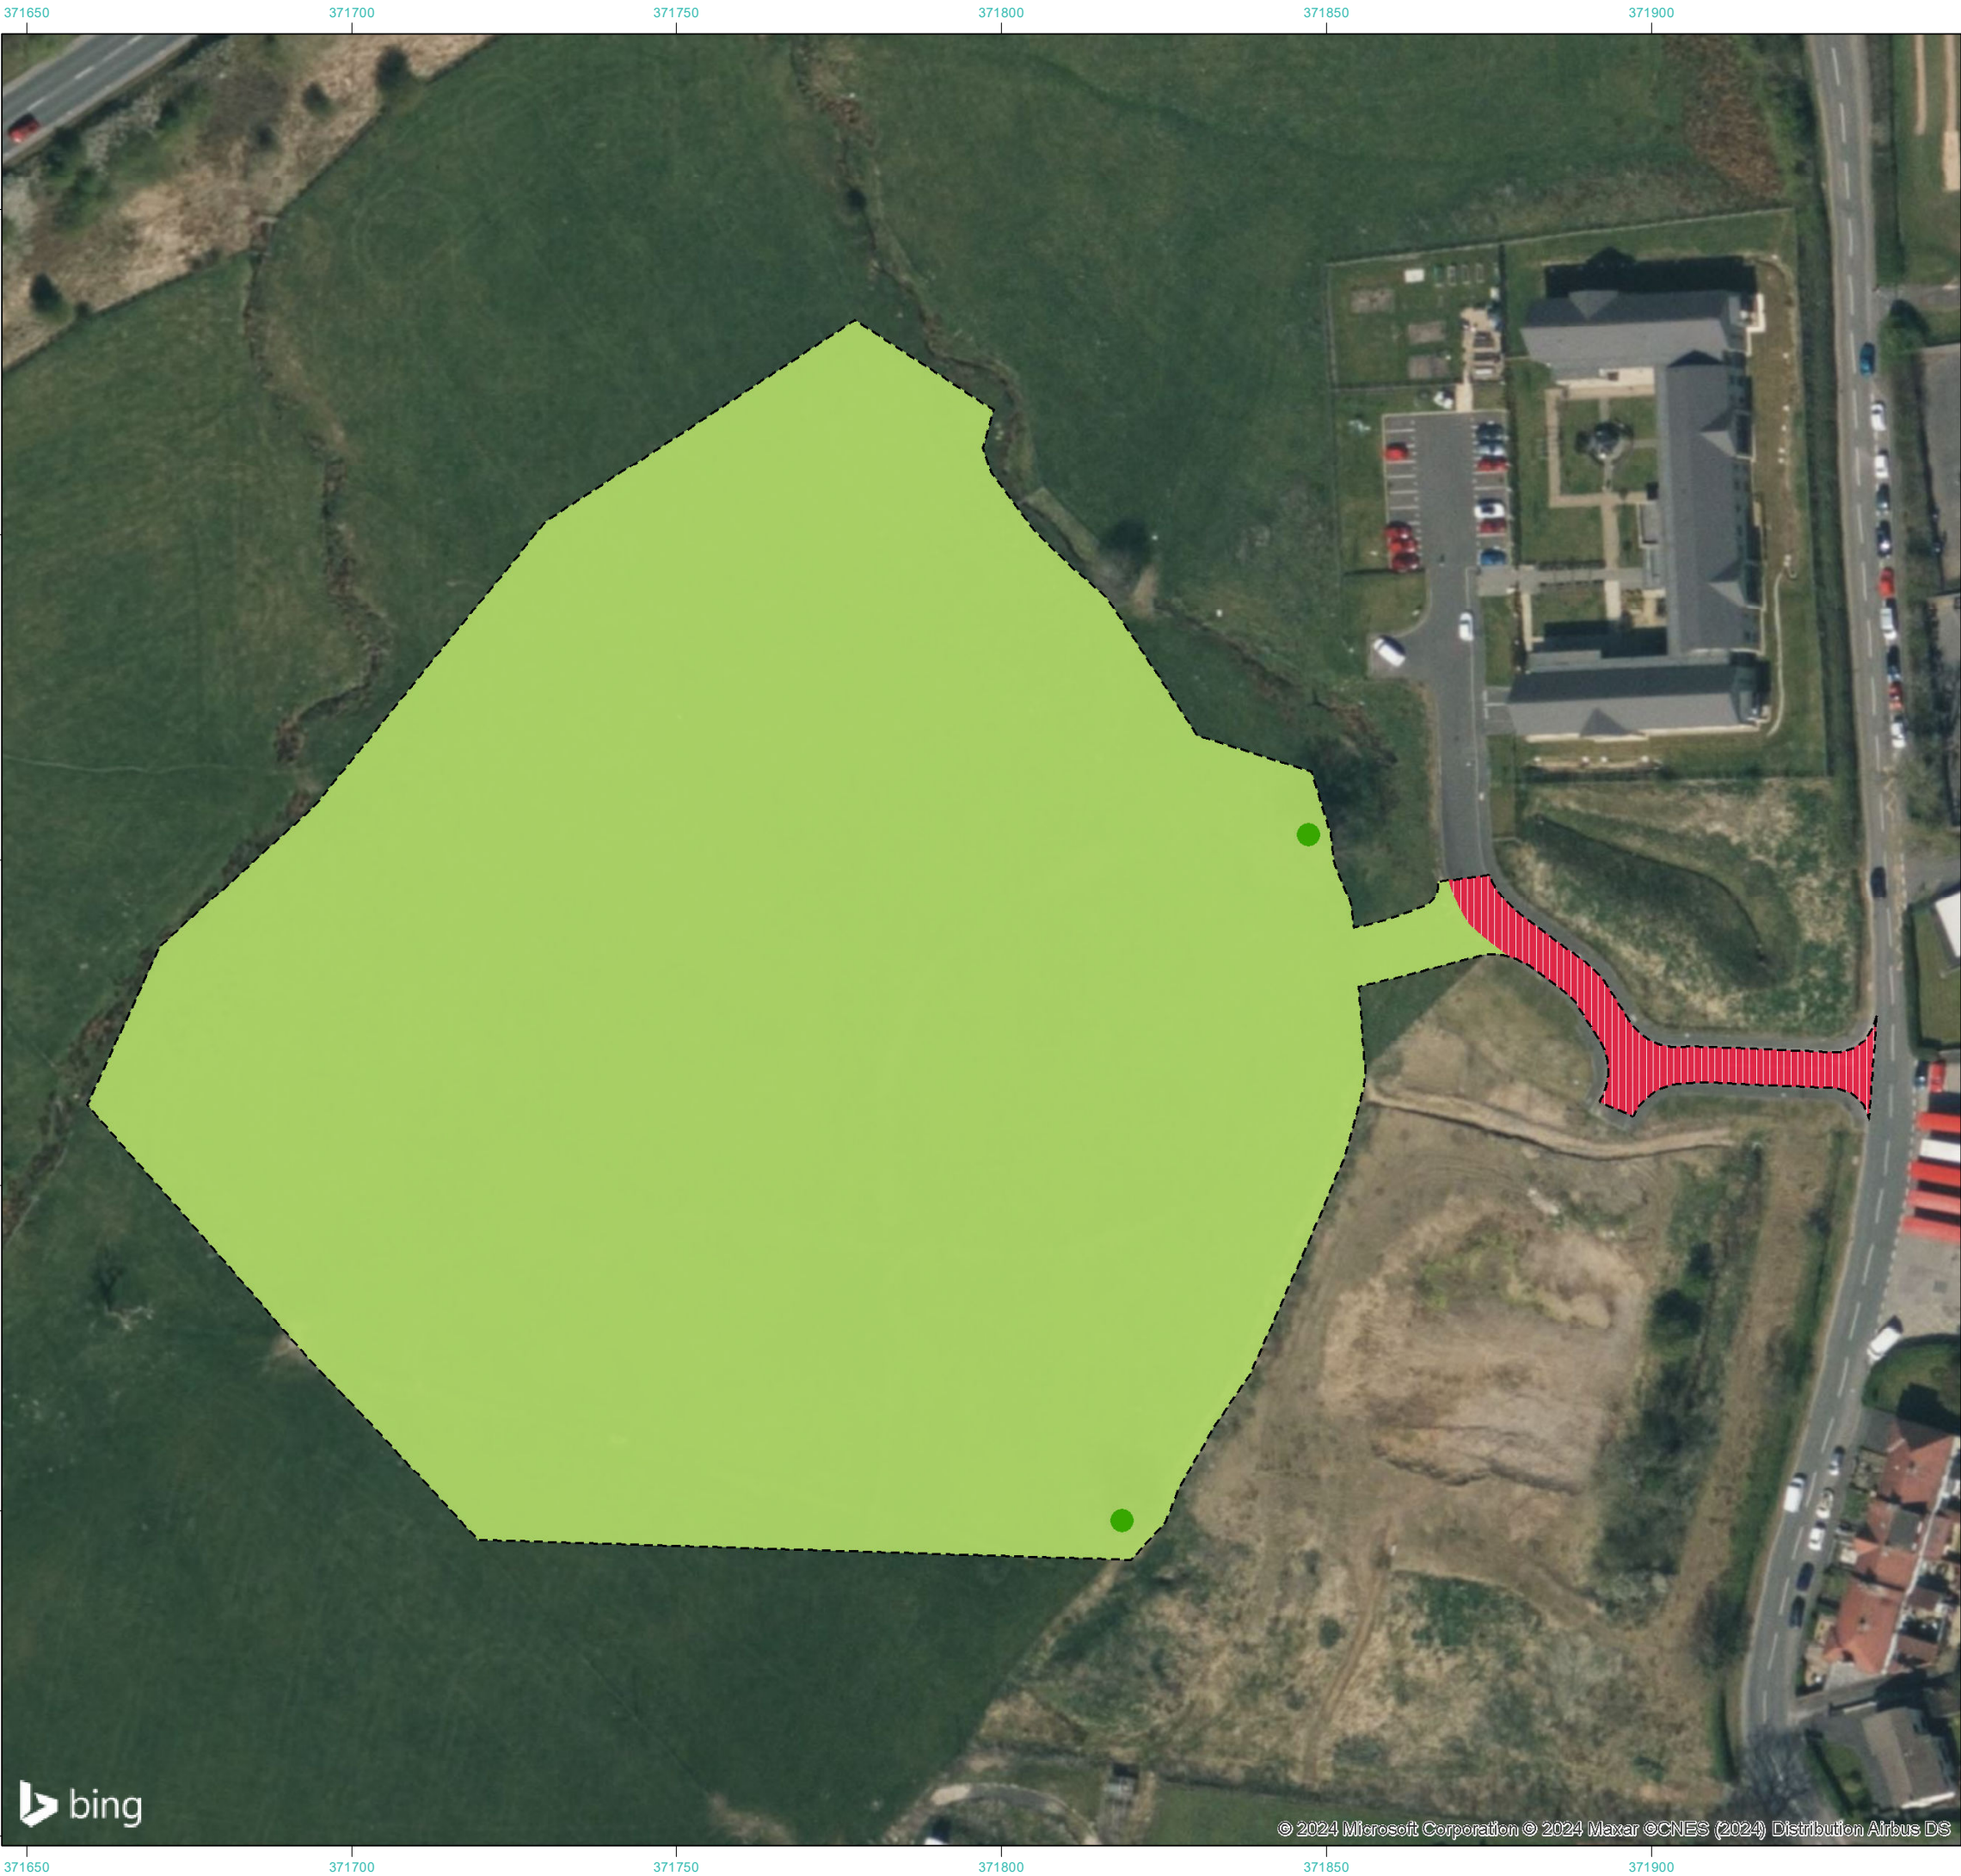
| Figure 1: UK Habitat Classification Map (Baseline) | | | | |

Photos which provide a general overview of the site and supporting data for the metric tool are provided in the PEA report. Figure 1 in Appendix A provides an overview of the habitat baseline as existing in June 2024.

The site area measures 2.54ha and includes the existing access road and an improved pasture field (UKHab Classification – g4 modified grassland). The grassland is in a ‘poor’ condition (see habitat condition assessment). All grassland habitat has been calculated as lost in the metric.

There are also two large oak trees on the site which are to be retained (good condition). The combined biodiversity value of the existing habitats is **6.18 habitat units**.

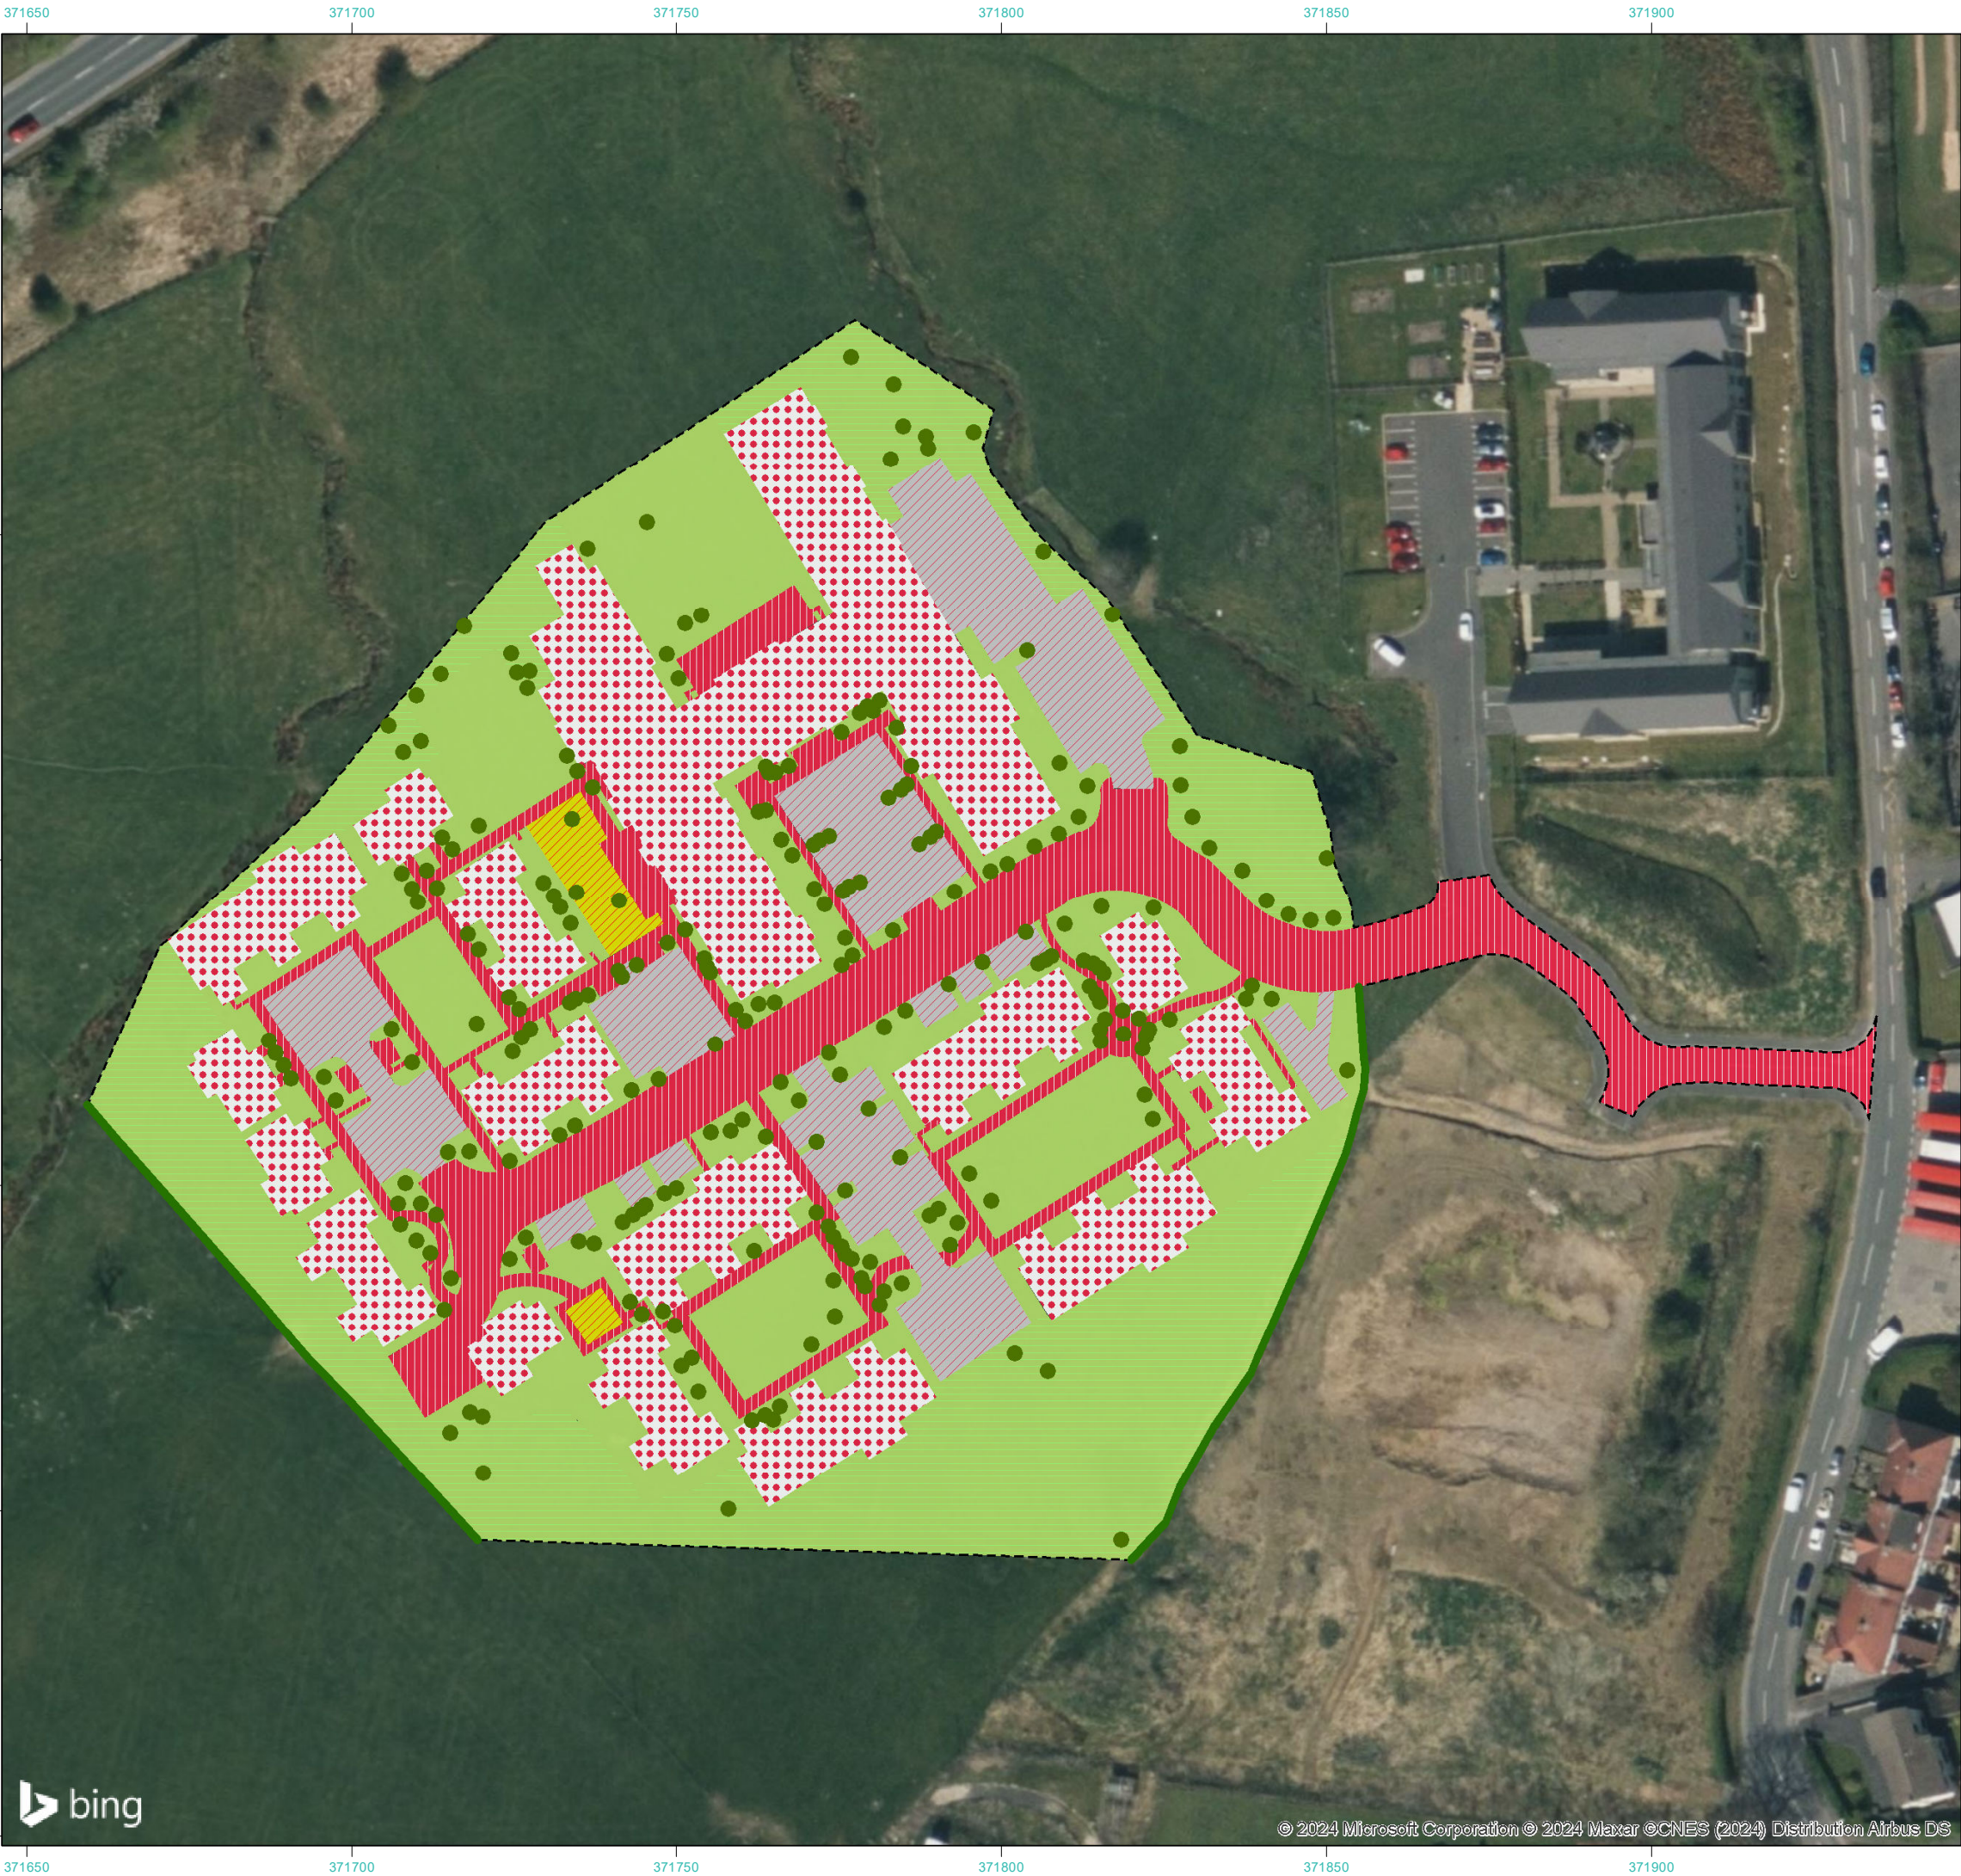
Figure 2 in Appendix B provides a UK Habitat Classification map of the site as proposed. It has been based on the DWG (CAD) file provided from the agent along with the landscape plan. This landscape plan has been enhanced with habitats (namely g3c other neutral grassland) that can be feasibly achieved at the site in order to achieve at least a 10% net gain.

The habitats with a measurable biodiversity value within the site would be: vegetated gardens; modified grassland (assessed to reach a ‘poor’ condition); and, a species rich grassland (other neutral grassland - assessed to reach a ‘moderate condition’). In addition, the landscape plan includes the planting of 101 native trees (all assessed to reach a ‘moderate’ condition).

Based on the post-development habitat plan (Figure 2), the development would result in excess habitat and hedgerow units being created on the site (i.e., excess value over the mandatory 10% threshold). The developer may wish to 'bank' these excess credits for any further development sites that are subject to the BNG condition (following the same rules as mentioned above).

The post-development habitat plan (Figure 2) has been based on the landscape plan with the addition of habitats which can be most feasibly be achieved within the site. This landscape plan is required to be supplemented with the design of a planting schedule and planting establishment and management measures which are typically completed by a specialist landscape contractor prior to the commencement of the works. A Habitat Management and Monitoring Plan which details such measures is recommended as this will form the basis for the habitat monitoring commitments that are to be made.

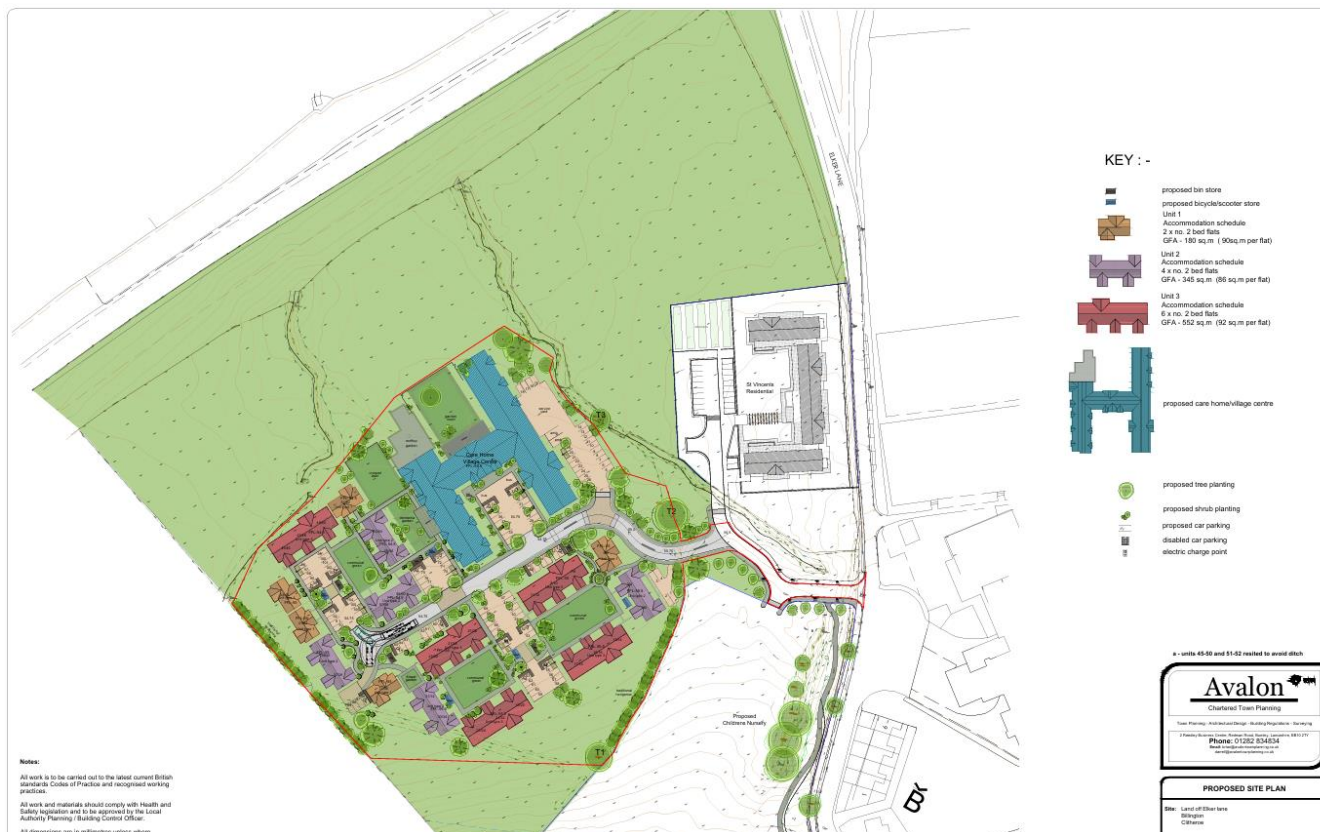
**Figure 2.1:** Site proposals with the streams marked as two black lines north and east of the development. Supplied by Knight Sky Ecology from Avalon, Dwg 01a, 09.09.2021

- 2.1. A River MoRPh Assessment has been undertaken of the two watercourses running through land off Elker Lane, Billington (National Grid Reference SD 716 355) as marked in Figure 2.1. The aim is to provide an assessment of the condition of the stream in order to inform a Biodiversity Metric Assessment to support proposals for a care home and residential dwellings on the site.

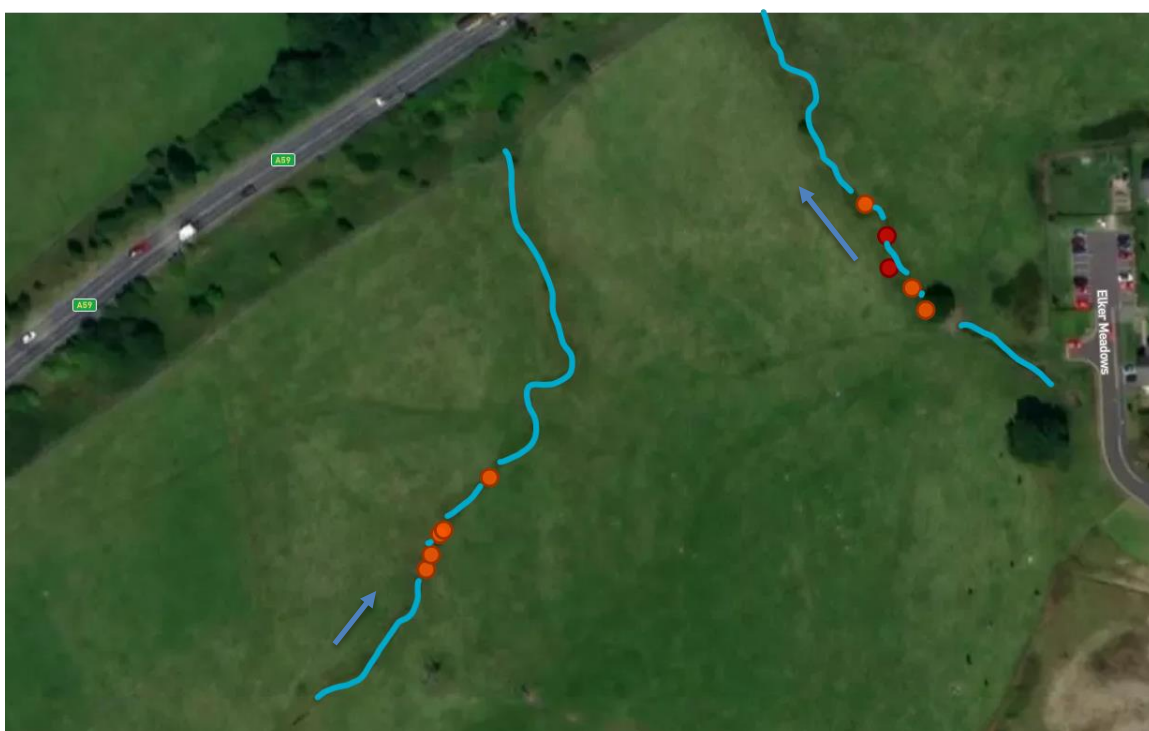
- 4.2. The survey locations (red dots) are shown on the aerial imagery map below (Figure 4.1) with the streams marked in blue and the flow direction indicated by the blue arrow. The water courses are un-named on OS maps so have been called Elker Lane West (ELW) and Elker Lane East (ELE).

**Figure 4.1:** Aerial view of the Elker Lane West (ELW) and Elker Lane East (ELE) streams in Land off Elker Lane in blue (arrow indicates flow direction). The 10 cross section survey locations (MoRPh 1 to 5 ELW and 1 to 5 ELE) are marked by red and orange dots. Map from Cartographer Copyright Mapbox, OpenStreetMap and Maxar.

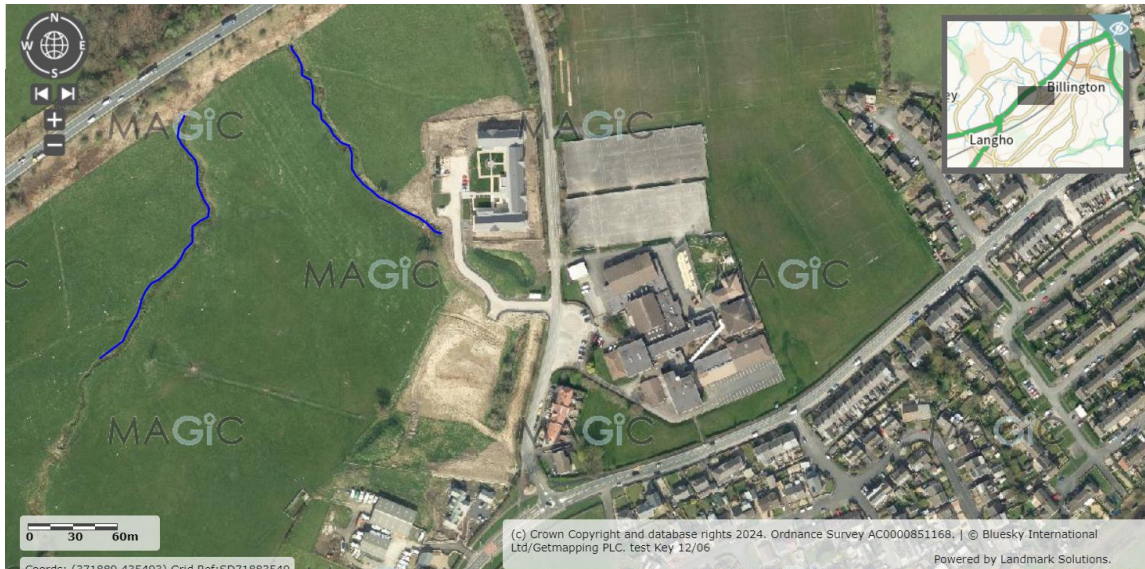
**Figure 4.2:** The location of the two streams (marked out in blue) in relation to the wider area. Map from Magic, (c) Crown Copyright and database rights 2022. Ordnance Survey AC0000851168.

- 4.3. Elker Lane West stream runs west to east, before heading north under the A49. Elker Lane East flows from south to north also heading under the A49. The site location in relation to the wider area is shown in Figure 4.2.
- 4.4. The stream is assumed to fall under the strategic significance category of 'Location ecologically desirable but not in local strategy' and therefore be of 'medium strategic significance' within the Biodiversity Metric. If this is not the case the estimated credits would need to be adjusted accordingly.

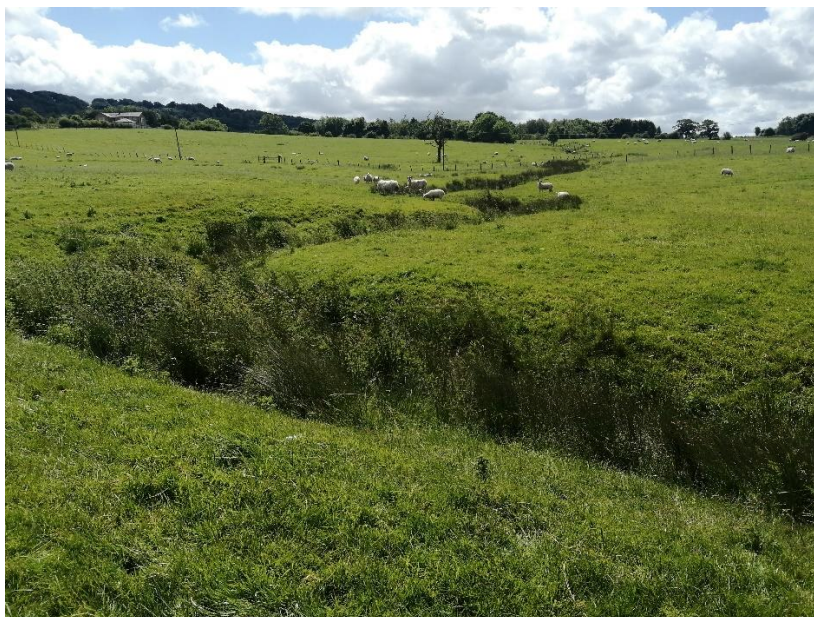
**Figure 4.3:** Looking west along ELW, showing steep banks and sheep grazing with tall grass and herb vegetation growing near the stream. (08/06/2024).

- 4.6. As can be seen from the photographs above, the surrounding habitat is grazed pasture with tall herb and grass vegetation along the bank tops and bank faces of both water courses with only one tree (vegetation terminology as per MoRPh methodology). Both streams are shallow and narrow, generally sat in a deep valley except where poaching occurs along sections of ELW. The flow varies from rippled to smooth and the bed material ranges from gravel and pebbles to sand and clay.

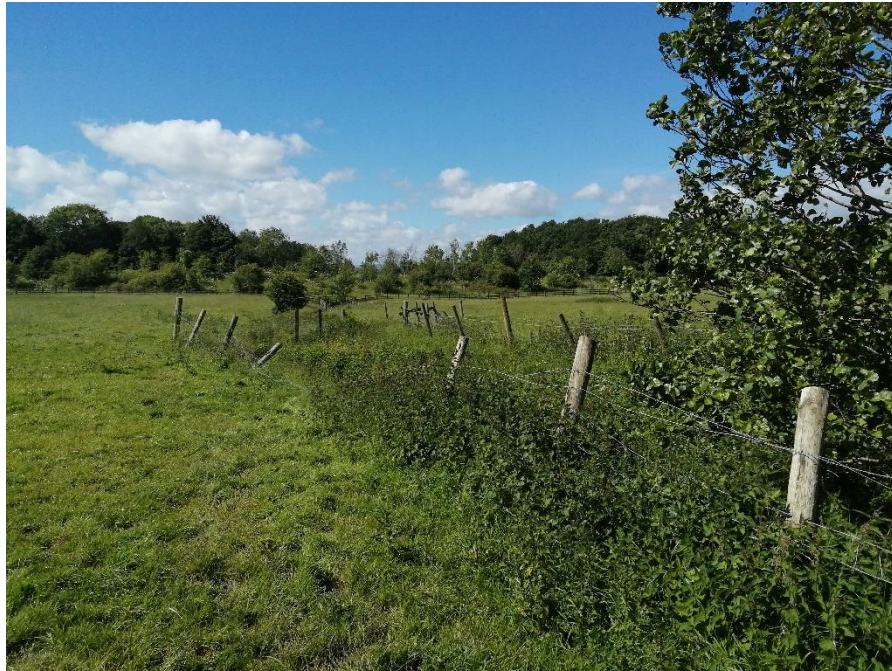
**Figure 4.4:** Looking downstream along the ELE towards the north showing the steep banks with one tree (alder) and tall herb vegetation on the bank top and face (08/06/2024).

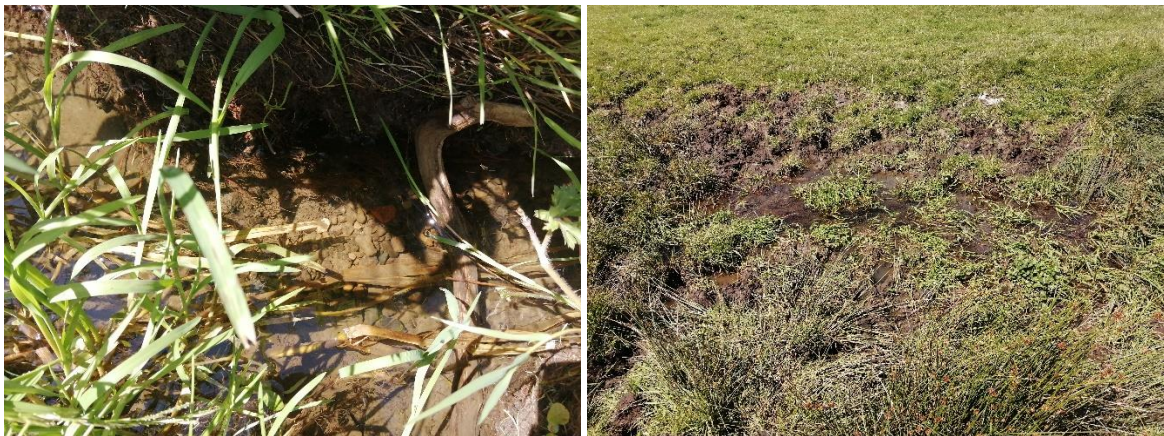
**Figure 4.5:** Left: The clear water of ELW with gravel pebble and silt as channel bed material plus overhanging long grass. Right: In areas poaching has occurred along ELW and the stream runs across the area which is predominantly short vegetation and earth. (08/06/2024).

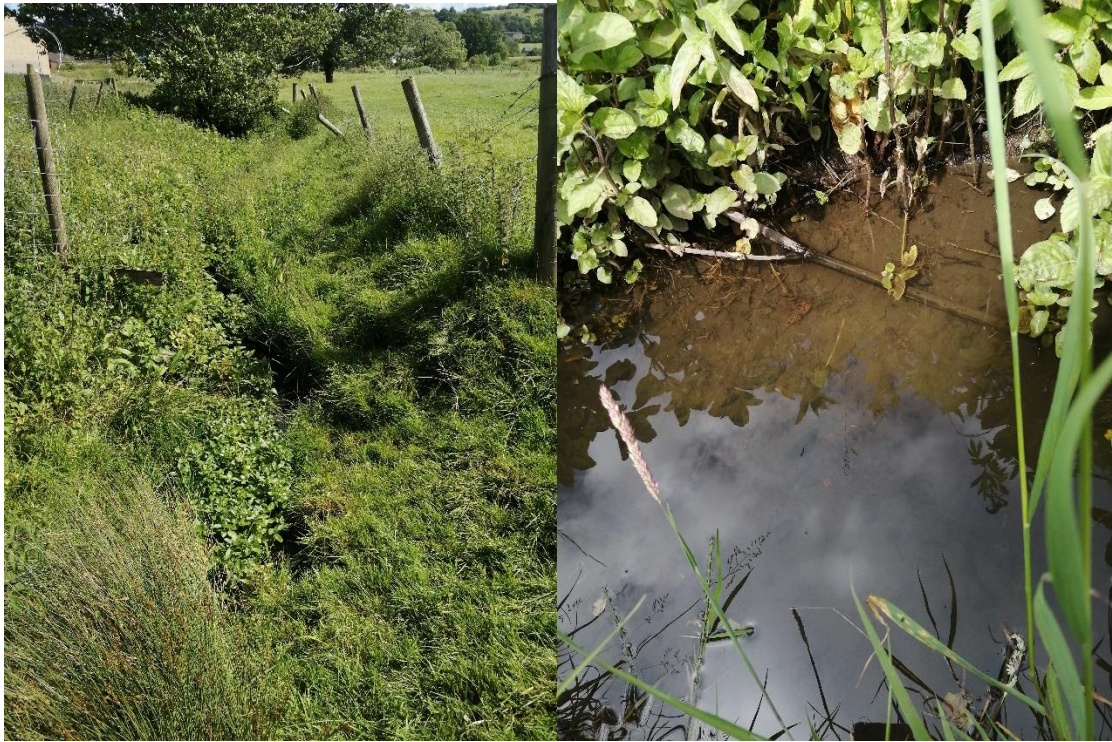
**Figure 4.6:** Left: Looking upstream along the ELE towards the south showing the steep banks with overhanging vegetation and the single tree. Right: The clear, slow flowing water with broadleaved vegetation emerging from the stream margins in 1 sector of ELE. (08/06/2024).
