**Bat Survey Report and Method Statement
European Protected Species (Bats)**

**Rear Extension to Pewter House Farm,
Carr Lane,
Balderstone,
BB2 7LN**

30.05.2024

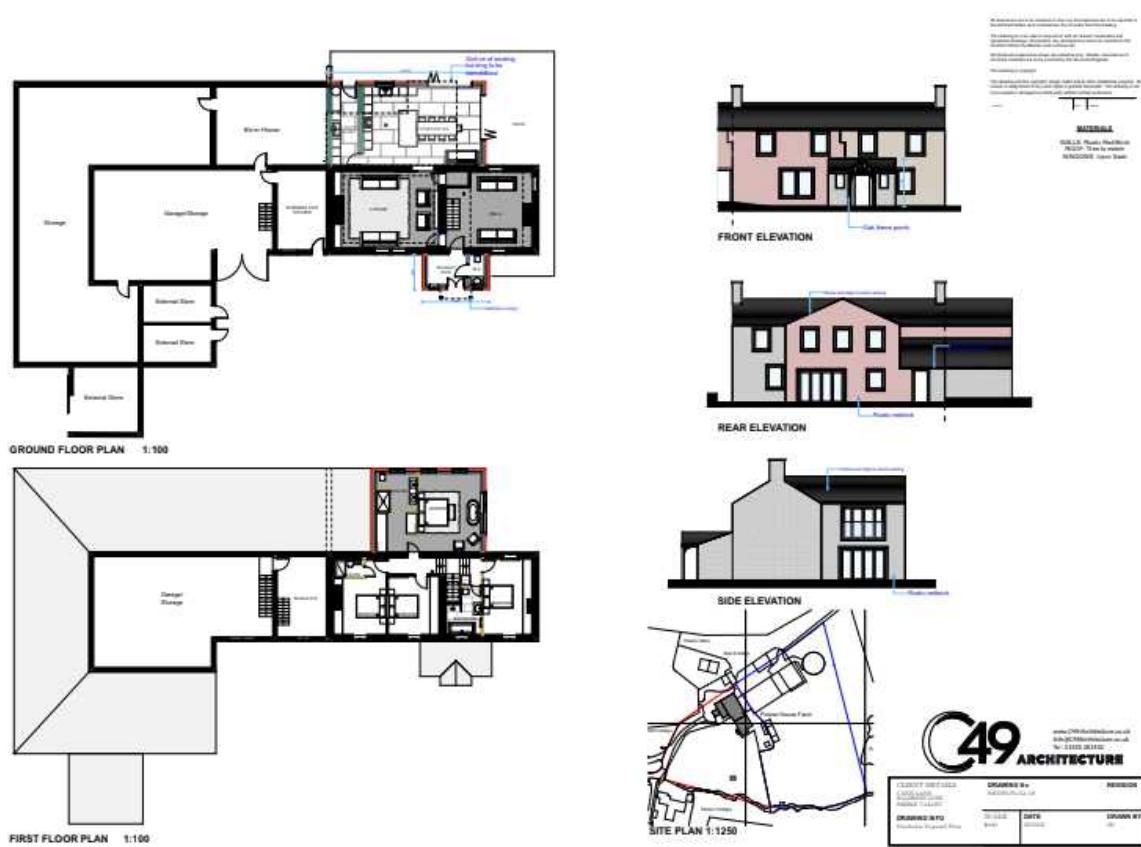
Proposed Works

Proposed works consist of the refurbishment of the existing farmhouse with a two storey extension to the rear. It is understood that this will involve some re-roofing works.

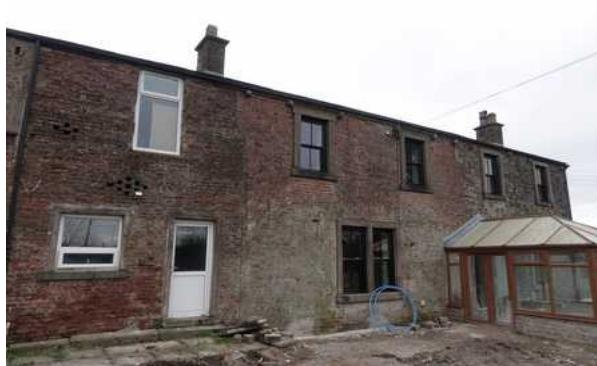
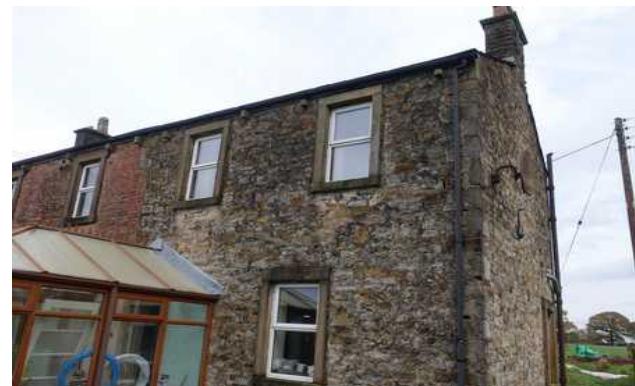
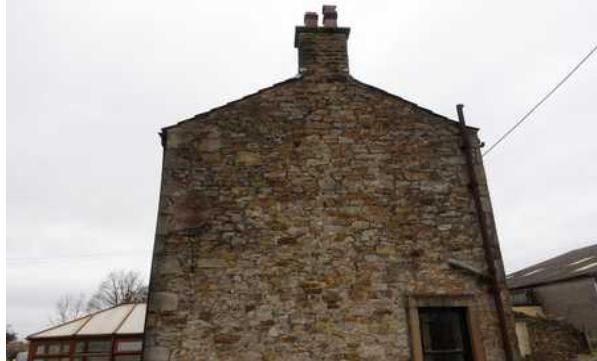
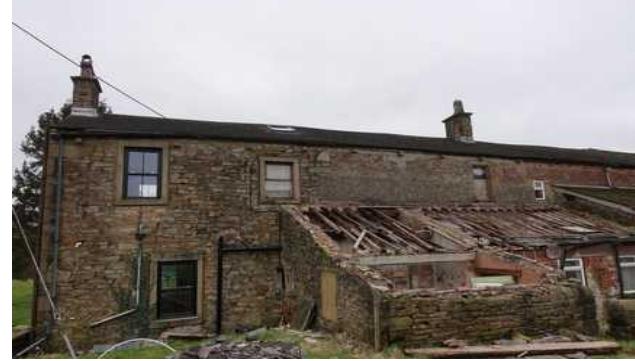
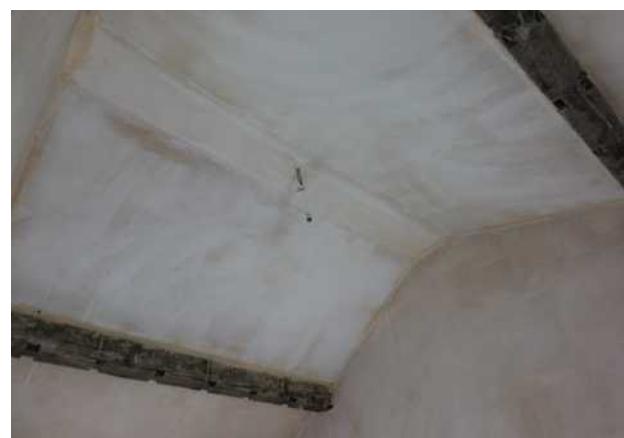
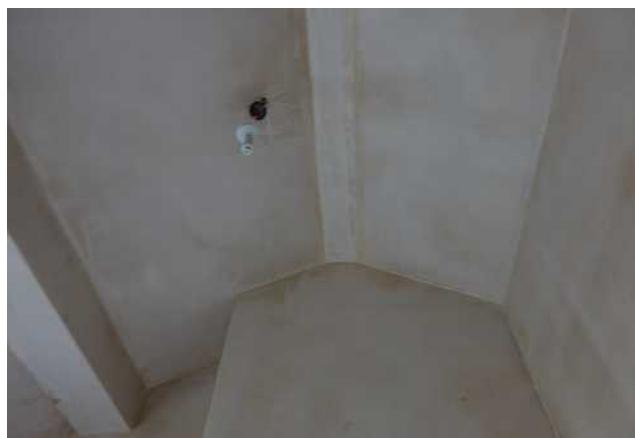
The property consists of a two storey brick and stone built farm house barn with a double pitched tiled roof, a two storey adjoining barn with stone slate and corrugated fibreboard roofs is present on the northern gable end. The farm house has a single storey extension to the rear which has had its roof removed.

External walls are generally well pointed however gaps and crevices suitable for roosting bats were noted on the frontage. The southern gable end is pointed with areas of lifted lead flashing.

Roof tiles are close fitting with no obvious missing, lifted or slipped slates present. Ridge tiles are pointed and well sealed.

Gaps are present behind timber fascia boarding at wall top level on the frontage.

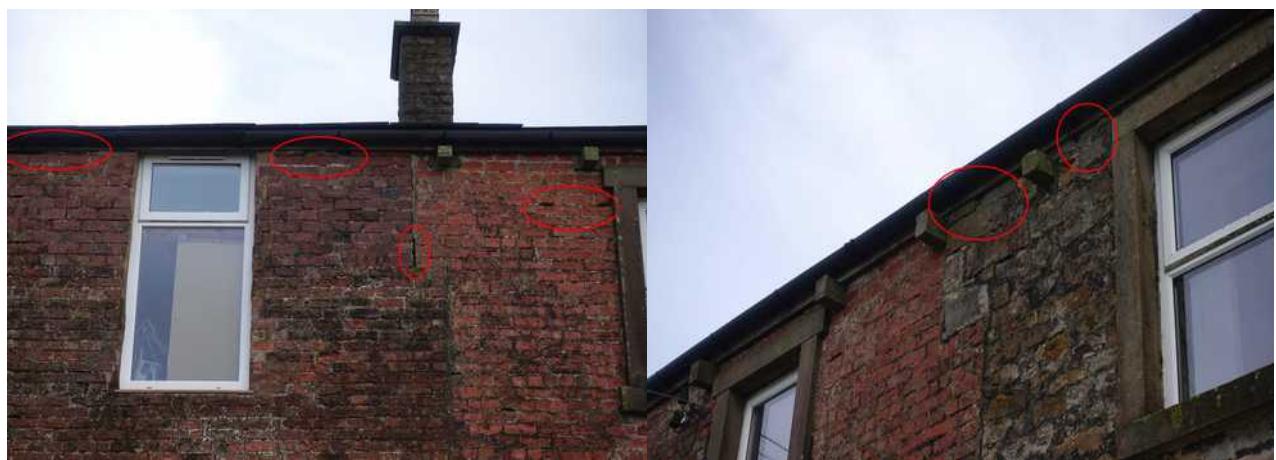
Gaps were noted at wall top level behind timber fascia boarding on the frontage of the farm house, two areas of lifted lead flashing were noted on the southern gable end. Lifted and slipped slates were present on the barn.

Gaps in pointing and behind fascia board at wall top on frontage.

No fascia boarding will be removed until a endoscope survey has been carried out to confirm continuing absence of roosting bats.

The reverse fascia boarding should be checked for dormant bats prior to moving.

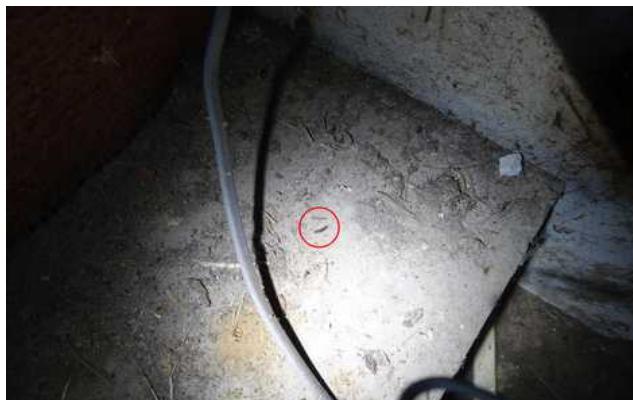
An inspection of the barn found a low number of scattered bat droppings close to the northern gable end of the farmhouse. Droppings were consistent with a low level of bat flight activity within the barn.

Bat dropping below gable end within barn

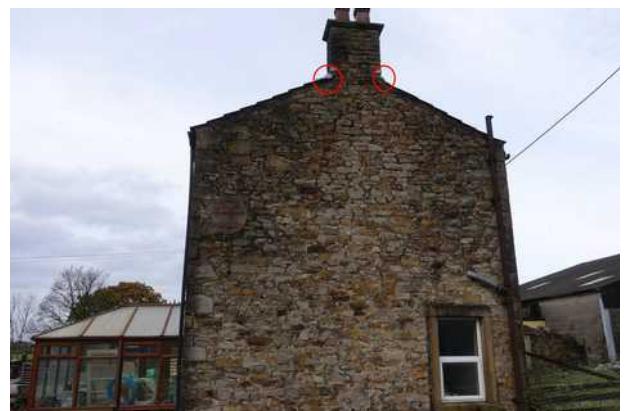
Gaps behind flashing on southern gable

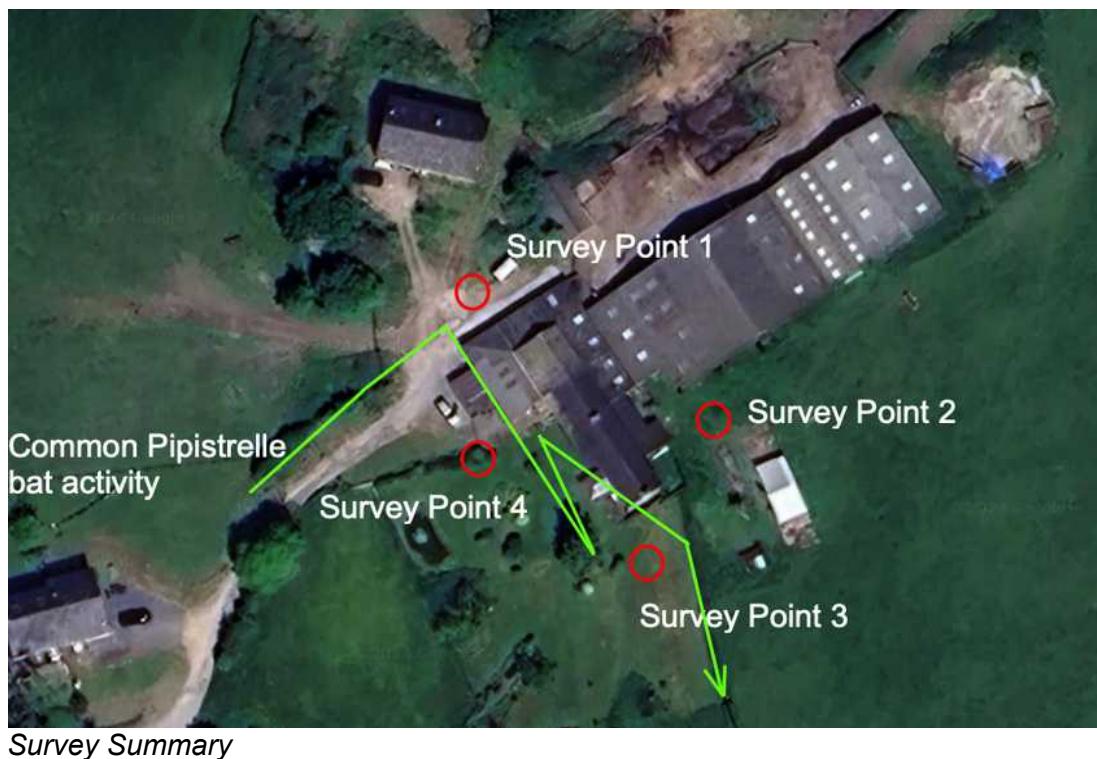
No bats were recorded emerging from the building and general bat activity was low with two pipistrelle bats observed to arrive from a treeline to the west at 22.01 and forage around the buildings in the lee of the wind before dispersing into the wider landscape to the south east at 22.35.

IR Video Coverage and Illumination level at end of survey.
