Proposed residential development
Land east of Chipping Lane
Longridge, Preston

Ground Investigation Report (Phase 1)

Proposed residential development Phase 1 Land East of Chipping Lane Longridge Preston PR3 2NA

GROUND INVESTIGATION REPORT

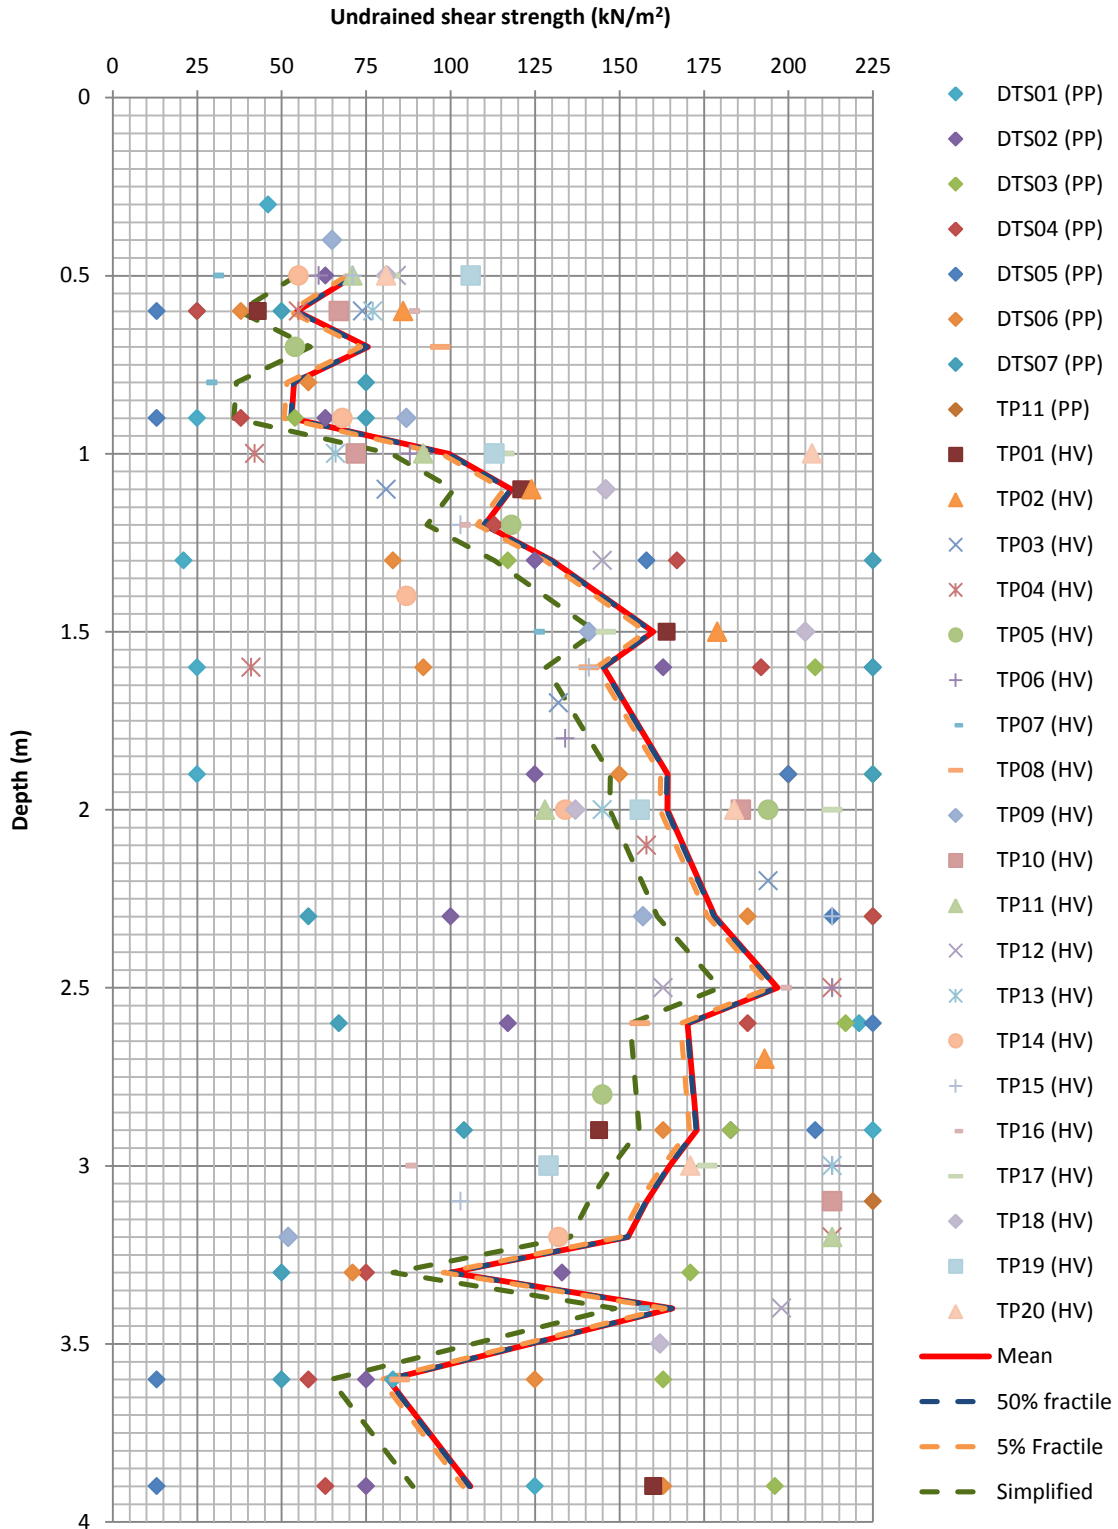
Title	Scale	Drawing number
Plot summarising results of pocket penetrometer and shear vane determinations by location	As shown	04

1) Equivalent undrained shear strength derived by multiplying Pocket Penetrometer (PP) results by 50

7.2.2.1 A detailed summary of ground conditions is provided in Section 5. Essentially ground conditions comprised of Topsoil overlaying cohesive Devensian Till deposits, the latter comprising low to very high strength brown mottled grey and orange brown/grey clay in the initial 1m-1.5m below surface level. Below such depths deposits generally exhibit an increase in shear strength and trend towards a brown mottled grey, dark brown and reddish brown colour with varying amounts of silt, sand and gravel. Locally, shear strengths were noted to reduce in value below depths of 2.5m-3.0m (refer to Drawing 04).

7.2.3.2 Laboratory testing indicates the Devensian Till deposits are plastic, thus our assessment of bearing values are based on the assumption that these soils predominantly exhibit cohesion. Calculations, based on a conservative undrained shear strength of say 60kN/m² (derived from measured insitu shear strengths taken below proposed founding levels – refer Drawing 04) indicates the following bearing values for strip/trench fill foundations:-
