Proposed residential development  
Land east of Chipping Lane  
Longridge, Preston

Ground Investigation Report  
(Phase 2)

**Proposed residential development  
Phase 2  
Land East of Chipping Lane  
Longridge  
Preston  
PR3 2NA**

## **GROUND INVESTIGATION REPORT**

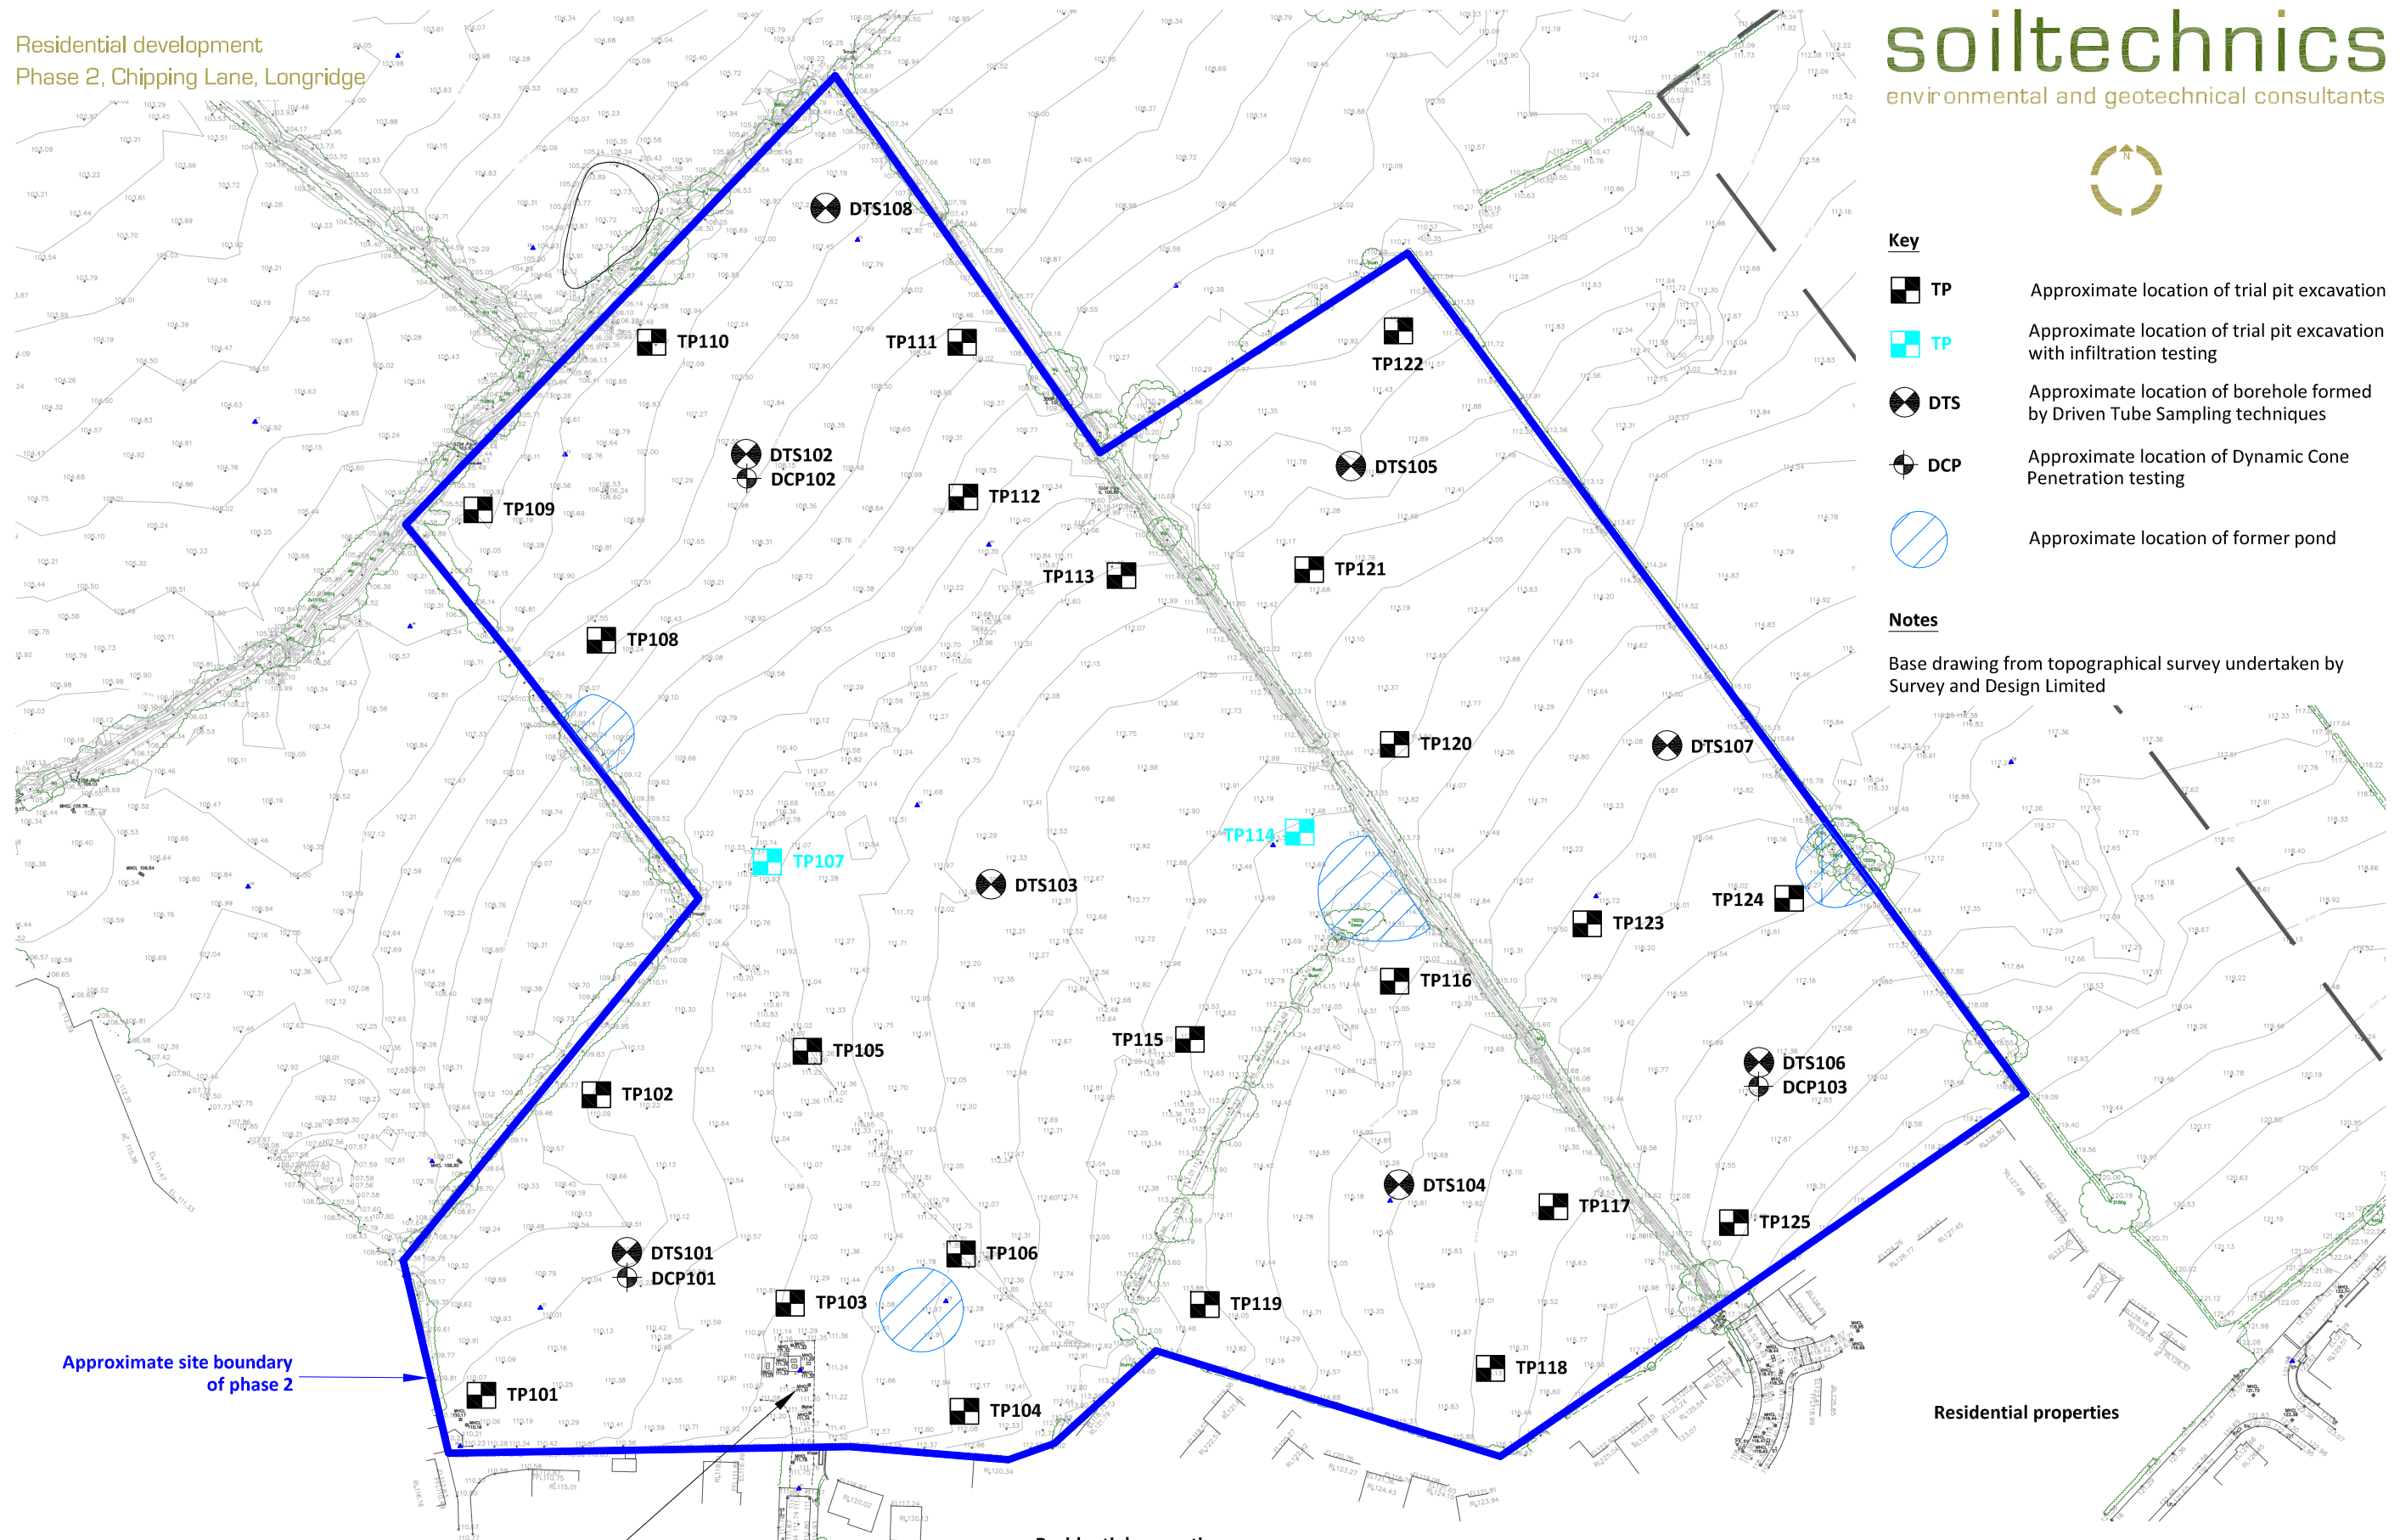
02b

Approximate site boundary of phase 2

Underground services access area

4.1.2 A plan of the site showing observed/existing site features and position of exploratory points is presented on Drawing 02b. The position of exploratory points relative to site development proposals is presented on Drawing 03. The position of exploratory points shown on these plans is approximate only and confirmation of these positions is subject to dimensional surveys, which is considered outside our brief.

8.5.4.1 A full description of the site and observed adjacent land uses is provided in Section 3 of this report. A plan summarising observations made on site during our site reconnaissance visit is presented on Drawing 02b.

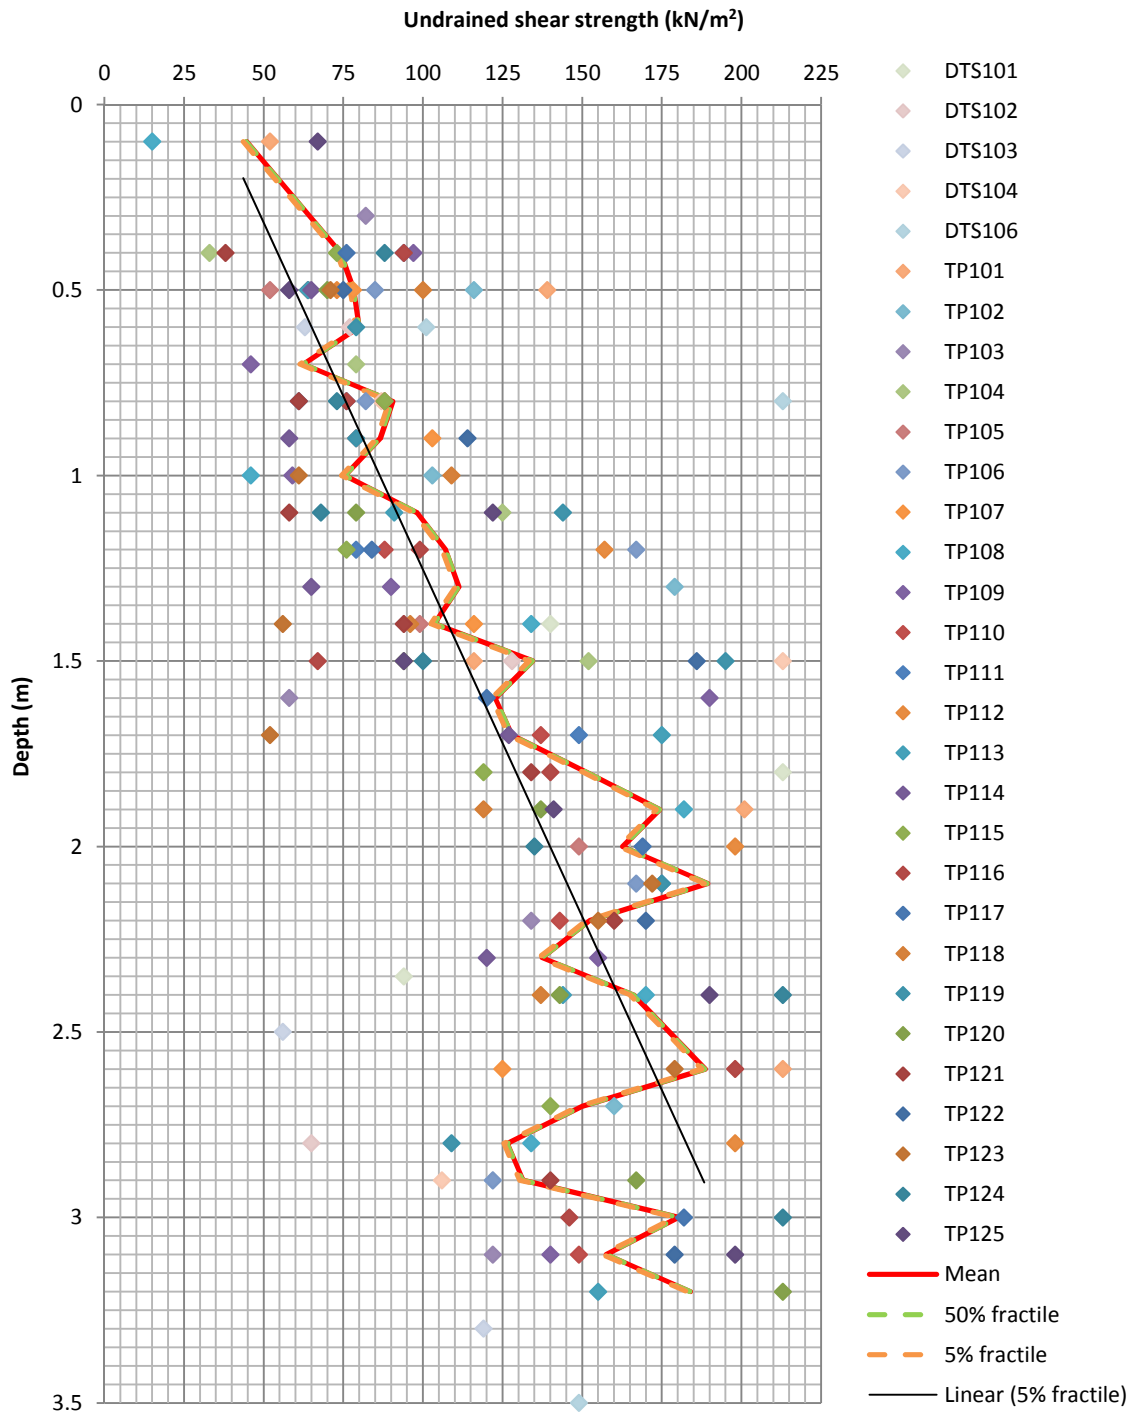
Title	Scale	Drawing number
Plot summarising results of shear vane determinations by location	As shown	05

7.2.2.2 A more consistent positive trend was noted in shear strength data derived using the shear vane within the Phase 2 development area compared to those taken within the Phase 1 area (refer to Drawing 05), with strength generally increasing with depth and only very localised softening of soils noted below depths of 2.0m. It is also noted that shear strength data derived using the pocket penetrometer is much more varied, with inconsistent strength measurements recorded with depth. The shear vane is, however, considered to provide much more reliable insitu shear strength results and we have adopted such values in the following foundation assessments.

7.2.3.2 Laboratory testing indicates the Devensian Till deposits are plastic, thus our assessment of bearing values are based on the assumption that these soils predominantly exhibit cohesion. Calculations, based on a conservative undrained shear strength of say 60kN/m<sup>2</sup> (derived from measured insitu shear strengths taken below proposed founding levels – refer Drawing 05) indicates the following bearing values for strip/trench fill foundations:

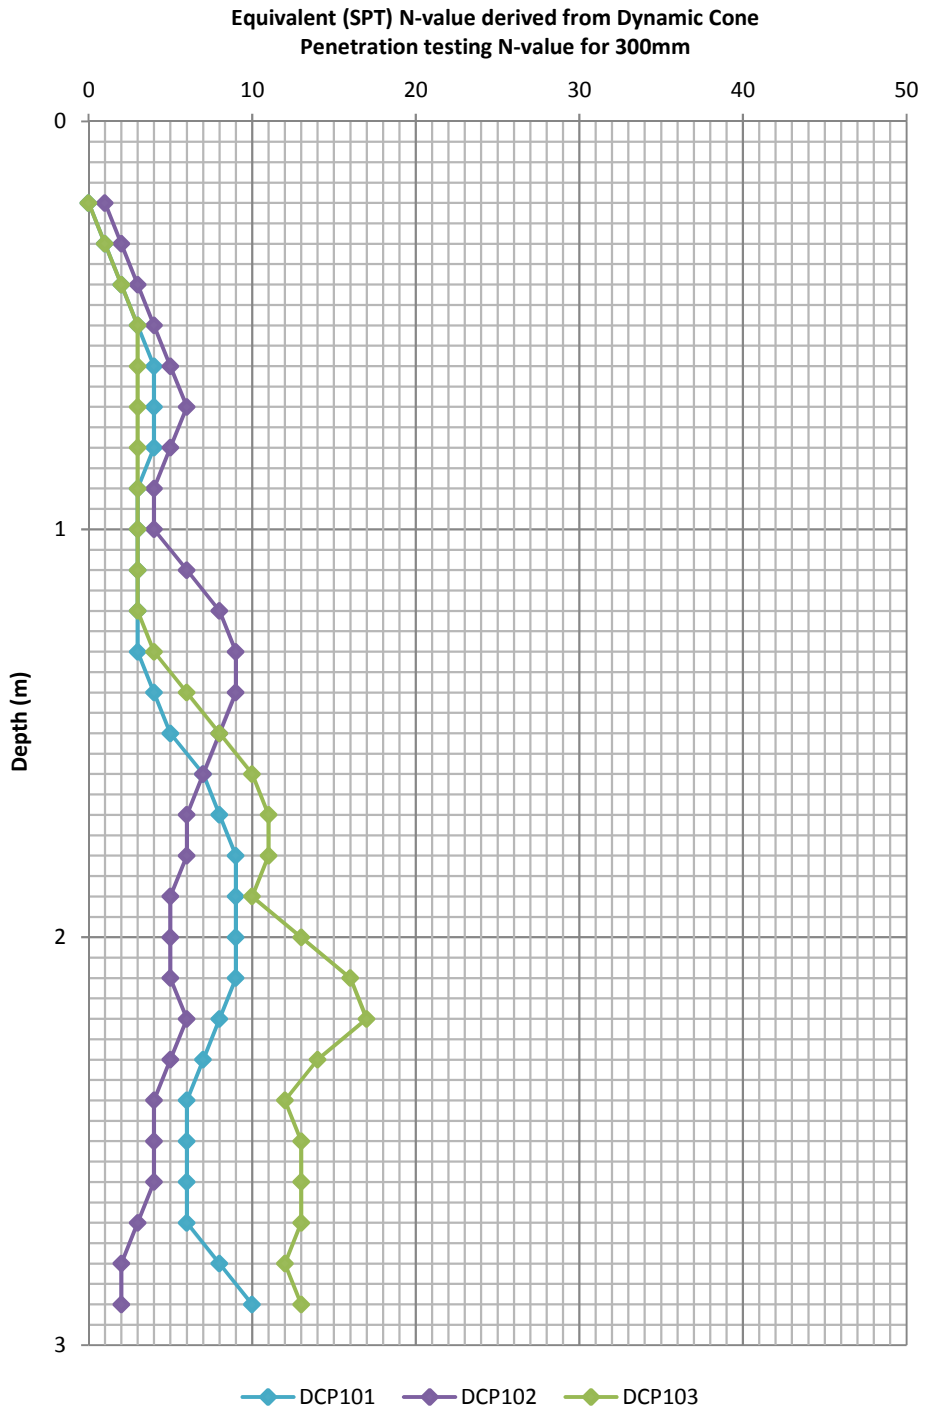
<p>Title</p> <p>Plot summarising insitu density testing utilising dynamic cone penetration (DCP) techniques</p>	<p>Scale</p> <p>As shown</p>	<p>Drawing number</p> <p>06</p>
---	------------------------------	---------------------------------

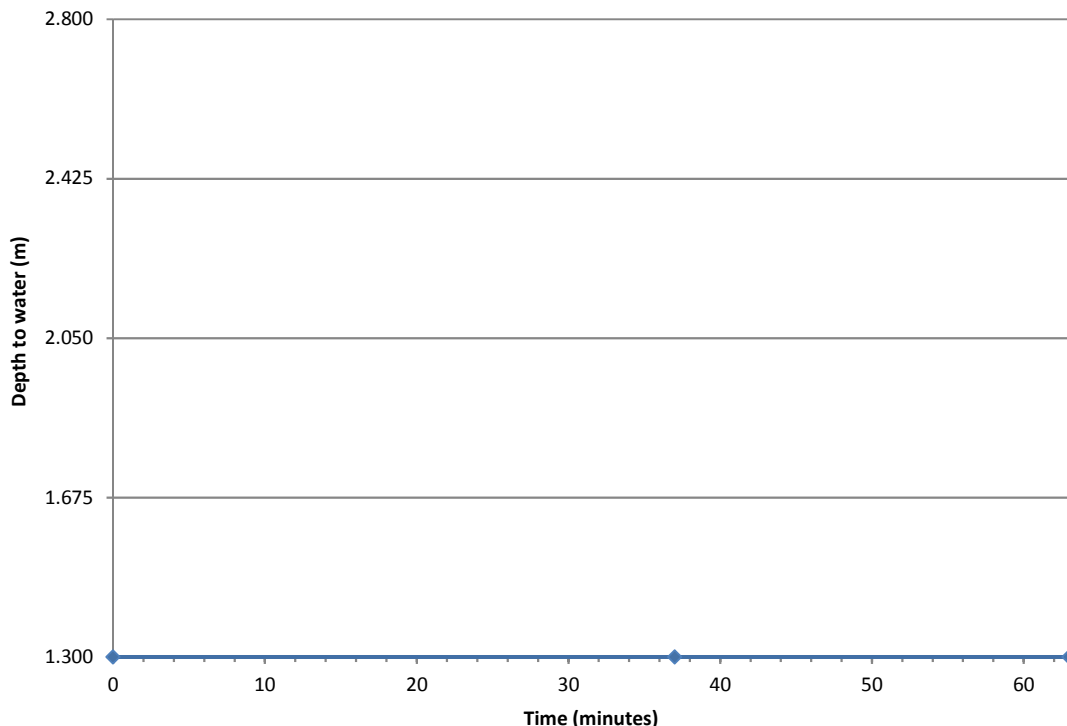
**DTS108**

**Plot showing time against depth to water:**

TIME (mins)	DEPTH TO WATER (m)	TIME (mins)	DEPTH TO WATER (m)
0	1.3		
37	1.3		
63	1.3

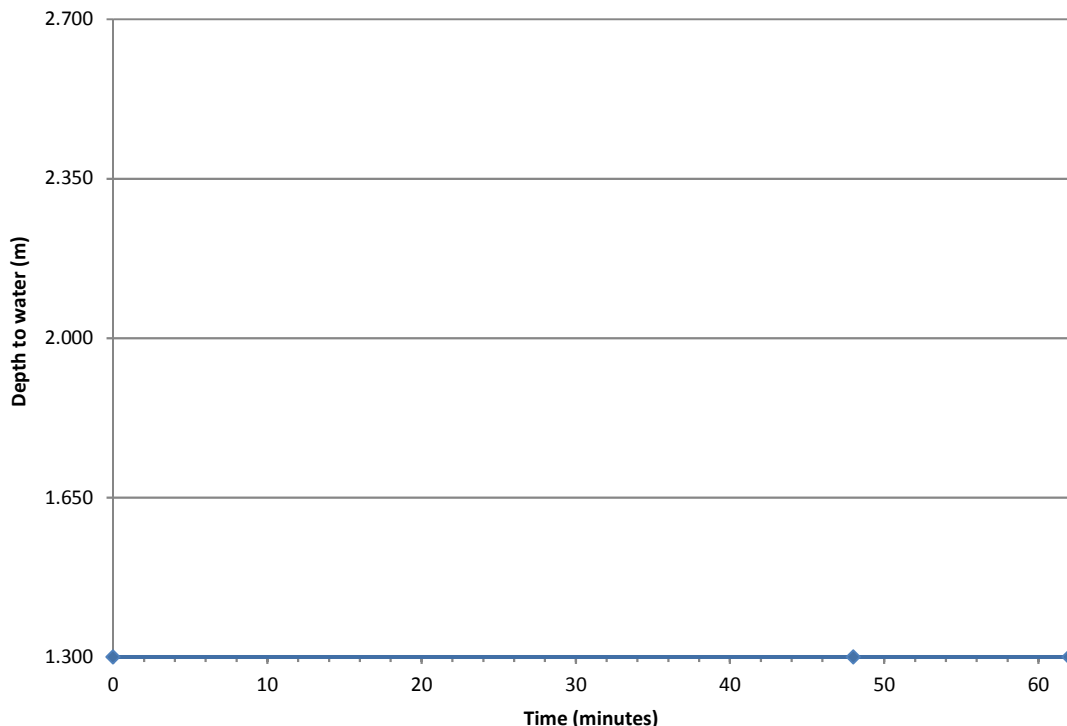
Trial pit number	Cycle number	Date of excavation
TP107	1	17/02/2016

**Plot showing time against depth to water:**

TIME (mins)	DEPTH TO WATER (m)	TIME (mins)	DEPTH TO WATER (m)
0	1.3		
48	1.3		
62	1.3

- 4.3.9 Trial pit records are presented in Appendix C.
- 4.3.10 Soil infiltration tests were carried out in trial pits TP107 and TP114 at depths of between 1.3m and 2.8m. Infiltration tests were carried out following the procedures described in the Building Research Establishment (BRE) Digest 365 (2007) "*Soakaway Design*", with records of test results presented in Appendix E. Water placed in each trial pit did not dissipate and soils are considered to be effectively impermeable.

7.6.1 Based on infiltration testing undertaken in trial pits TP107 and TP114 at the site (refer to Appendix E), the Devensian Till deposits are considered to be effectively impermeable and would not be able to dispose of water using soakaway systems. Alternative means of storm water disposal will be required. Disposal into Higgin Brook could be an option and we understand that the surface water sewer, which cuts across the south-western part of the site, outfalls into the brook and serves a similar residential development adjacent to the south-east.
