# SPRINGWOOD, WHALLEY ROAD STONYHURST

## Nocturnal Bat Survey Report

*September 2023*

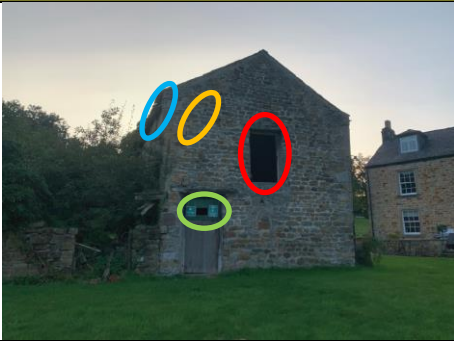
Table 3.1 – Emergence locations

- Three common pipistrelle bats emerging from the first-floor barn entrance. The first at 20:30 and the following two at 20:51 (E1).
- One common pipistrelle emerging from a crevice in the external wall on the eastern aspect at 20:30 (E2).
- One common pipistrelle emerging from a gap in the ground floor door at 20:39 (E3).
- Two common pipistrelles emerging from underneath the overhanging roof tiles on the eastern corner of the southern aspect at 20:45 (E4).

| Reference | Location |
|---|---|
| VP2<br>E1 – Red<br>E2 – Orange<br>E3 – Green<br>E4 - Blue | |

- 3.3.3. Please find the following summarising the roosts:
- Roost 1** – emerged from open first floor barn entrance (**E1**), gap in ground floor barn door (**E3**) on the eastern aspect and arrow hole (**E6**) on the northern aspect. These emergence points connect to the interior of the barn on the upper floor. The roost is deemed to be located within internal crevices relating to stone brick work and/or supporting timbers (exact roost location unknown). A peak count of 4 common pipistrelle, recorded on both surveys – **Assessed as a day, non-breeding roost**.

- Roost 2** – emerged from crevice in stonework on eastern aspect. A count of 1 common pipistrelle (E2) recorded

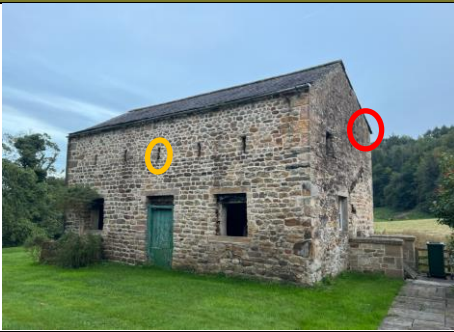
Table 3.2 – Emergence locations

- VP1 recorded one common pipistrelle emerging from under the roof tiles of the southern corner of the western aspect at 20:00 (E5).
- VP1 recorded one common pipistrelle emerging from the central arrow hole on the northern aspect at 20:10 (E6)
- VP2 recorded one common pipistrelle emerging from a crevice in the wall on the western aspect of the barn at 20:12 (E7).
- VP3 recorded three common pipistrelles emerging from underneath the overhanging roof tiles on the eastern corner of the southern aspect at 19:59, 20:04 and 20:18 (E4).

| Reference | Location | |
|---|---|---|
| VP1<br>E5 – Red<br>E6 – Orange | | |

- **Roost 5** – emerged from the lifted roof tiles on the southern corner of the western aspect. Roost located between external tiles and internal roofing felt. A count of one common pipistrelle (E5) recorded on the 2<sup>nd</sup> survey only – **Assessed as a day, non-breeding roost.**

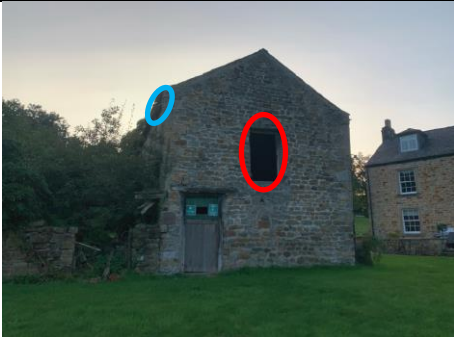
| Reference | Location | |
|---|---|---|
| VP2<br>E1 – Red<br>E4 – Blue | | |

- **Roost 3** – emerged from underneath the overhanging tiles on the east corner of the south aspect. Roost located between external tiles and internal roofing felt. A peak count of 3 bats (E4) recorded on both surveys – **Assessed as a day, non-breeding roost.**

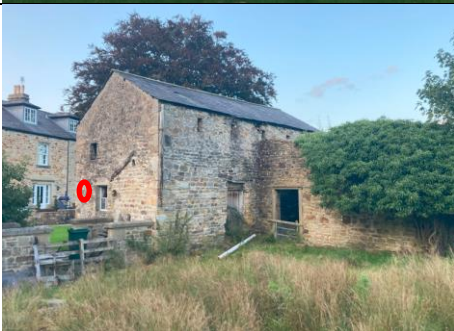
- VP3 recorded four common pipistrelles emerging from the emerging from the first-floor barn entrance at 20:08 and 20:12 (E1).

| Reference | Location | |
|---|---|---|
| VP3<br>E7 | | |

- **Roost 4** – emerged from crevice in stonework on western aspect. A count of 1 common pipistrelle (E7) recorded on the 2<sup>nd</sup> survey only – **Assessed as a day, non-breeding roost.**
