**8-10 Shawbridge Street, Clitheroe**

**Bat Report**

| Document | | BOW17_1491 8-10 Shawbridge Street, Clitheroe | |

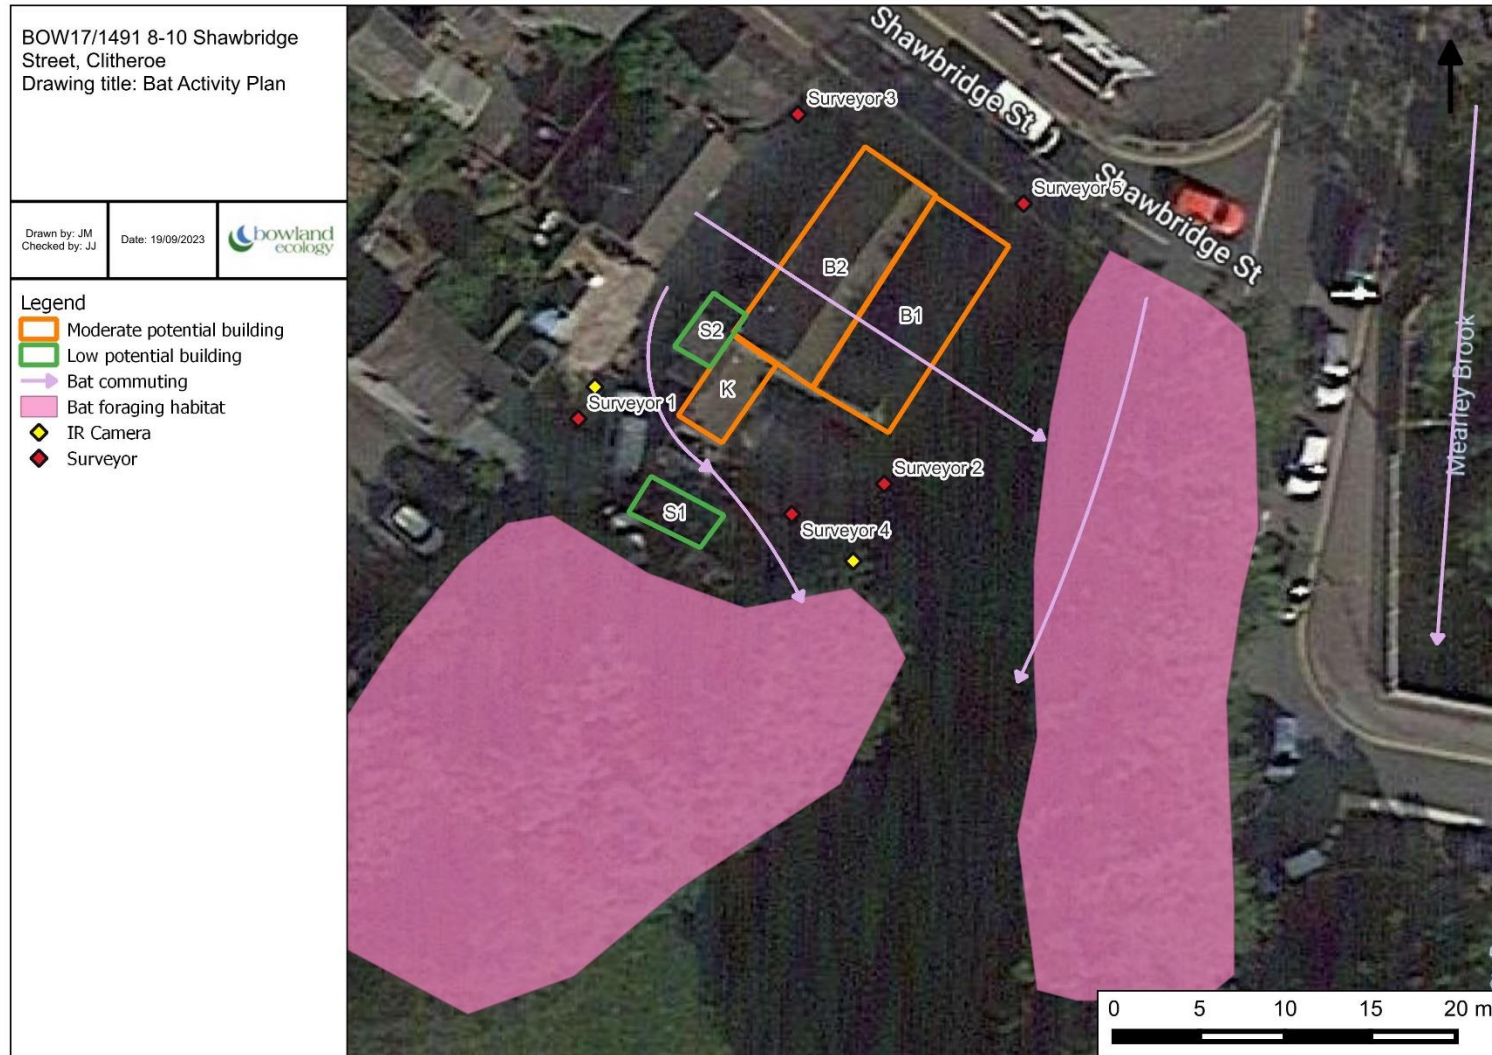
## Appendix C –Bat Activity Plan

- 3.12 To summarise, on the first survey, a common pipistrelle possibly emerged from behind the bargeboard at the eastern elevation of B1 at 20:54, however this could not be checked with the IR camera footage as high light levels (early in the survey) distorted the video image. Soprano and common pipistrelles were noted foraging and commuting along site boundaries on both surveys with noctule activity also noted on the first survey. Overall activity levels from both surveys were considered to be moderate.

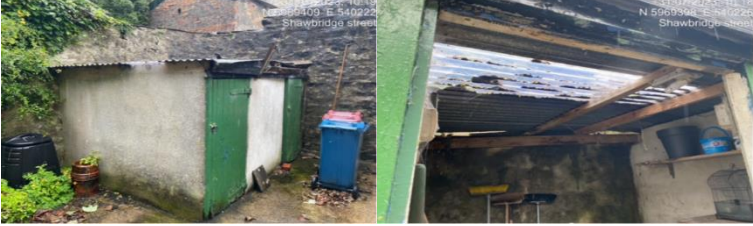
| <p>Shed 1<br/>(S1)</p> | <p>Shed 1 is a small brick and render storage shed with a corrugated asbestos and plastic roof. The shed is considered to provide <b>low</b> potential for roosting bats.</p> | |

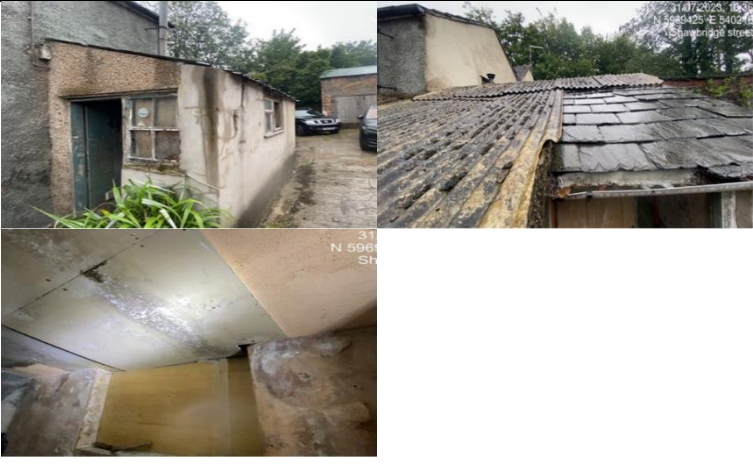
- 3.8 S2 is a large brick and render shed attached to the west of B2 and the Kitchen annex, with a corrugated asbestos and slate tile roof. The structure is in a state of disrepair with numerous PRF's comprising lifted roof panels and gaps into the internal space around boarded up windows. Internally, the structure has past and current evidence of damp visible on wooden ceiling panels. The shed is considered to provide **low** potential to support roosting bats.
- 3.9 S1 is a small, stone and render storage shed located at the southern boundary of the site. The roof is corrugated asbestos and plastic sheeting. Internally, the shed is damp and draughty with numerous gaps into the internal space. The shed is considered to provide **low** potential to support roosting bats.
- 3.10 Overall, no bats or evidence of bats was found during the building inspections.

| <p>Shed 2<br/>(S2)</p> | <p>S2 is a large brick and render shed attached to the west of B2 and K, with a corrugated asbestos and slate roof. The shed is considered to provide <b>low</b> potential for roosting bats.</p> | |

- Prior to the demolition of K (Kitchen Annex) and S2 (outbuilding), any features with bat roost potential (K: bargeboards and end roof tiles, S2: lifted roof panels and windows) will be undertaken carefully and systematically, by hand to avoid crushing or killing any bats that may potentially be resting beneath;

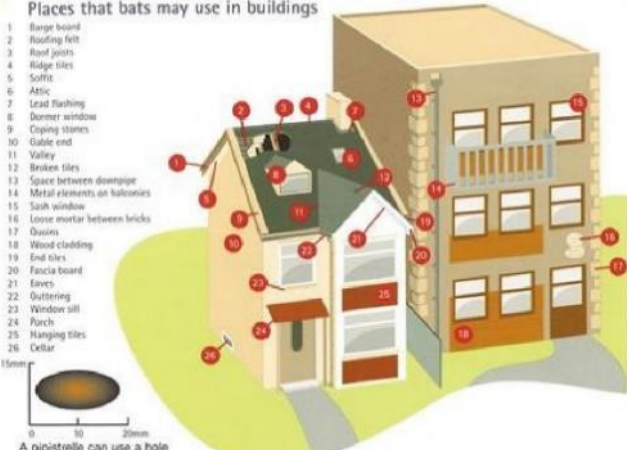
### Places that bats may use in buildings

1 Barge board  
2 Roofing felt  
3 Roof joints  
4 Ridge tiles  
5 Soffit  
6 Attic  
7 Lead flashing  
8 Dormer window  
9 Coving stones  
10 Gable end  
11 Valley  
12 Broken tiles  
13 Space between downpipe  
14 Metal elements on balconies  
15 Sash window  
16 Loose mortar between bricks  
17 Quoins  
18 Wood cladding  
19 End sills  
20 Fascia board  
21 Eaves  
22 Guttering  
23 Window sill  
24 Porch  
25 Hanging tiles  
26 Cellar
