Your Ref: Cuthbert Hill Farm  
Our Ref: 8951

**RE: SCOPING BAT, BIRD, AND BARN OWL SURVEY  
LOCATION: CUTHBERT HILL FARM  
PROPOSAL: CHANGE OF USE OF A STEEL FRAMED AGRICULTURAL BUILDING TO A CAMPING BARN**

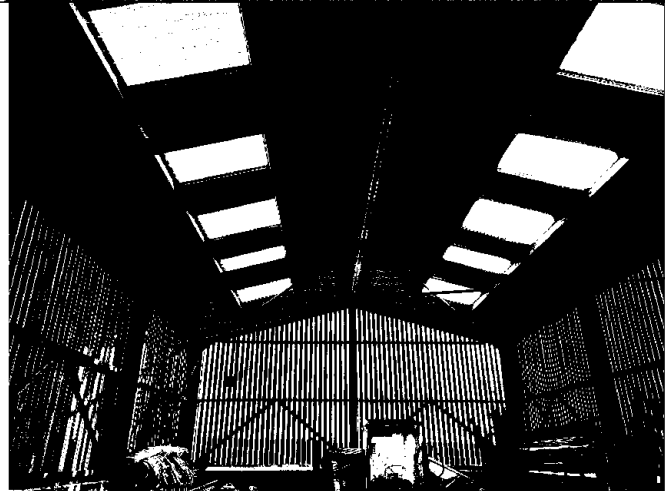
The roof is corrugated and unlined, and the beams are metal. This is not suitable for roosting bats.

Two birds' nests were identified, one at each end of the barn under the apex of the roof. They were not in use at the time of the survey.

There were no indications of use of the building by barn owls

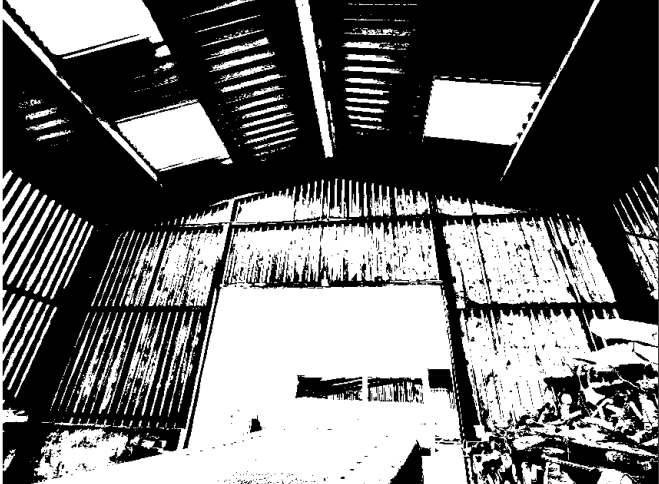
<p>Bird nest identified under apex of roof.</p>

We consider that the risk to birds is low, and as long as work is undertaken outside of the breeding season, there should not be any disturbance. With the erection of bird boxes post-conversion, the risk to birds can be considered negligible.
