## BAT, BARN OWL & NESTING BIRD SURVEY AT

Lords Farm, Bolton by Bowland

It is understood that the farmhouse and attached barn at Lords Farm, Bolton by Bowland, will be altered and re-roofed as part of a renovation project.

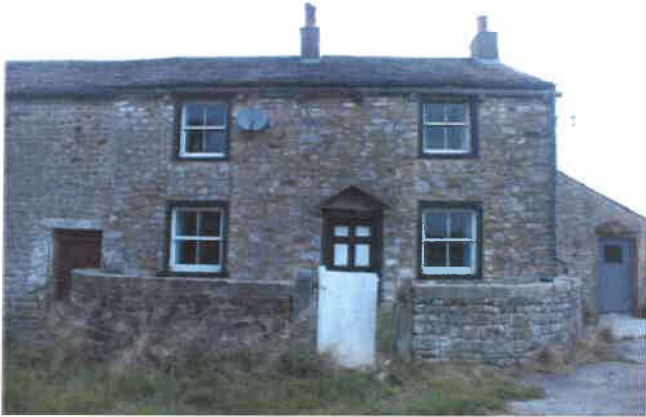
The walls of the building are made from natural stone and are in good condition. There are no gaps or cracks, the pointing between the dressed stone is intact. An area of brickwork at the base of the chimney on the north-east gable was degraded but without leaving gaps suitable for use by roosting bats.

| Photograph | Notes |
|---|---|
| | <p>Farmhouse, Building 1, walls and roof in good condition overall</p> |

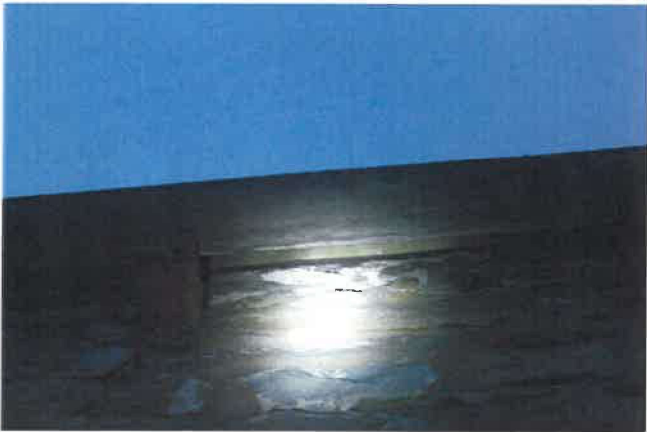
| Photograph | Notes |
|---|---|
| | <p>Eaves sealed</p> |

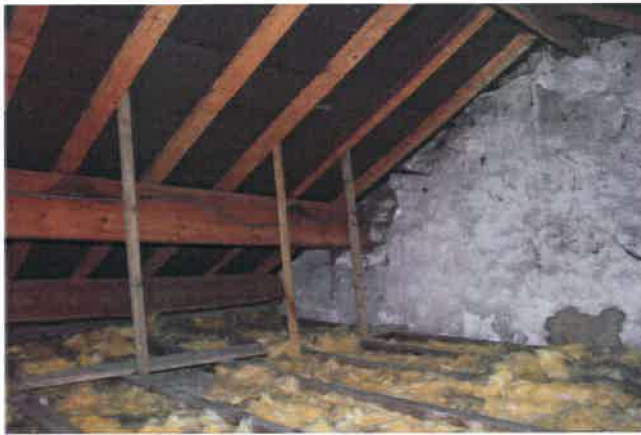
The farmhouse had two adjacent roof voids. The timber beams in the roof were found to be in good condition with no rot, splits or gaps suitable for roosting or hibernating bats. There was a good covering of cobwebs under the roof and spanning the internal space. The roof lining was intact. Rat and mouse droppings were found but no indications of use by bats could be found.

Roof void lined with lining and timbers in good condition

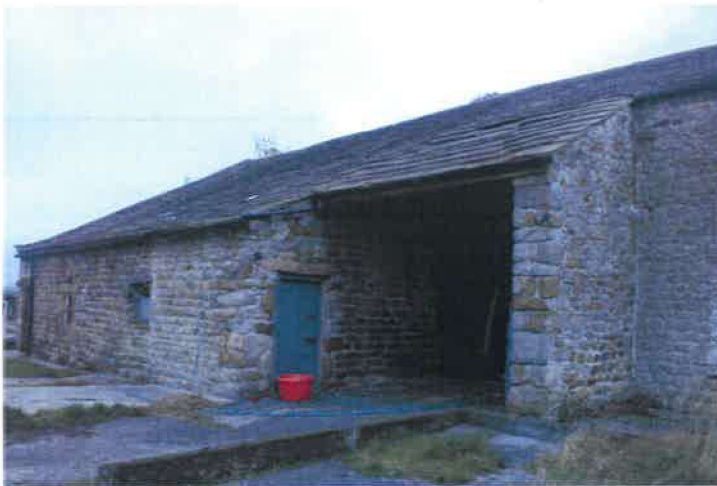
The roof of the building is made from stone slate and is lined only on the north-west pitch which appears to have been restored. There were several raised slates across the roof, the majority on the south-east pitch which has not been restored as recently. There were also gaps at the roof verge. The ridge tiles were well fitted in place. The full extent of the roof could be seen from the ground with close focus binoculars and a 1,000,000 candle power torch. No indications of use by bats could be found, although slates higher on the roof could be less reliably inspected.

Barn, Building 2, with walls in good condition.

Gaps were noted under raised slates.

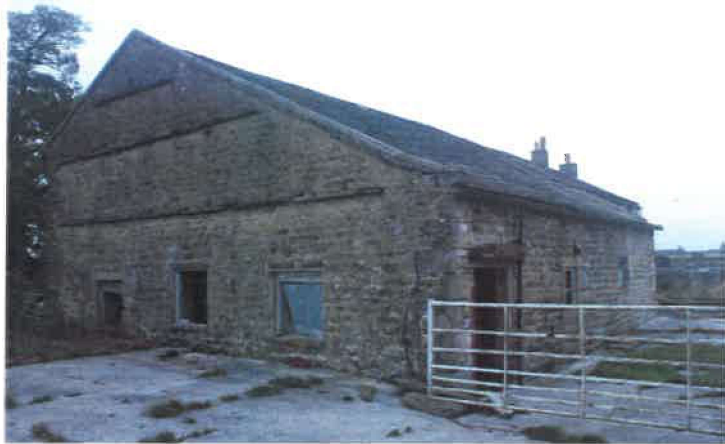
There were open doors, windows and pop-holes on each exposed elevation. The large wooden lintel had over the main door had a crevice within it, but no signs of use by bats. Several white doves (*Columba livia domestica*) were found roosting on the porch timbers.

Several open doors, windows, pop holes allow access.

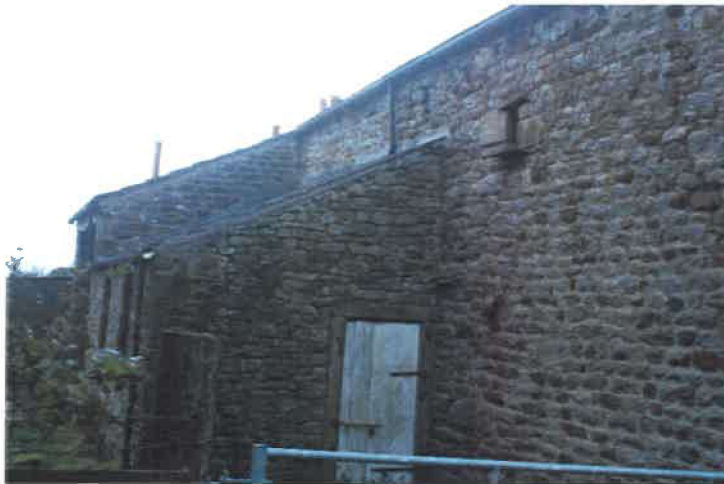
The walls of the building are made from natural stone and are in good condition. The walls are largely well pointed, but there are areas where pointing is missing at wall tops, corners and rear lean-tos.

Crevices in walls found where pointing missing in certain areas.

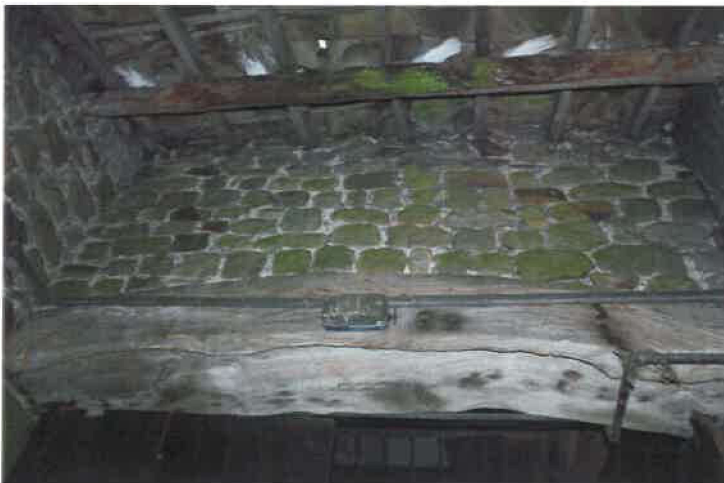
Doves roosting in barn porch

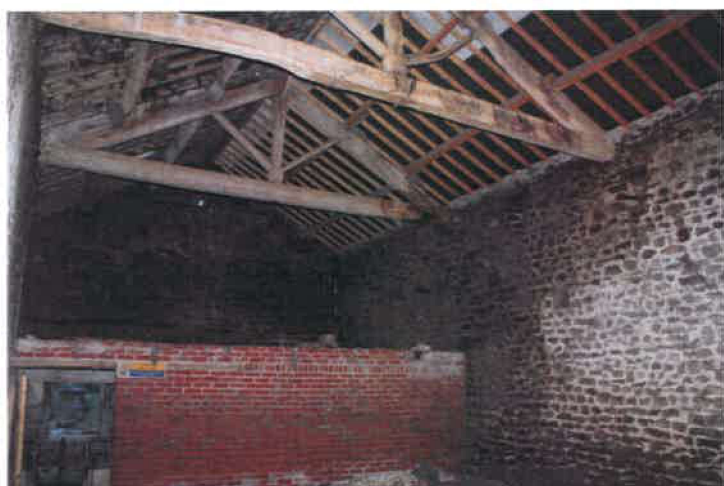
The barn had separate roof voids, but had raised hay lofts at either end. The timber beams in the roof were found to be in excellent condition with no rot, splits or gaps suitable for roosting or hibernating bats. Where present on the north-west pitch, the lining was intact. On the unlined pitch, several gaps in the slates could be seen. There were potential roost features behind and above roof timbers. There was a light covering of cobwebs under the roof and spanning the internal space. No indications of use by bats were found, but the debris on the floor reduced possibility of identification of occasional droppings, and some potential roost features were high within the barn roof.

The internal space is large and open, with roof half-lined. Timbers are in good condition, though bats may roost behind/above them.

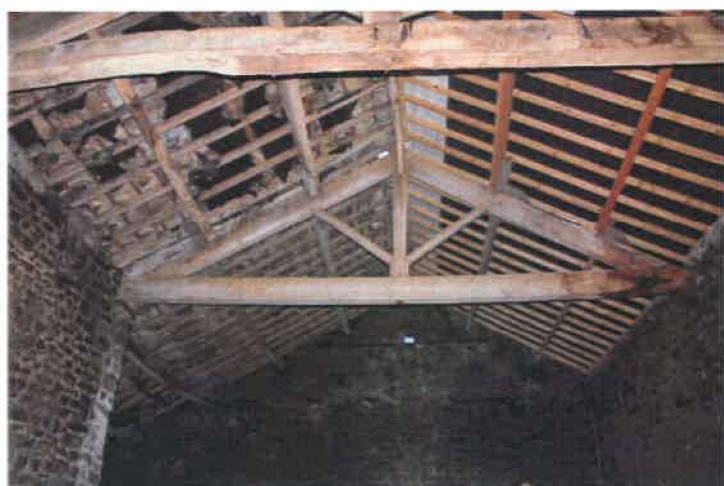
Gaps in the slates are visible on the unlined part of the roof.
