Preliminary Bat Roost Assessment Report

**9 Moorfield,
Whalley,
BB7 9SA**

20.04.2021

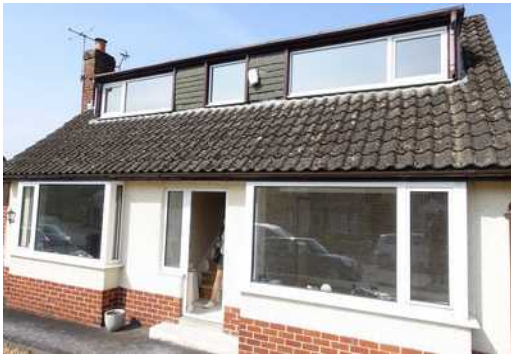
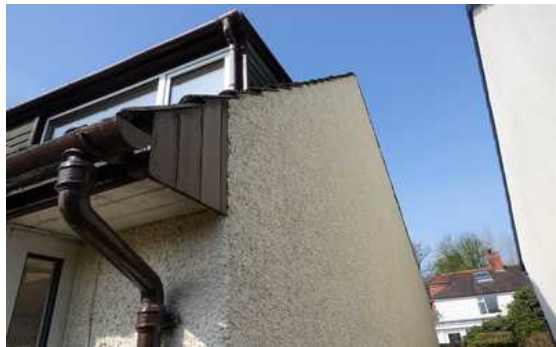
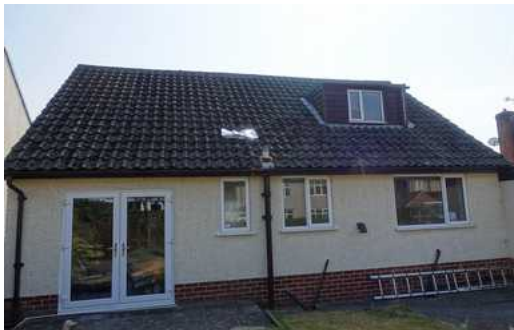
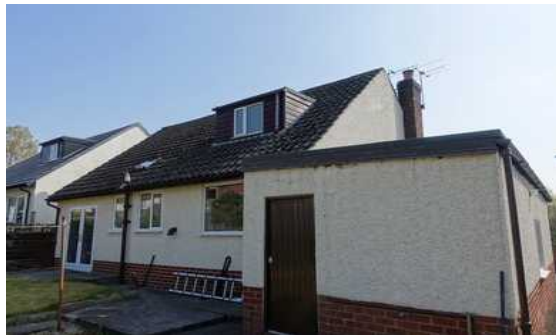
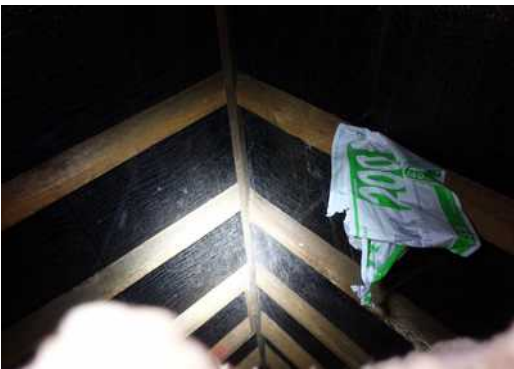
The property consists of a detached dormer bungalow with a double pitched tiled roof, an adjoining single storey flat roofed garage is present on the southern gable.

External walls are rendered, pebble dashed and painted with no obvious cracks, gaps or crevices present. Timber soffits are close fitting.

Roof tiles are close fitting with no slipped, lifted or missing tiles present. The ridge is pointed and well sealed. Roof tiles are lined with a bituminous roofing felt, the loft spaces show evidence of a rat infestation. Some shallow gaps were observed behind hanging tiles on the front dormer.

The building can be considered to offer negligible to low roosting bat potential.

As a precautionary measure hanging tiles should be removed by hand with care.
