Preliminary Bat Roost Assessment

Site: Ivy Cottage, off York St, Clitheroe

7th November 2023

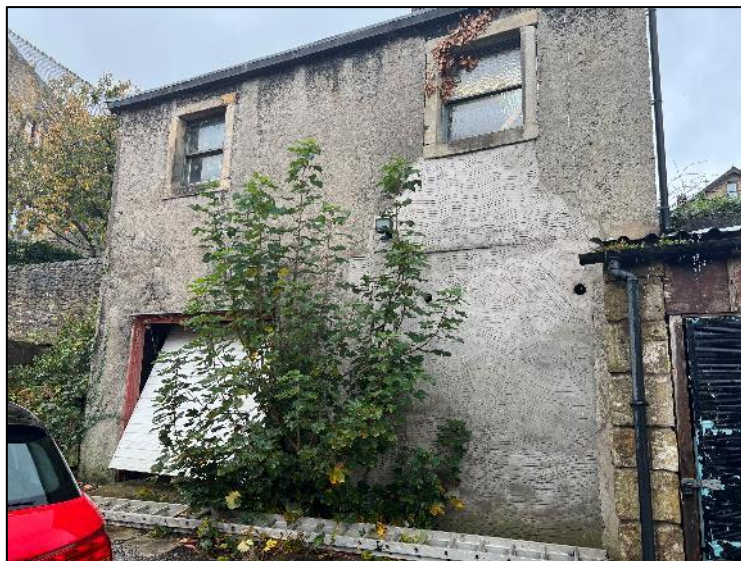
The heavy ivy *hedera sp.* covering to > 50% of the fasci front (south) elevation has been removed with some remnants on the southwestern elevation. The ground floor has an up and over garage door entrance, as do the attached garages.

Photo 1: Southeast (front) elevation showing ivy covering and garage door on ground floor.

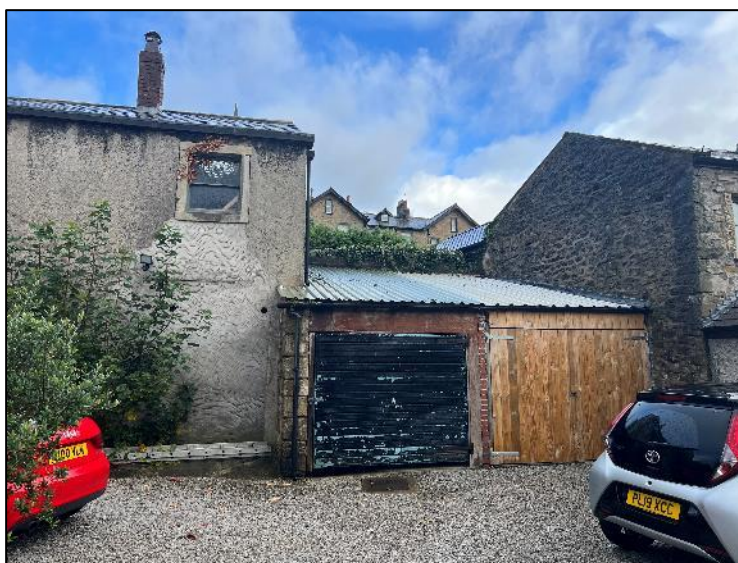
Photo 2: Southeast (front) elevation showing attached garages door on ground floor.

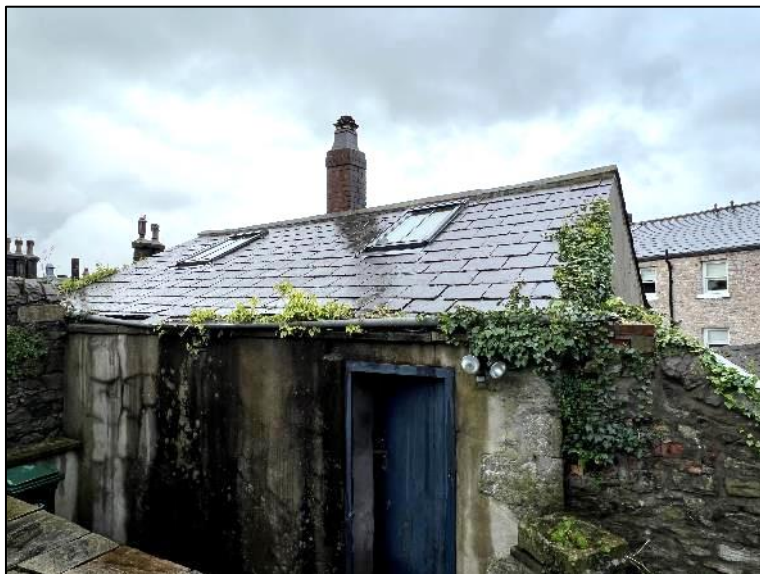
There are rooflight windows on the west elevation which appear to be a more recent addition and in a good state of repair.

Photo 3: Northwest facing roof pitch with rooflight windows.

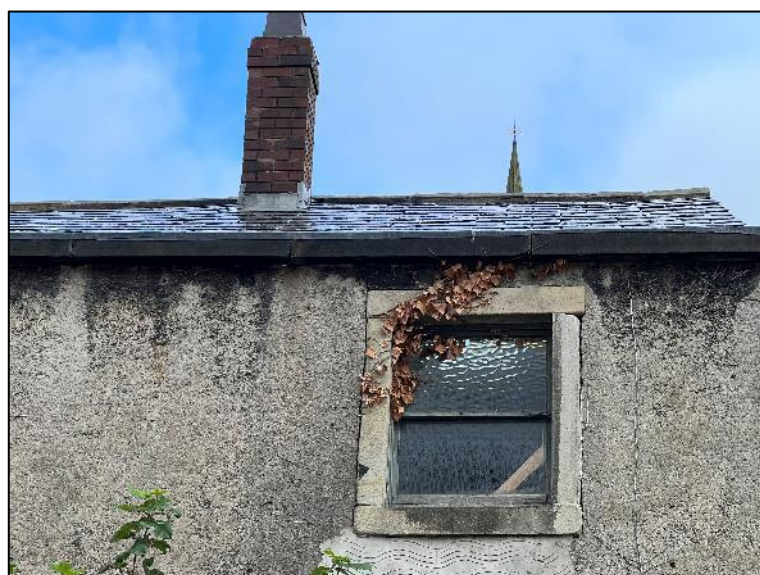
The ridge tiles appear in good condition, with recent mortar repairs evident. All leadwork around the property is sound, with no gaps or crevices suitable for roosting bats.

Photo 4: Southeast facing gable end with dense ivy coverage, recently mortared ridge tiles and lead work to chimney.

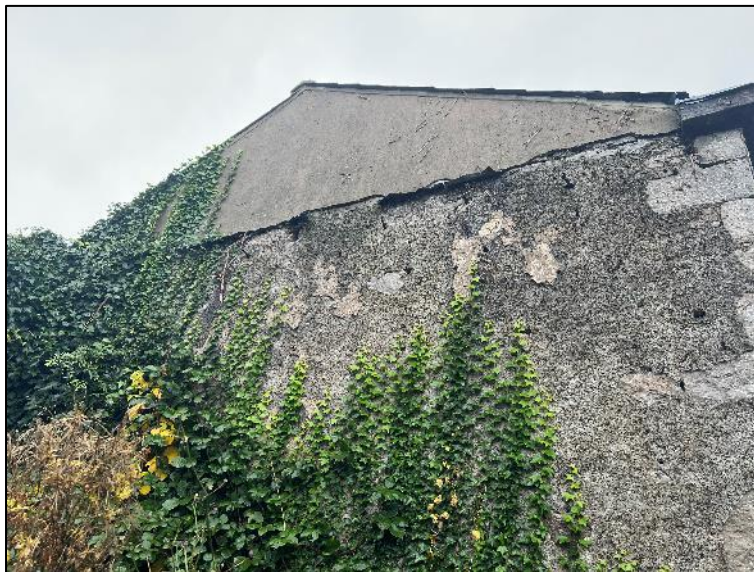
The gable end on the south elevation was previously densely covered in ivy (ARK, 2021), having now been cleared on the majority of the elevation, still obscures some areas. However there are no suitable bat roost crevices in the visible parts of this fascia. The area of lead flashing that can be seen to have lifted, does not form a crevice underneath.

Photo 4: Southwest gable end formerly covered with vigorous ivy growth.

Recommendations: Bats
No further surveys required. No Further Surveys. However , as there is little research or evidence of how bats use such dense ivy, a precautionary approach will be taken. Ideally carried out outside the peak bat activity season (Mid-May – Mid September), the upper sections of the ivy and any roofing materials if/when removed will be done under the supervision of a suitably qualified ecologist . One bat box will be placed on the building where the ivy is removed to provide roosting space for any transient bats that may rely on the habitat occasionally. Also, if bats are found during any stage of the development, work should stop immediately and a suitably qualified ecologist should be contacted to seek further advice.
Recommendations: Birds
Any building works, or ivy and scrub removal should be undertaken outside the period 1st March to 31st August. If this timeframe cannot be avoided, a close inspection of the building and ivy to be removed should be undertaken by a suitably qualified ecologist, immediately prior to clearance. All active nests will need to be retained until the young have fledged.

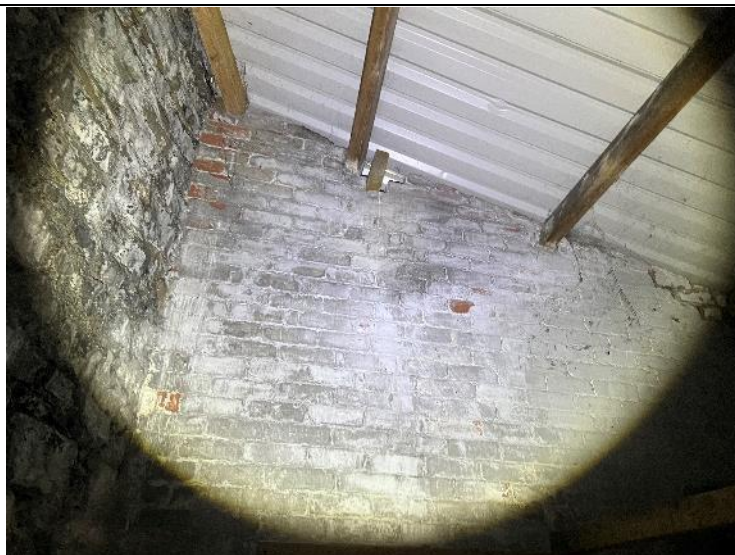
The dividing wall on the ground floor has been opened up giving access to the attached garages internally, with the internal mortar visibly sound all the way up with no gaps or crevices forming potential bat roosting spaces.

Photo 7: Internal view of roof structure in adjacent garages.

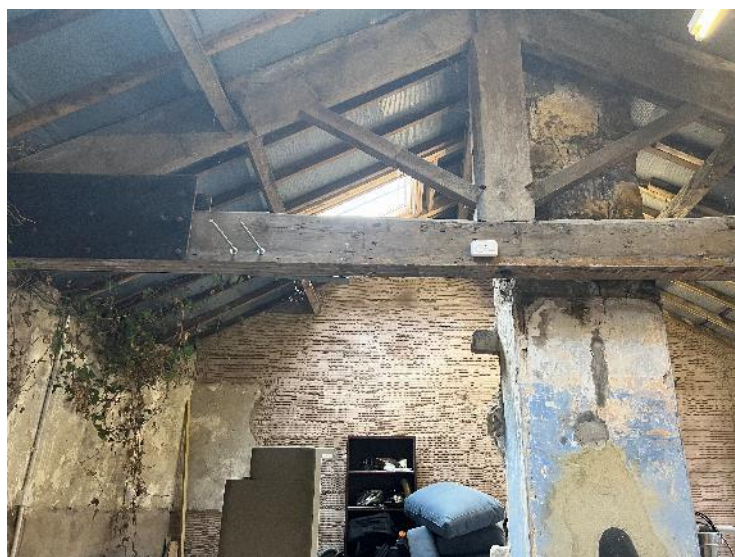
The first-floor space is dry and airy, and the roofing materials are in a good state of repair. The roof timbers and membrane having been recently updated have no signs of damage or gaps. The main roof truss has rotted at one end and is supported by an iron bracket.

Photo 8: Internal view of roof structure in upper storey.

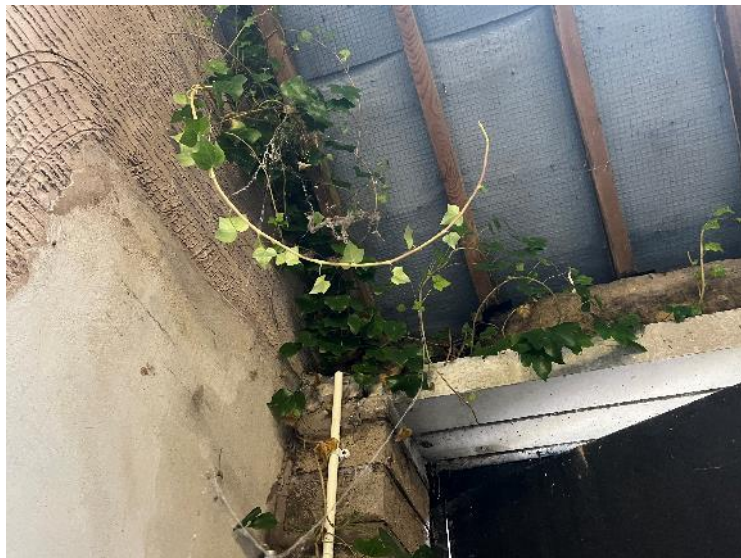
Where the roof meets the wall plate the ivy has breached the joint in places, intruding into the interior.

Photo 8: Ivy invading the interior.
