**BAT SURVEY AT -
REDWOODS
THORNEYHOLME
DUNSOP BRIDGE**

DATE AND TIME OF VISIT
23 rd Nov 2023, 1.00 PM

REFERENCE NO. 6958

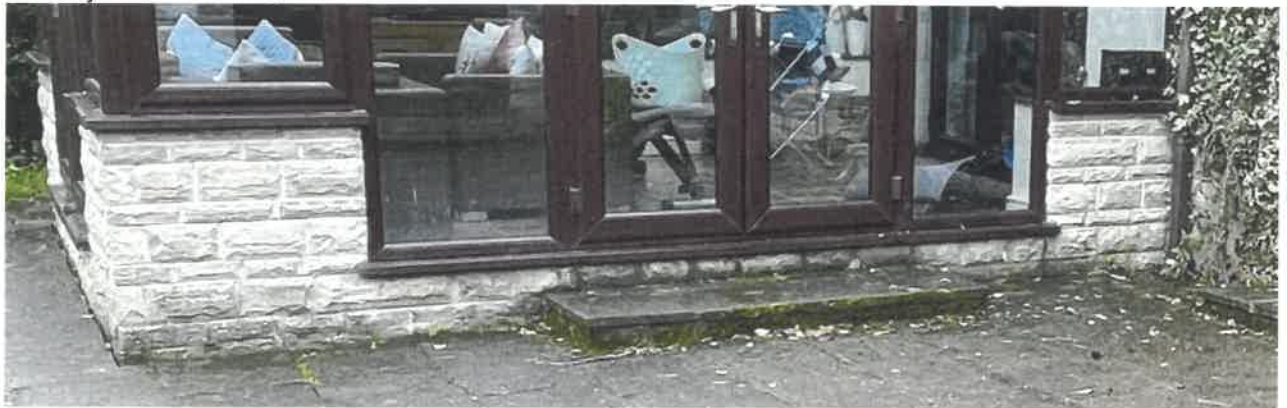
The walls of the conservatory are coursed stone base walls Upvc glazed frames above. The adjacent house wall is the same coursed natural stone.

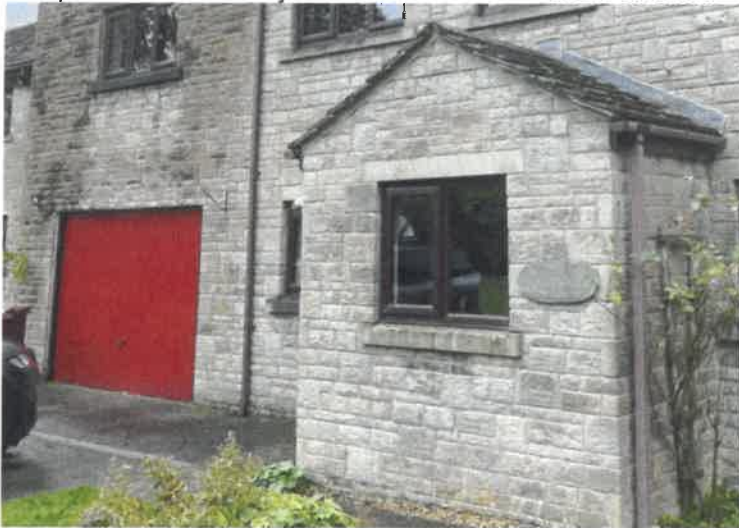
The porch walls and adjacent house walls are coursed stone.

The walls are in very good condition and devoid of cracks or crevices. There are no possible access points into the walls of this property.

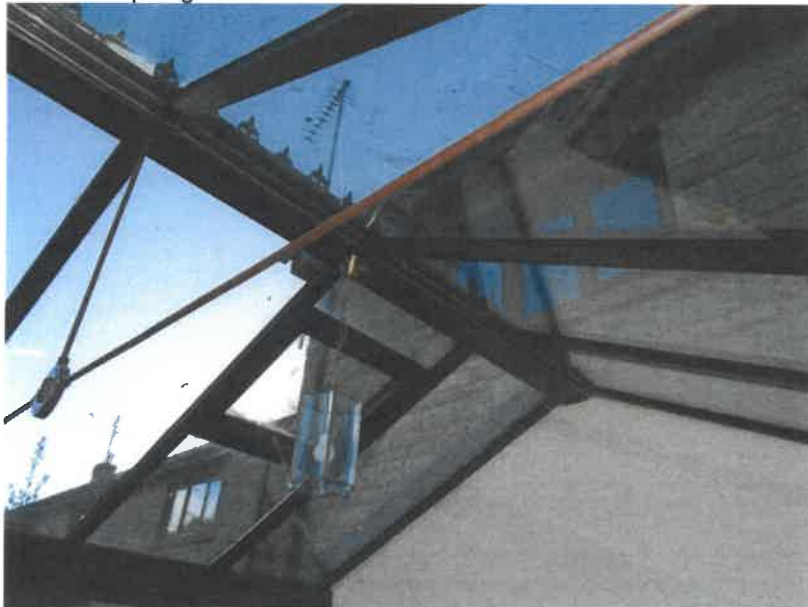
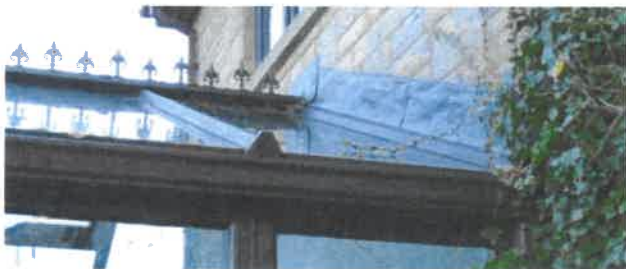
The conservatory roof is clear glass and Upvc frame. Lead flashing at abutment with the house wall. Moulded upvc gutters flush fixed.

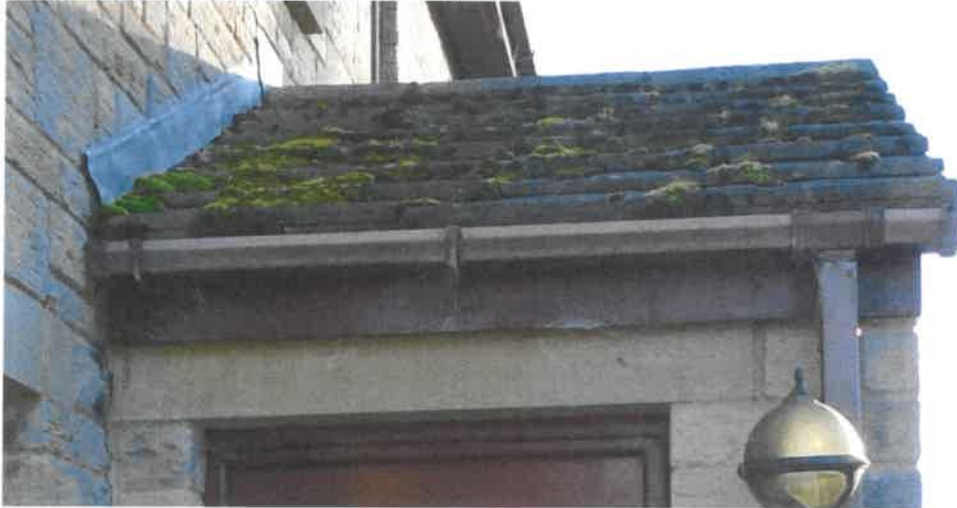
The Porch roof is artificial stone slate with pointed ridge tiles. The upvc fascia's are flush fixed to the walls. Lead flashing at abutment with the house walls.

The south pitch of the porch roof being abutted by the lean to extension roof.

The examination of all exterior surfaces did not reveal any signs of bat presence. The construction of the new front extension will involve the removal of some slates on the south pitch of the porch roof, this will not disturb or uncover any bat population.

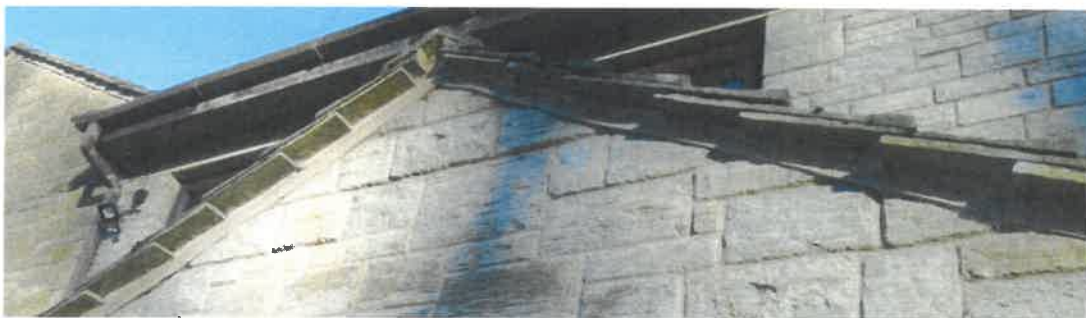
The porch roof was examined closely. There was significant moss coverage to the slates, however they were all tight fitting and the pointing was in reasonable condition with no crevices.

The verge to the porch is well pointed with no access points

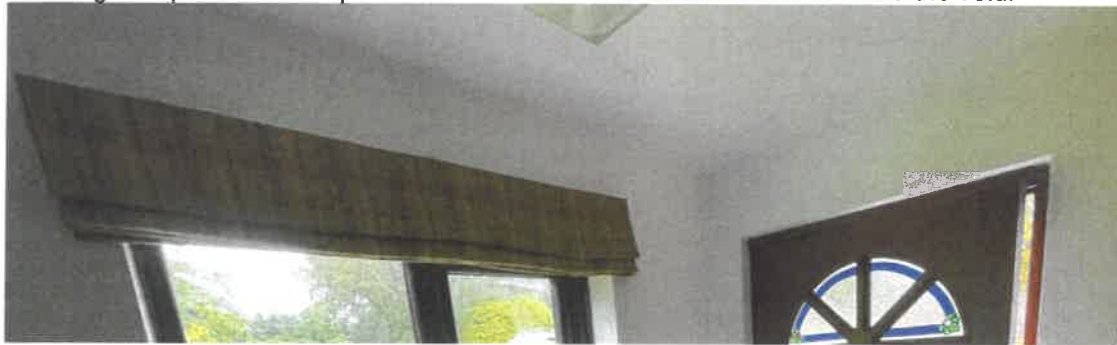
A ceiling was present in the porch however there was no hatch for access to the void.
