**BAT SURVEY AT -**

THE PRIORY  
HELLIFIELD ROAD  
GISBURN  
CLITHEROE  
LANCASHIRE  
BB7 4HQ

UPDATE TO ORIGINAL BAT REPORT DATED  
8<sup>th</sup> Oct 2021

DATE AND TIME OF VISIT  
5<sup>TH</sup> Dec 2023 9.00am

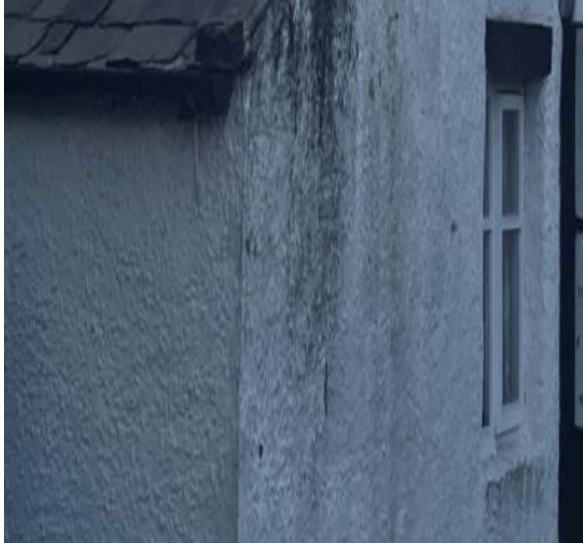
The walls are solid stone with a white render finish.

The render has no cracks or crevices with the potential for bat access.

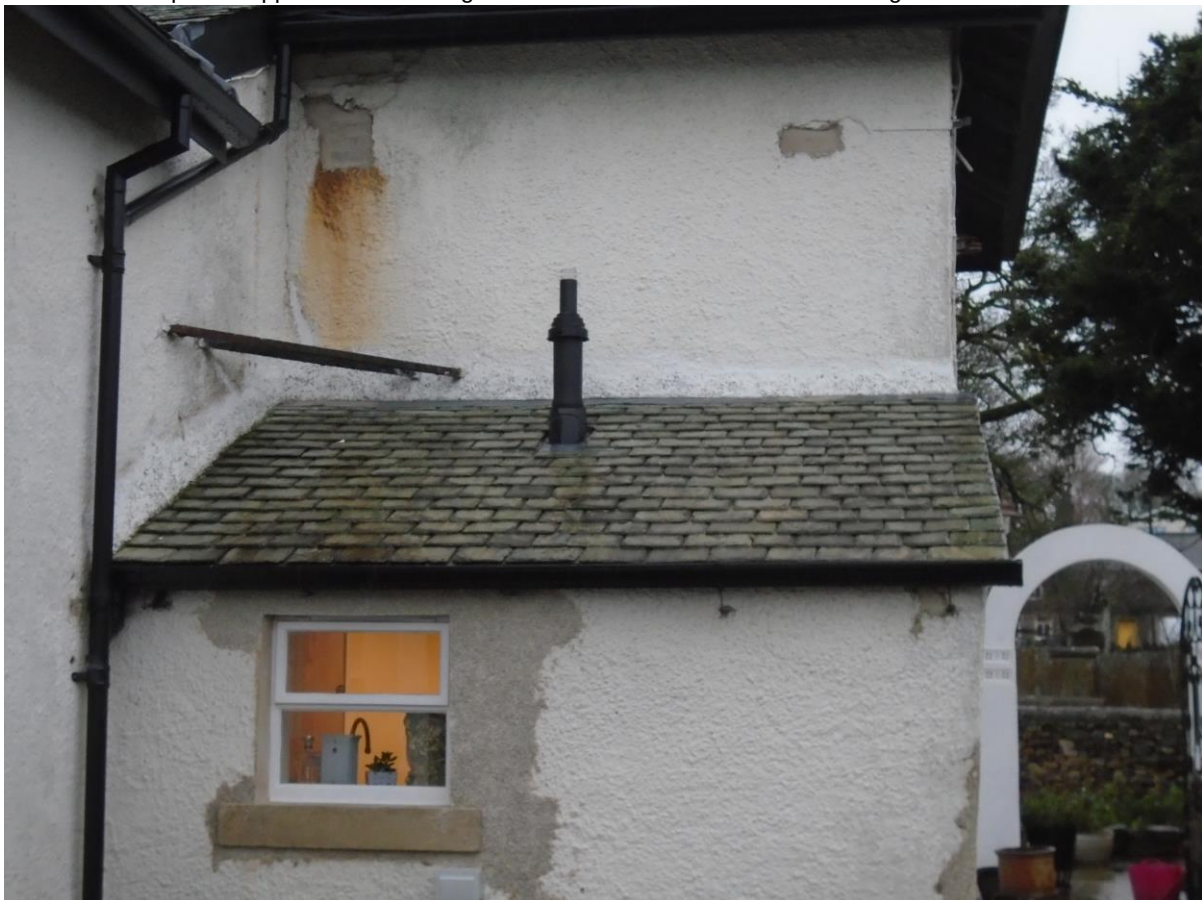
Lean to roof

The roof is a mono pitch lean to, with a natural slate finish. The gutters are on brackets.

The roof was replaced approx 12 months ago. No evidence of bats was found during the work..

The eaves and roof structure were closely examined the structure is in excellent condition as to be expected due to the recent replacement . The structure is tight fitting with no crevices with the potential for bat access.

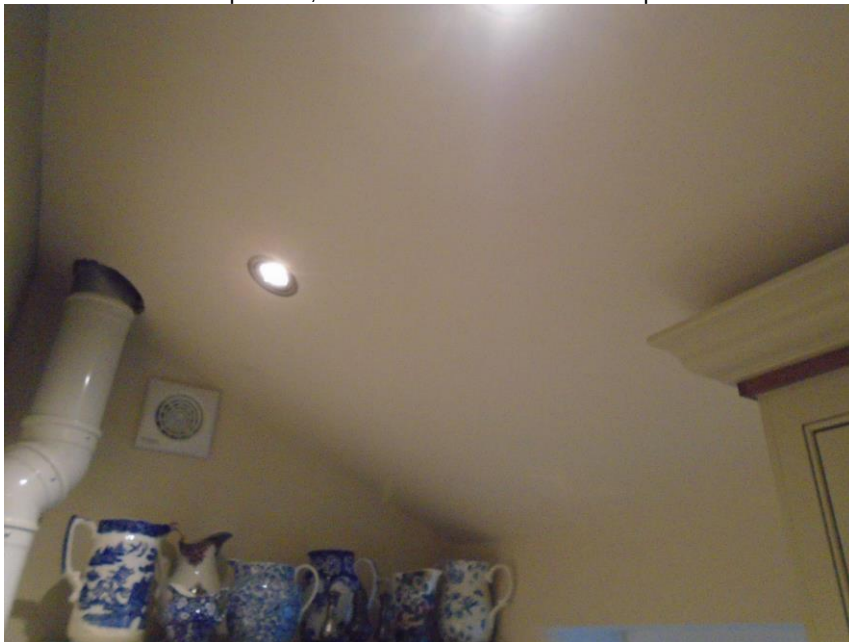
There is no roof void present, the rafters are lined out. The space functions as a utility room
