HERITAGE STATEMENT INCLUDING JUSTIFICATION FOR REPLACEMENT

Proposal: Listed building consent for replacement of windows to front elevation

Site address: 6 Main Street, Bolton by Bowland, BB7 4NW

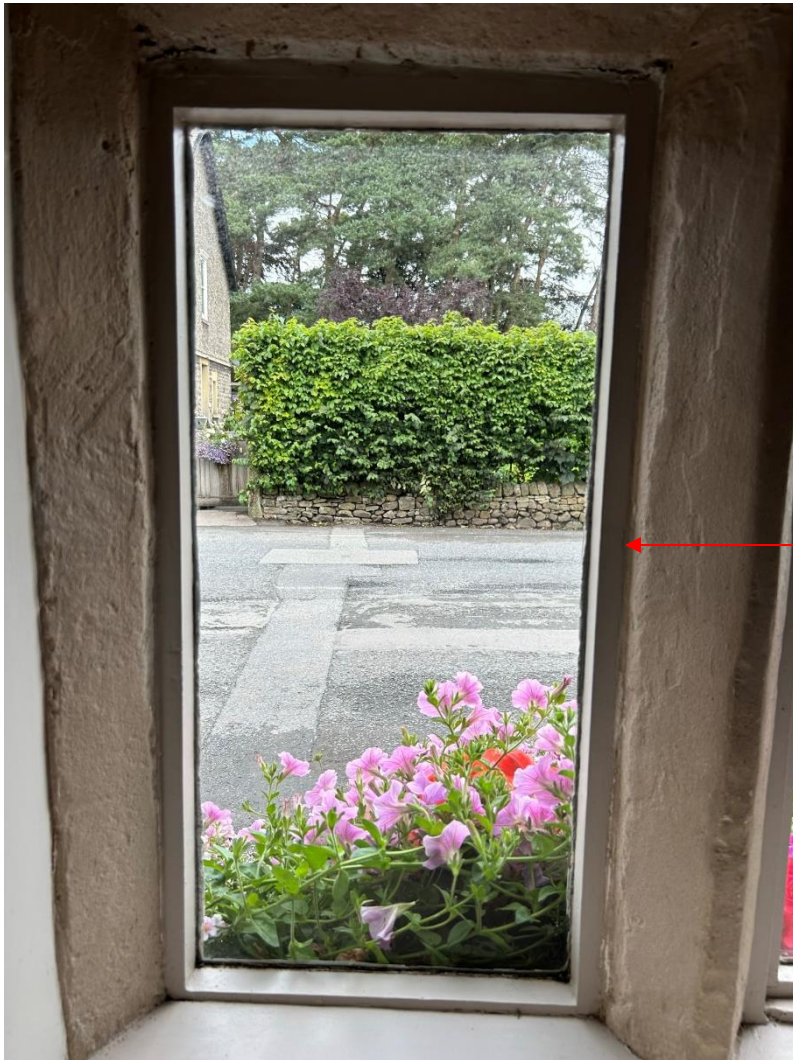
Photo 6: Ground floor fixed window (internal)

Simple & crude timber profiles which lack the detail typically exhibited by good quality period joinery

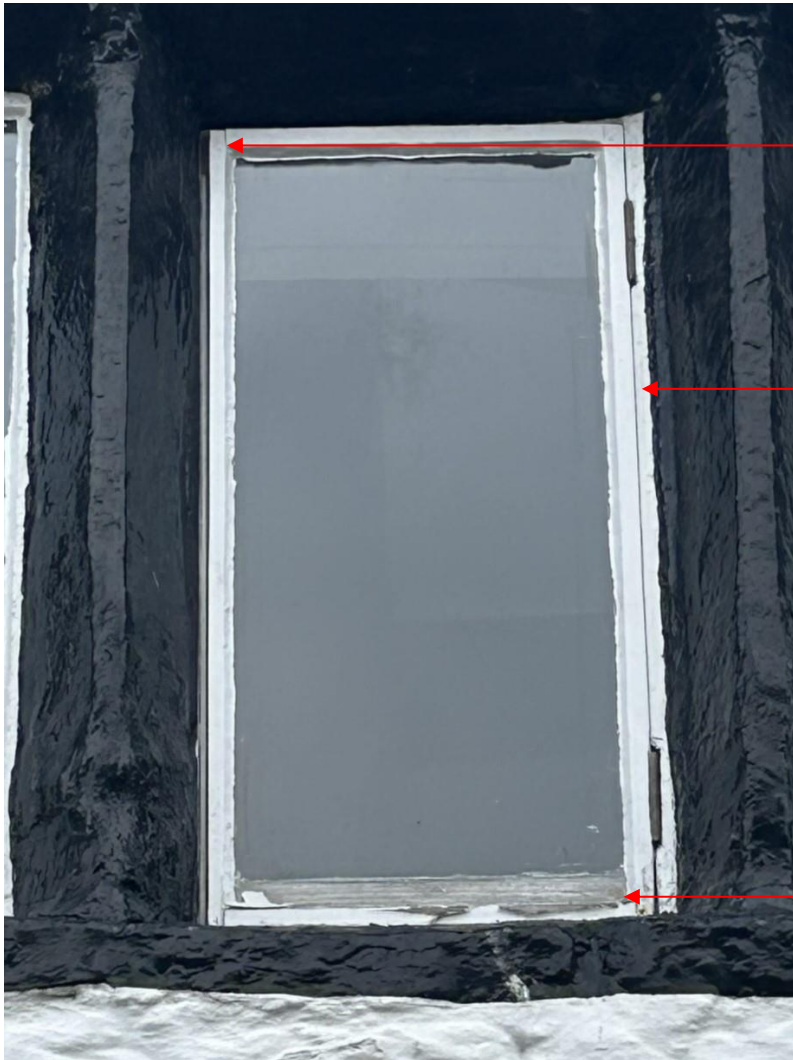
Photo 8: First floor side-hung casement

- missing paint, putty and decay to the 1st floor side opening sash;
- cracking to joints and putty which results in swelling and will be followed by decay (once joints start to open and timber swells it is difficult or impossible to remedy and the lifespan of a window will be compromised);
- difficulty in opening and operating the side-hung sashes due to cracking joints, swelling and distortion;
- excessive drafts from the side opening sashes, which have proven difficult to draft-proof; and
- missing handle from the 1st floor side-hung sash.

Cracking and damage to sash

Uneven gap due to swelling & distortion

Missing putty, flaking paint, cracking & decay

Taking into account the above, if the windows are to be replaced, slim profile metal framed windows are the best solution both for the building and occupant, in my judgement.

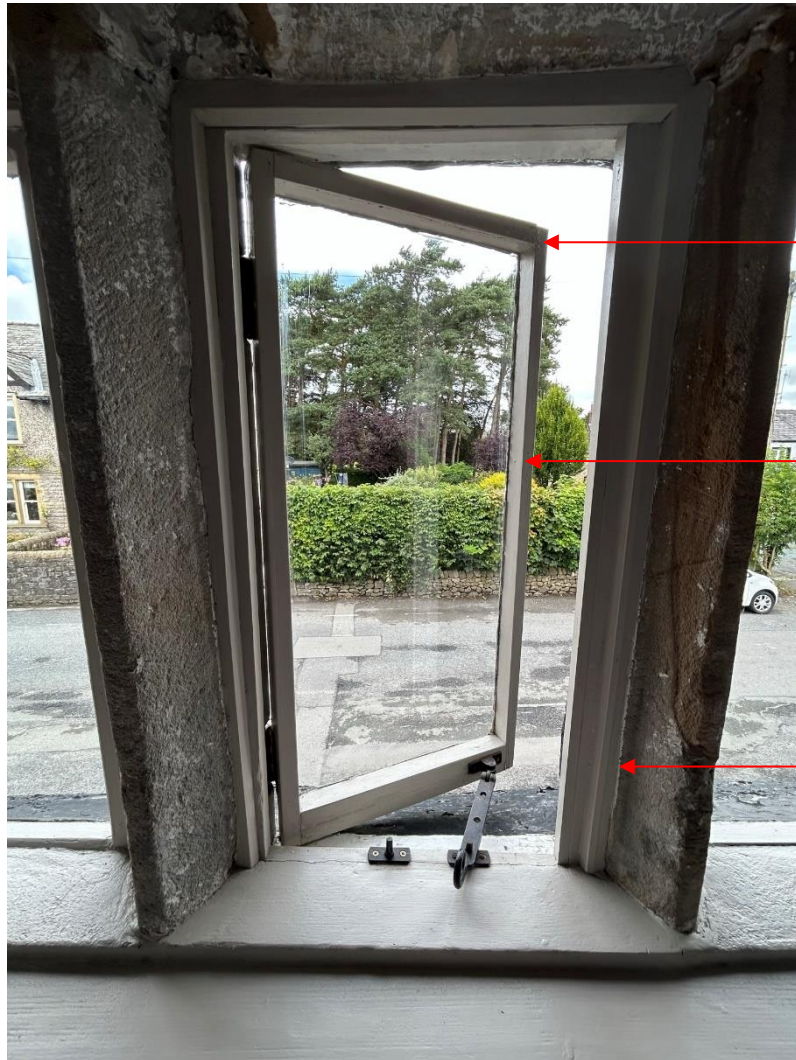
Photo 10: First floor side-hung casement (internal)

Damage to sash

Missing window latch that will be difficult to accommodate without fixing an additional block of wood as per the ground floor

Simple & crude timber profiles which lack the detail typically exhibited by good quality period joinery

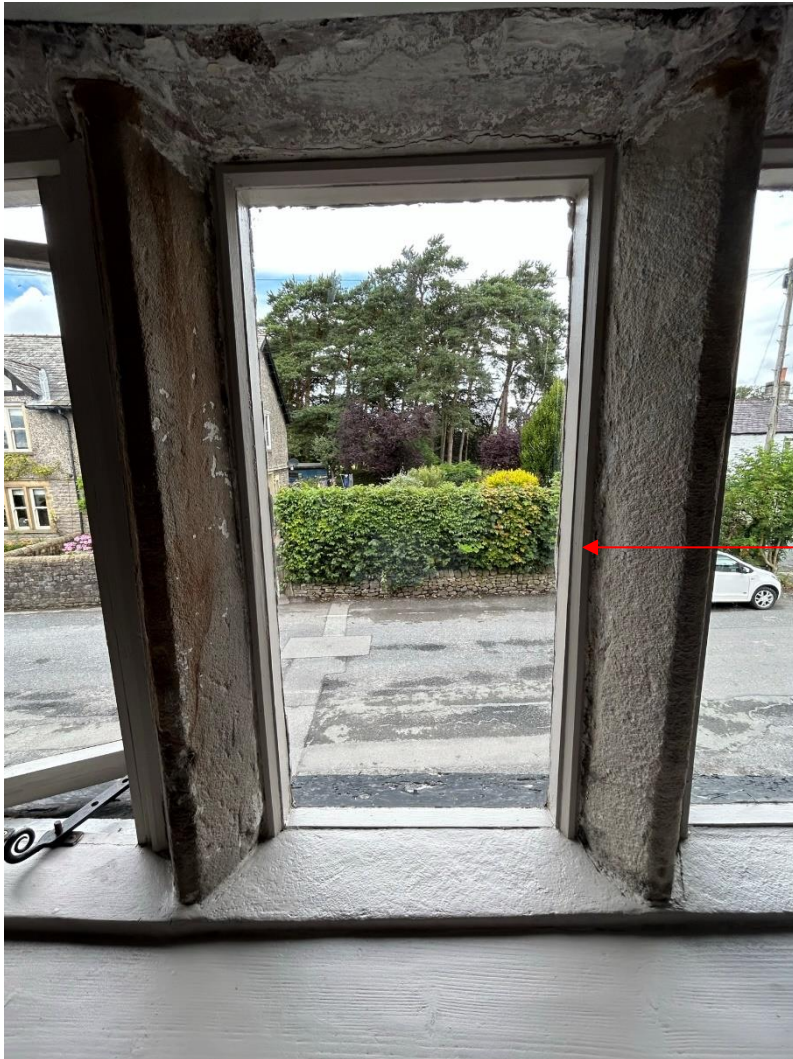
Photo 11: First floor fixed window (internal)

Simple & crude timber profiles which lack the detail typically exhibited by good quality period joinery
