**Phase I Environmental
Assessment
(Desk Study)**

**Alston Dairy
Alston Lane
Preston
PR3 3BN**

22/1269.1.1

Geo² Remediation Limited

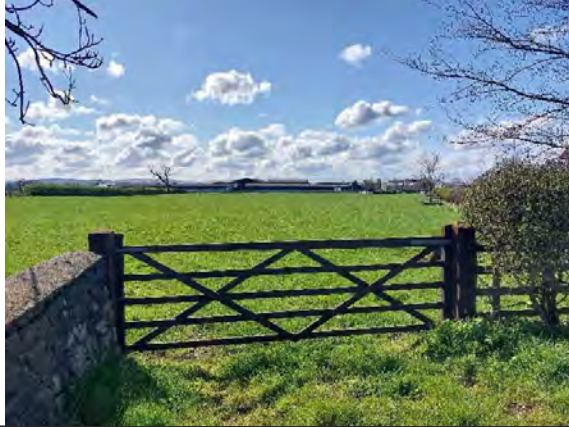
Photo 2: Walled northern boundary, Pinfold Lane to the left (north of site). Intermittent mature trees. Facing east to residential dwelling

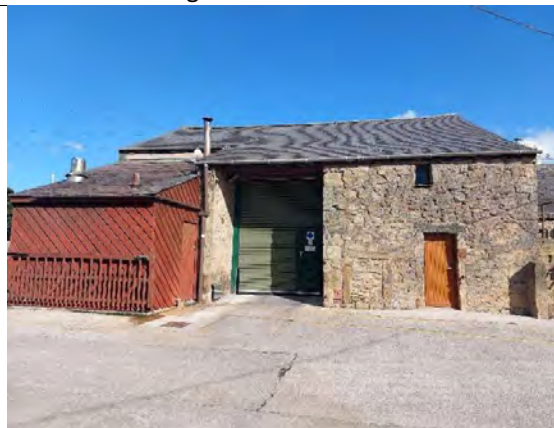
Photo 12: Original farm building on the southern boundary, with two steam boilers within the wood panelled outhouse on the left-hand side. Facing north

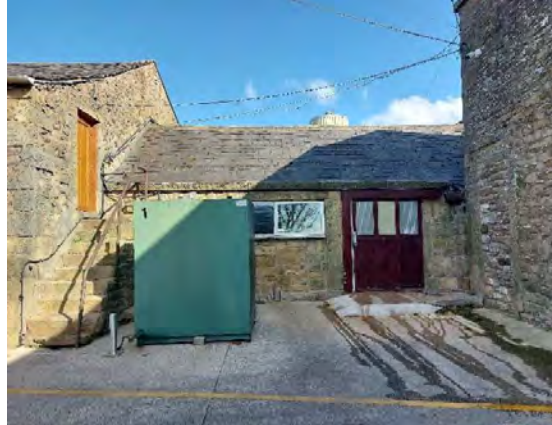
Photo 13: Second, smaller original farm building on southern building. Diesel tank (green), which feeds the steam boilers in Photo 12. Facing north. Building to the right (east) is on the Farm, not the Dairy site

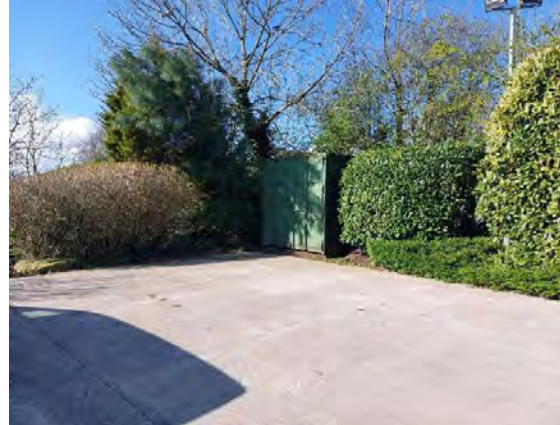
Three above ground tanks containing diesel were recorded during the site walkover, located in the southwest corner, southern boundary and eastern boundaries. No leaks or spills were observed around the tanks, with the tank seen on the eastern boundary recorded as being in good condition. The tank in the southwest corner, located within a container is understood to be banded.

Photo 14: Diesel tank enclosed in the green container, understood to be bunded. Used by the delivery HGVs. No evidence of spills or leaks. Located southwest corner, facing southwest

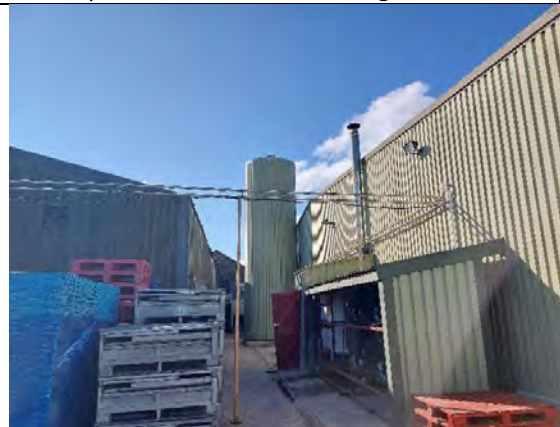
Photo 18: Elevated pipework which transports the milk from the Farm to the left/west to the Dairy to the right/east. Taps at both ends need to be opened for milk flow. Facing south.

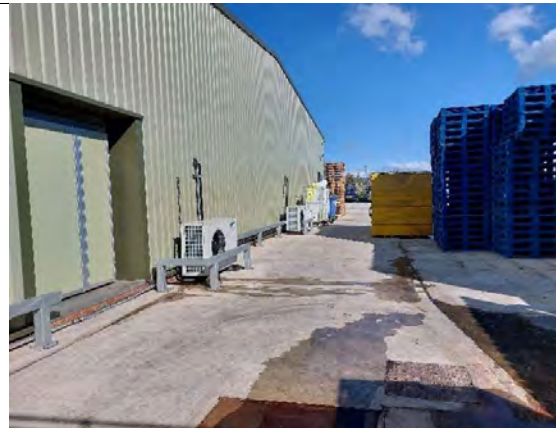
Photo 22: Rear (eastern side) of the Dairy extension building, facing north.

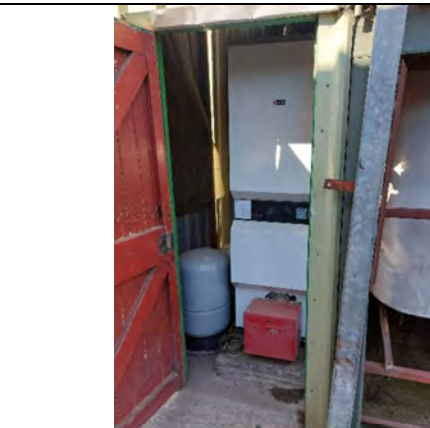
Photo 23: Boiler which operates the refrigeration units, located south of the refrigeration units. Facing east

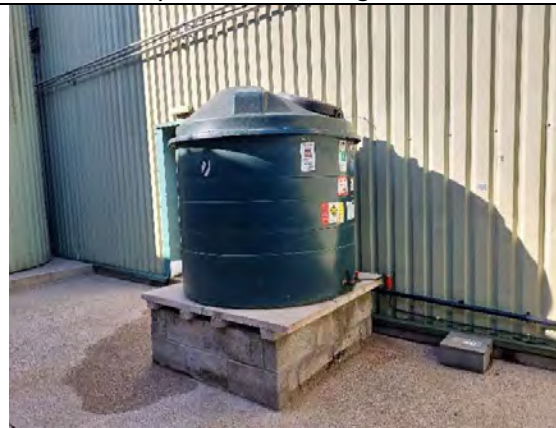
Photo 24: Diesel tank, linked to the boiler for the refrigeration units. No evidence of spills or leaks. Liquid on the surface is water coming from doorway to the left. Facing southwest.

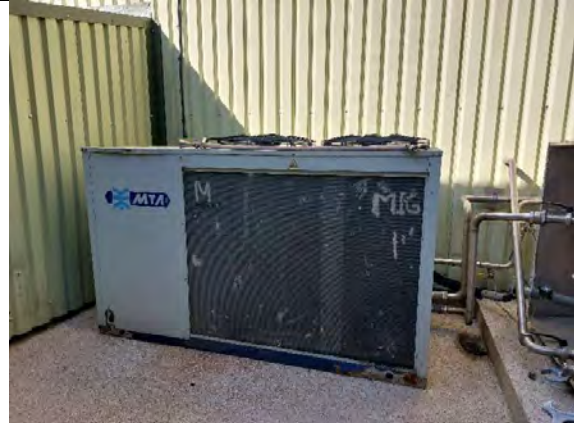
Photo 26: Generator for the water tower, located south of the water tower. Facing west

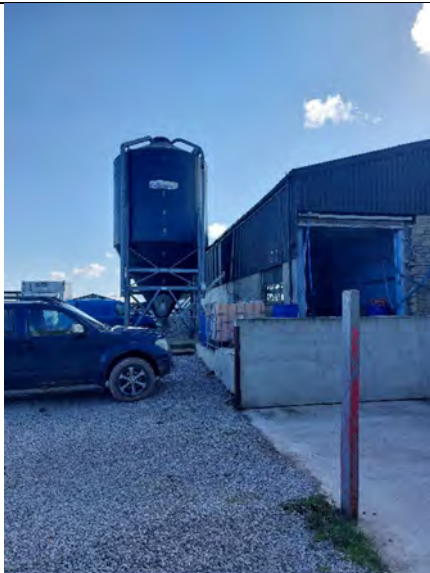
Photo 29: Silo related to the Farm and south of the Dairy's boundary. Facing east

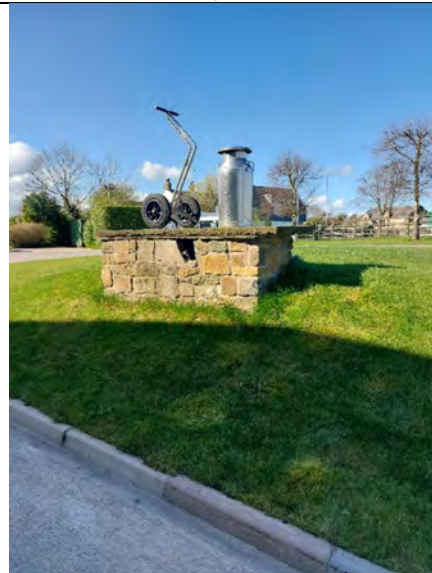
Photo 30: This stone structure contains a water borehole, which currently only services the Farm. Located in front of (west of) the Dairy extension building. An outside tap is also located in the grass to the left (south). Facing southwest.
