**PROPOSED RESIDENTIAL DEVELOPMENT
NORTHCOTE ROAD
LANGHO, BLACKBURN
FOR
OAK TREE DEVELOPMENTS**

PHASE II GEO-ENVIRONMENTAL INVESTIGATION REPORT

22009/GEIR/005

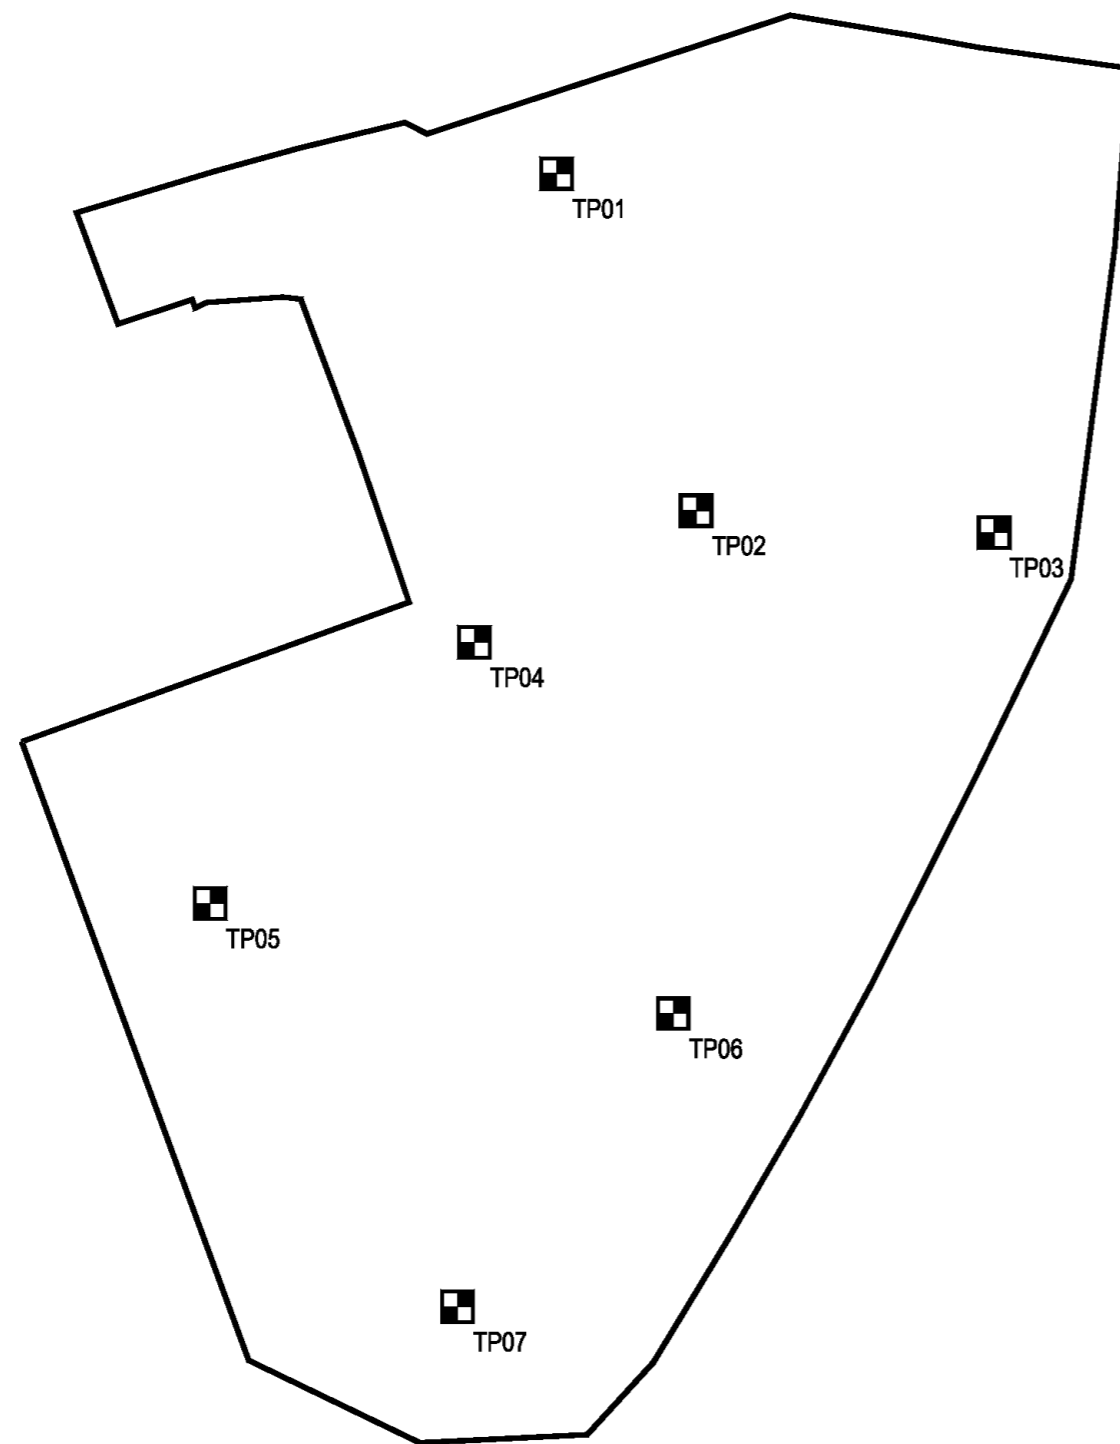
Plan On Investigation Locations

- 4.2.1 The ground conditions at this site have been investigated by the excavation of a total of seven (7 No.) trial pits supervised by a REFA engineer utilising a backhoe style excavator. Trial pits were excavated to a maximum depth of 2.00m bgl.
- 4.2.2 During the excavation works representative samples of the soils encountered have been obtained for laboratory analysis and testing. Visual appraisal of the strata present has been undertaken during these investigations.

4.5.2 The investigation locations have been spread over the whole area of the site in accordance with the recommendations laid down in BS10175: 2011 “Investigation of Potentially Contaminated Sites”. The initial ground investigation strategy is detailed within table 3.

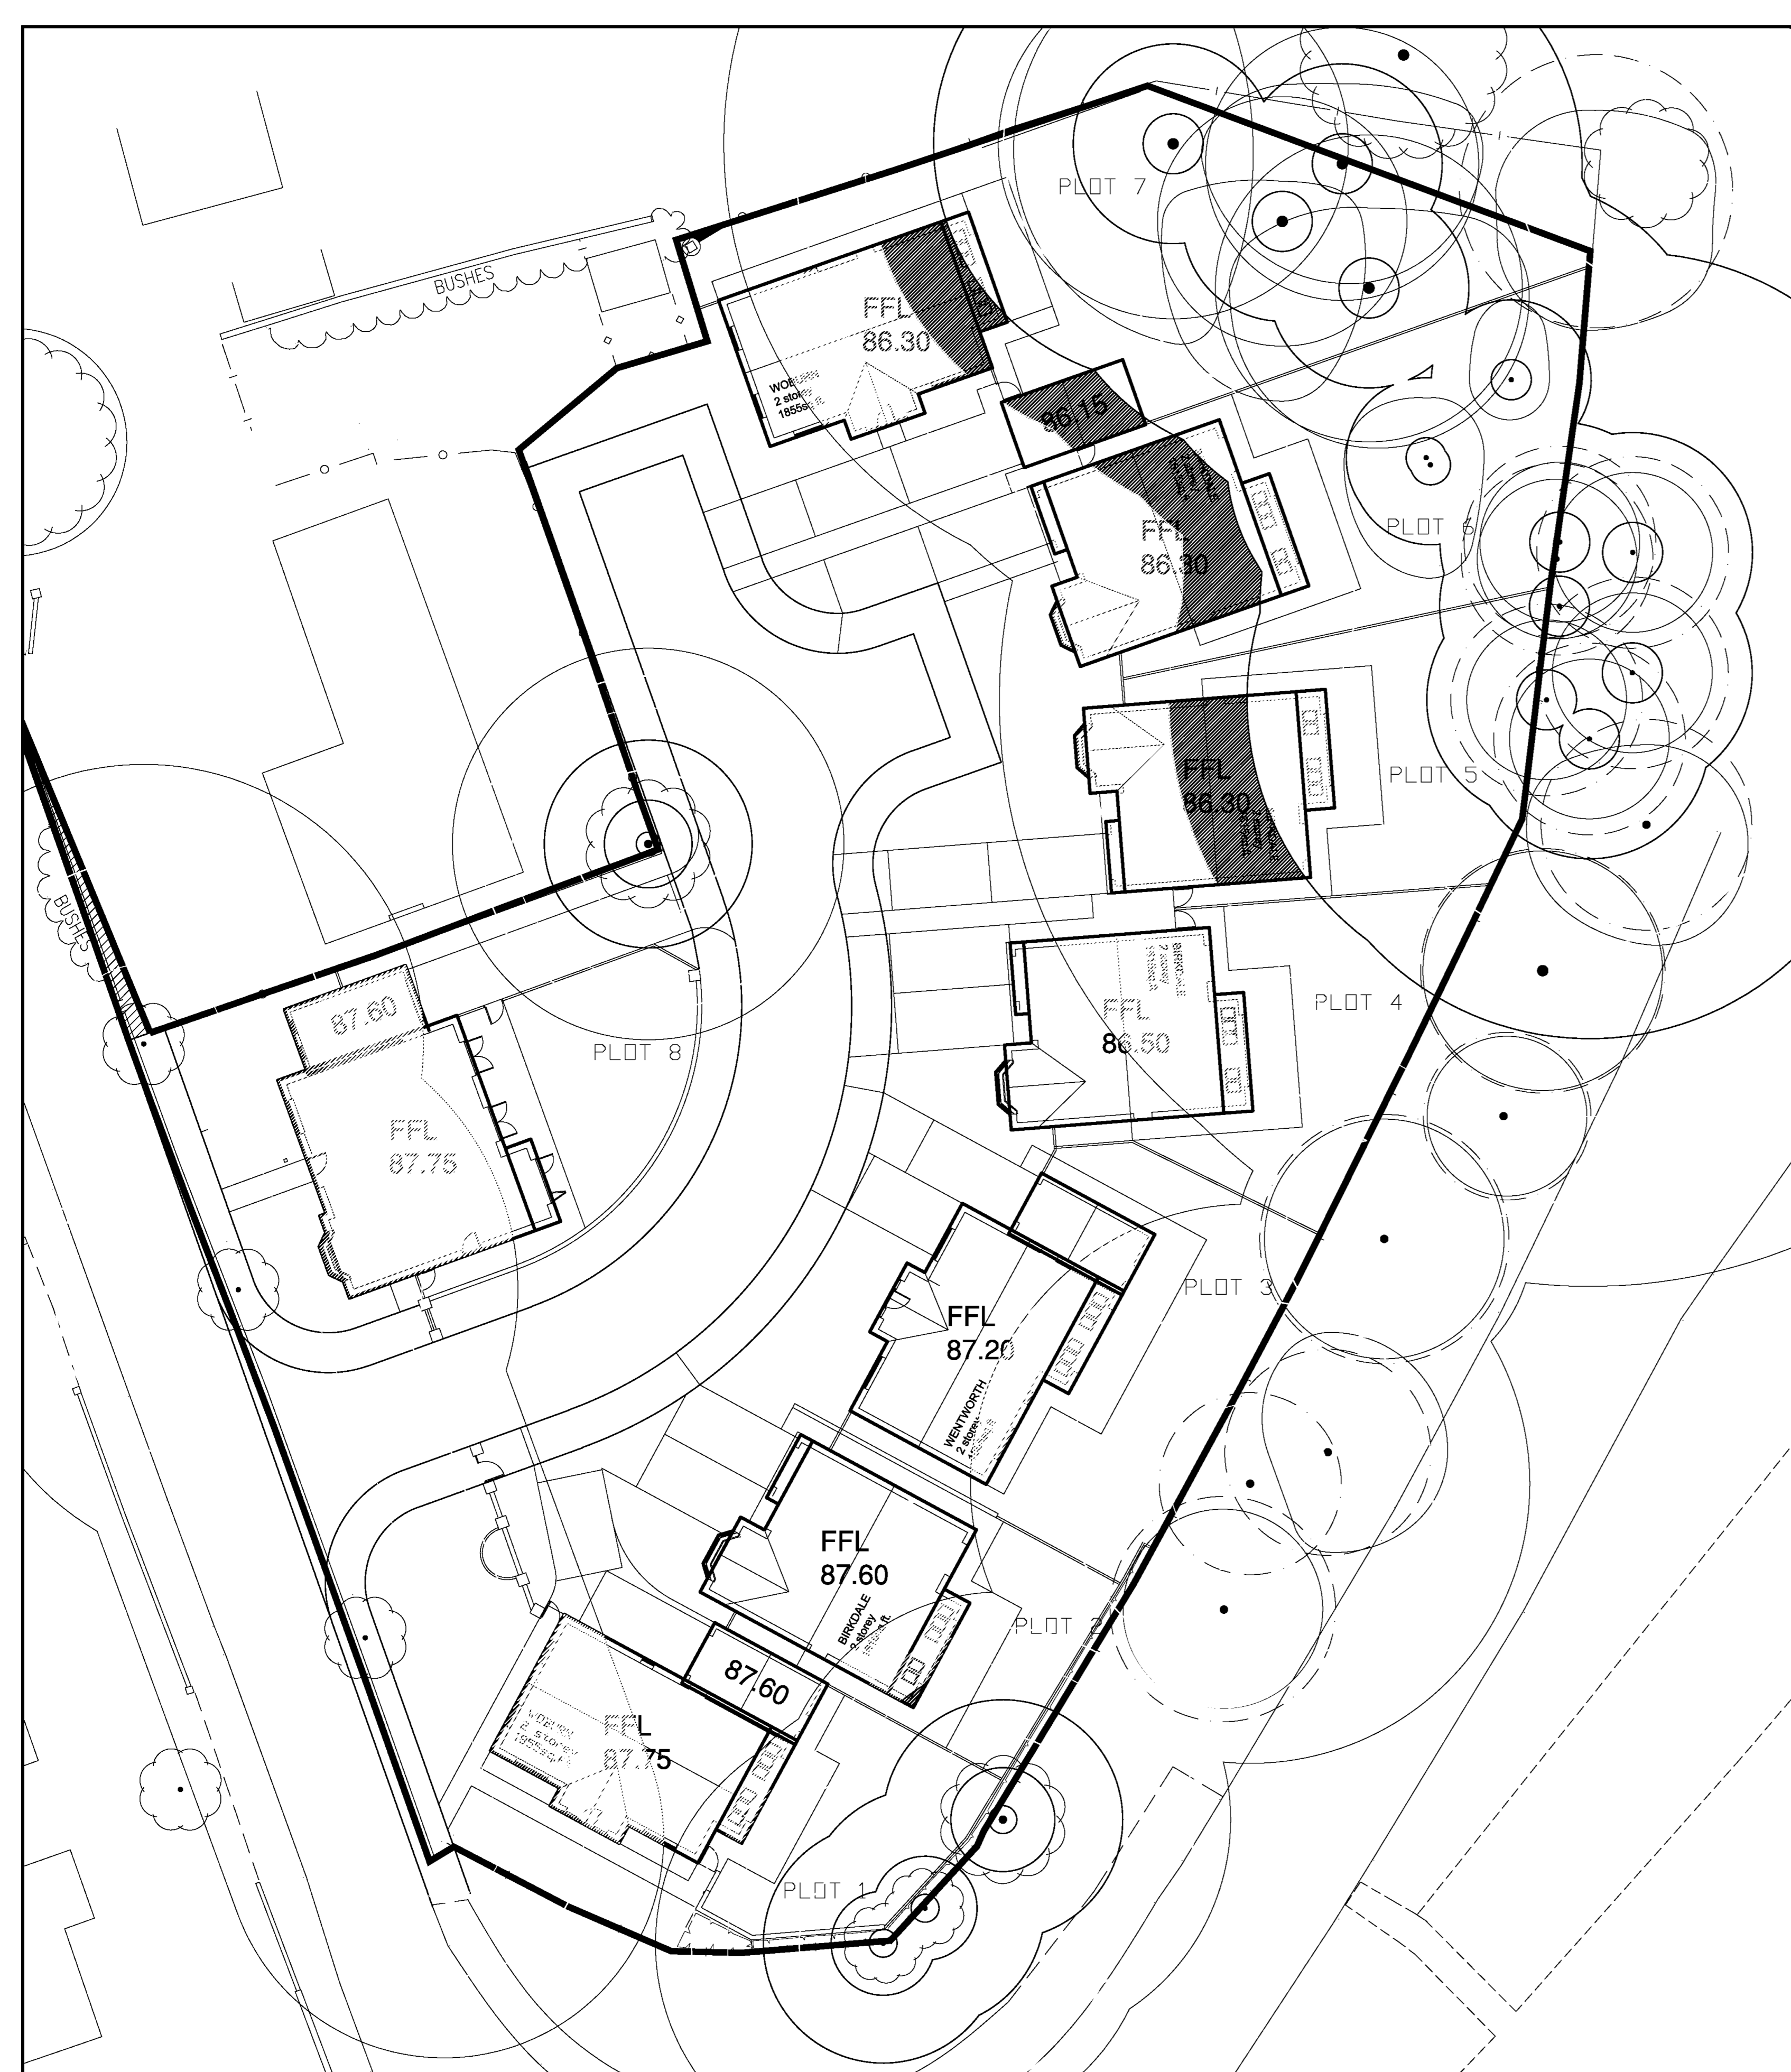
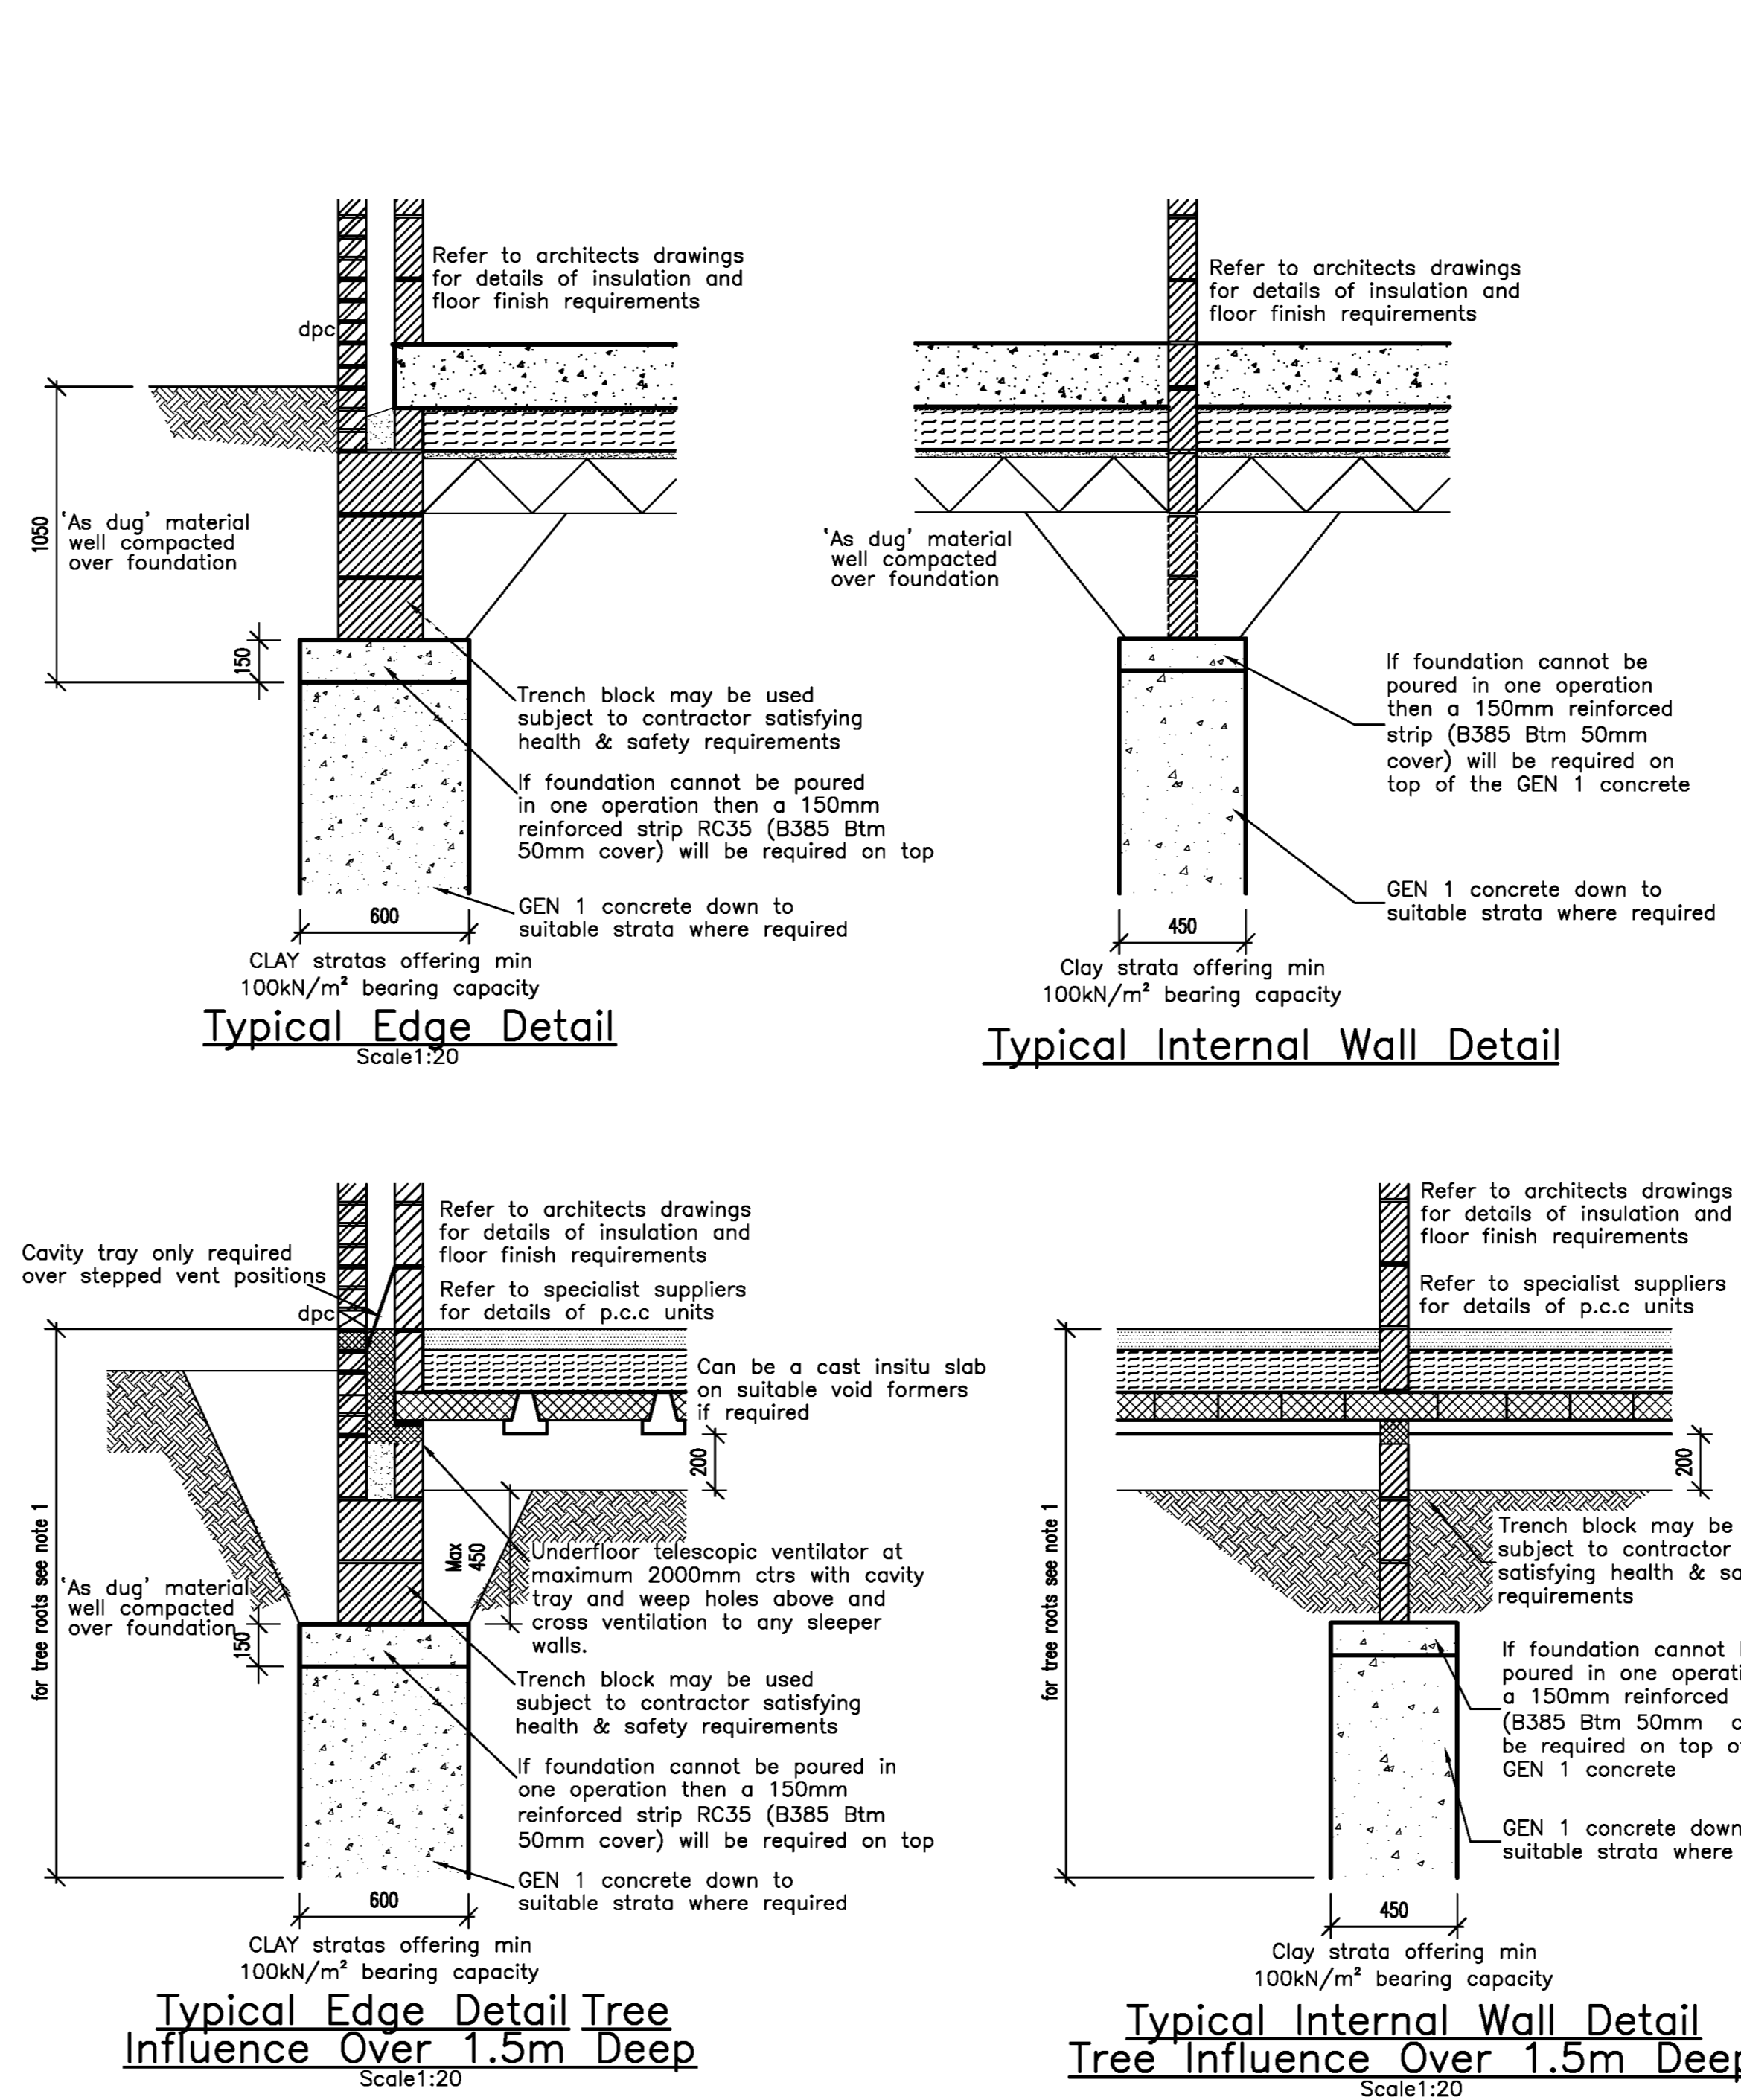
SITE SUMMARY BASED ON REFA 'PHASE II GEO-ENVIRONMENTAL INVESTIGATION REPORT 22009/GEIR/003' APRIL 2022

Summary of ground conditions.	Ground conditions encountered some made ground over soft-firm clays
Bearing capacity.	Clay 100kN/m ² @0.9m-1.5m BOGL
Foundation solutions.	Standard strip foundations.
Rock strata.	If any foundation excavations encounter rock then whole plots needs to bear onto rock.
Reinforcement in footings.	N/A
Further investigations required.	None
Strata plasticity.	Cohesive Strata LOW plasticity.
Ground Gas/Radon protection measures.	N/A
Design sulphate class.	DS-1.
ACEC class.	AC-1s.
Groundwater and excavation instability.	GW noted across site, levels vary. Perched water. Localised ground water management maybe required
Contamination.	N/A
Obstructions.	N/A
Mining.	N/A
Environmental constraints.	Existing Trees

The foundation types indicated are based upon the facts established from observations and field tests during the trial pit and borehole investigations. It should be recognized that natural strata may vary considerably from point to point and the ground water regime may be influenced by seasonal or other factors. The foundation types indicated are therefore for 'GUIDANCE PURPOSES ONLY' and should be reviewed in the light of the actual conditions on site during the construction work.

All foundations to be formed upon uniform strata offering a bearing capacity of at least 150kN/m² to the approval of the Building Inspector and Engineer.

Formation depth of all foundations to be minimum 0.50m below finished ground level upon approved strata. All foundation excavations must be inspected and approved by the Building Inspector prior to the placing of concrete.

- 8.5.1 The ground investigation has identified firm to stiff clays over the whole site area which are considered capable of offering a safe bearing capacity of at least 100kN/m² at a minimum depth of 0.90m bgl.
Greater bearing capacity may be achieved with depth. Based upon this information, it is anticipated that the majority of the site will adopt traditional strip type foundations constructed at depths carrying between 0.90 – 1.50m bgl.
