**BAT SURVEY AT -
LOWER HOUSE FARM
PAYTHORNE
CLITHEROE
BB7 4JD**

**DATE AND TIME OF VISIT
19TH Jan 2024 10.00am**

REFERENCE NO.6832

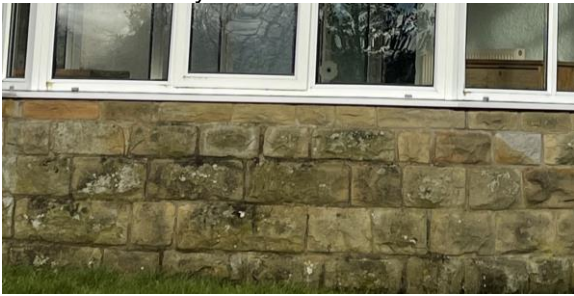
The conservatory has a coursed stone base wall with upvc glazed frame over.

The conservatory walls are in reasonable condition and do not provide any roost habitat for bats.

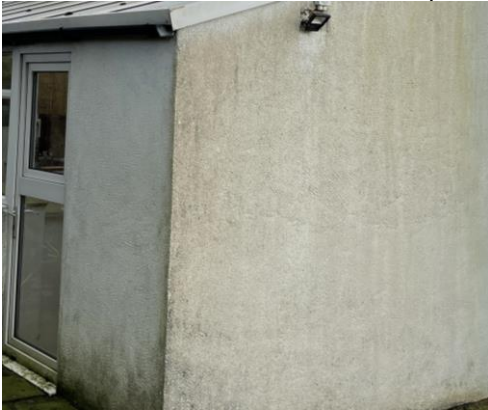
The rear lean to structure has white painted render walls.

The render walls to the house and the rear lean -to walls are in reasonable condition with no access points, cracks or crevices.

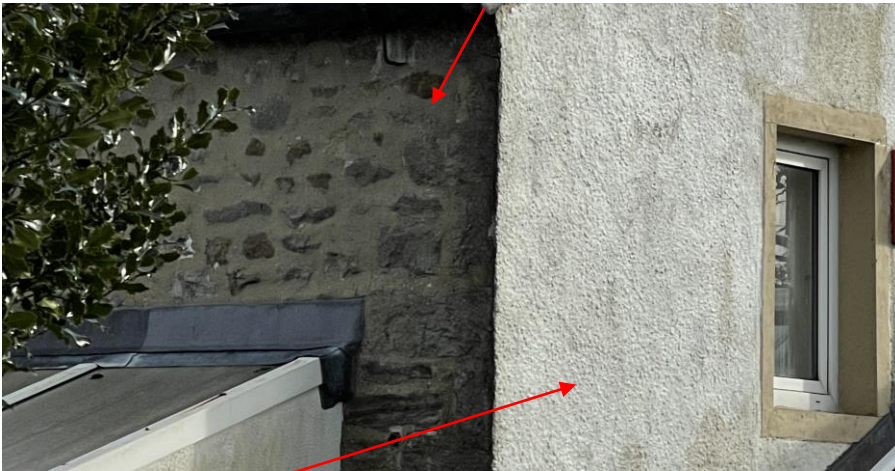
The rear north west and north east side elevation is random stone with flush pointing.

The random stone sections of house wall are in reasonable condition with no significant access points, cracks or crevices.

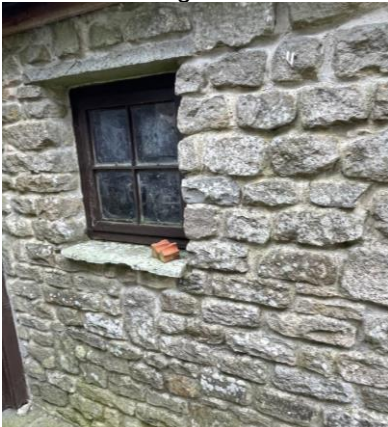
The out building walls are coursed random stone

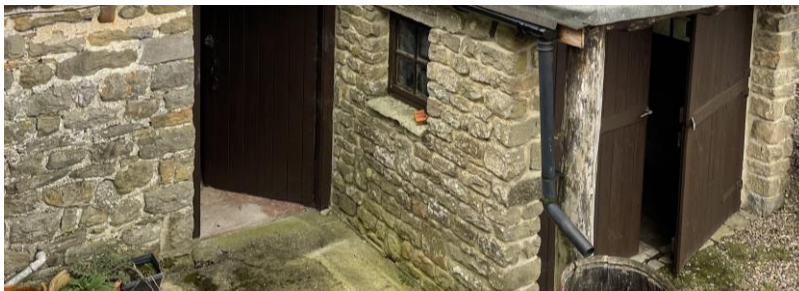
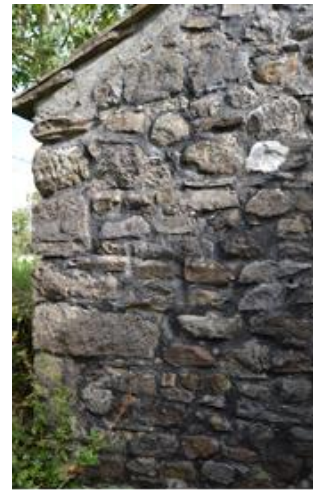
The outbuilding walls are in reasonable condition with all pointing present there are no access points, cracks or crevices which provide any bat roost potential.

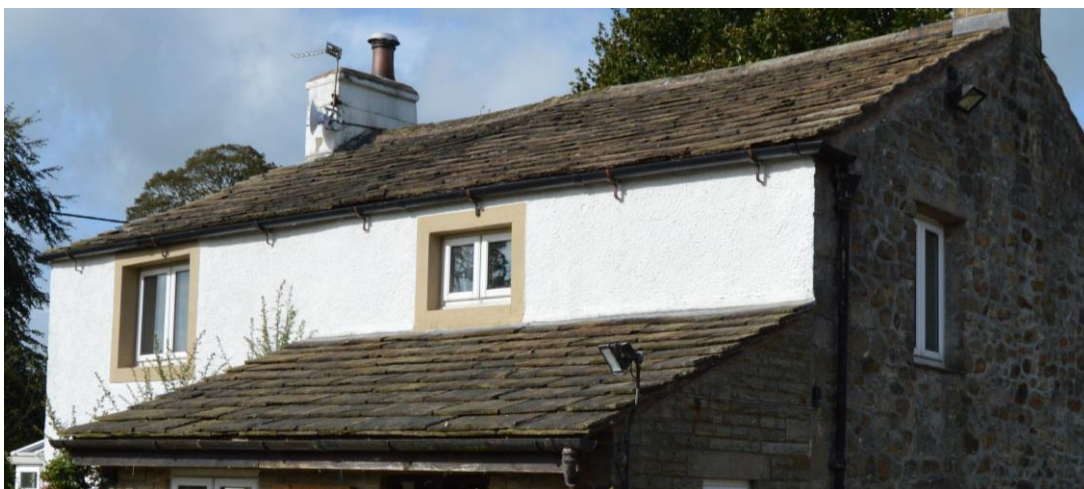
The grey slate main house and porch roof are in reasonable condition, examined from ground level with binoculars no apparent lifted /slipped slates were noted. The ridge and verge pointing was all in good condition.

These roofs will not be affected by the proposed extensions.

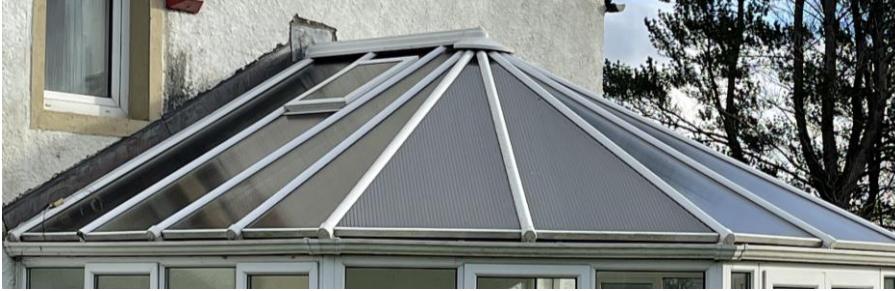
The conservatory roof is a pitched and hipped upvc frame with opaque polycarbonate sheets. Integrated upvc gutters to the eaves. Lead flashed to the house wall.

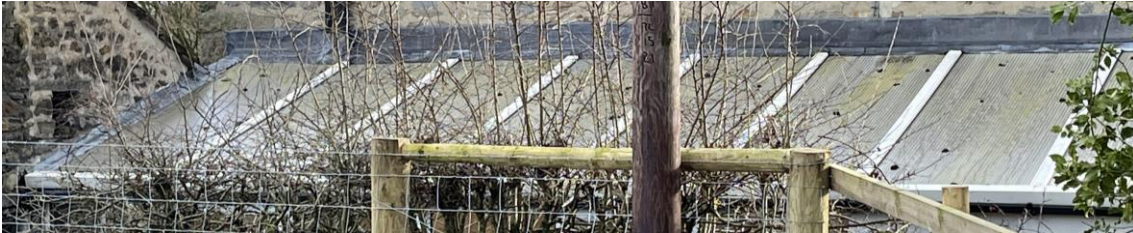
The rear Lean -to roof is a upvc frame and clear polycarbonate sheets. Lead flashed to the house wall.

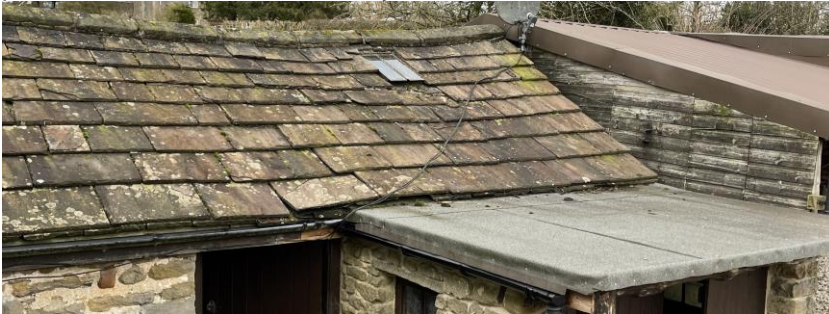
The outbuilding has a pitched grey slate roof with a pointed ridge and verges. A felt flat roof is present to the front more recently added section. The felt is laid directly on to a ply deck

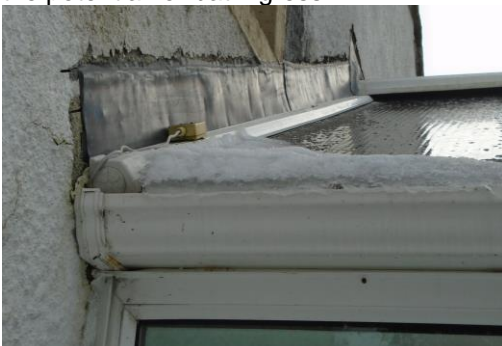
Conservatory lead flashing.

The conservatory roof is in good condition and does not provide any access points cracks or crevices.

The flashing at the abutment with the wall is in good condition and does not provide any voids with the potential for bat ingress.

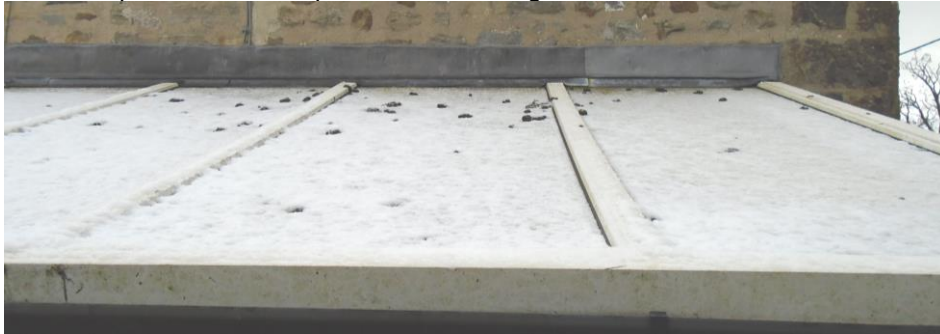
The Lean -to roof is in reasonable condition and does not provide any access points cracks or crevices.

The flashing at the abutment with the house wall is in excellent condition and very tight fitting. No voids are present with the potential for bat ingress.

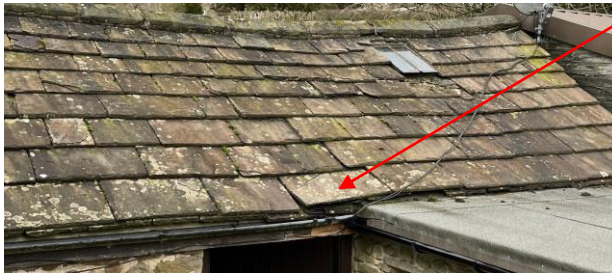
The outbuilding roof is in reasonable condition however a lifted slate was noted on the front elevation at the abutment with the felt flat roof.

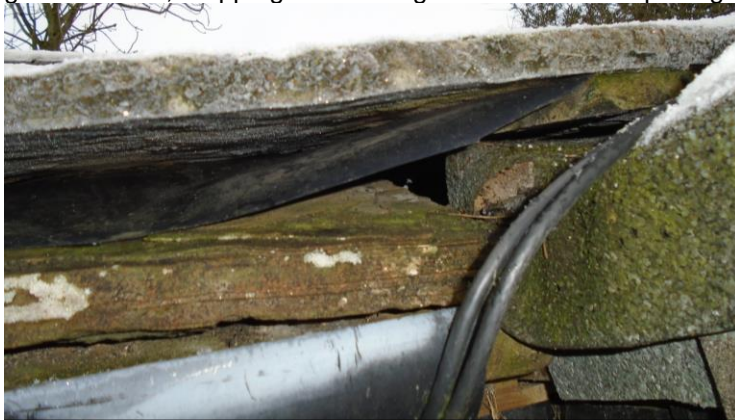
Due to the height of the building it was possible to closely inspect the gap, there were no signs of grease marks, droppings or staining in or around the opening nor were any bats currently present.

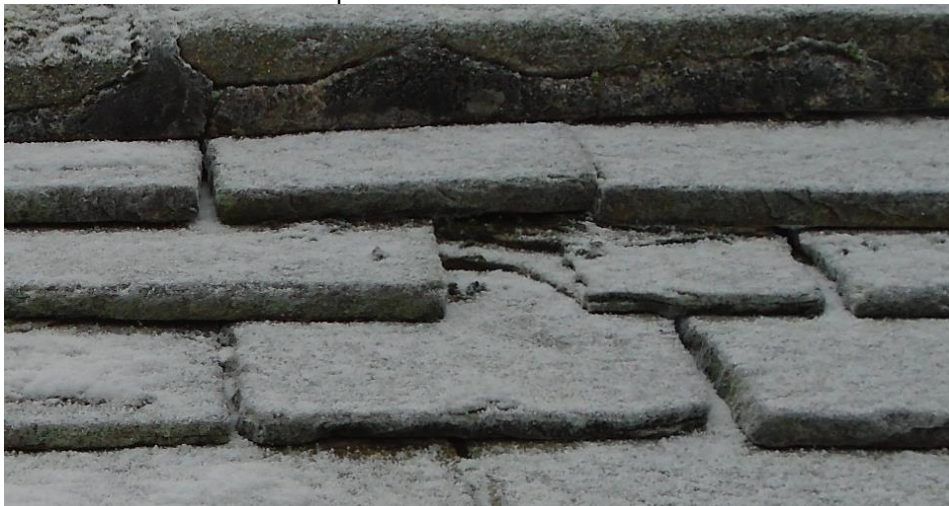
The rear roof pitch generally has tight fitting slates, a broken slate was noted below the ridge however an accessible void was not present .

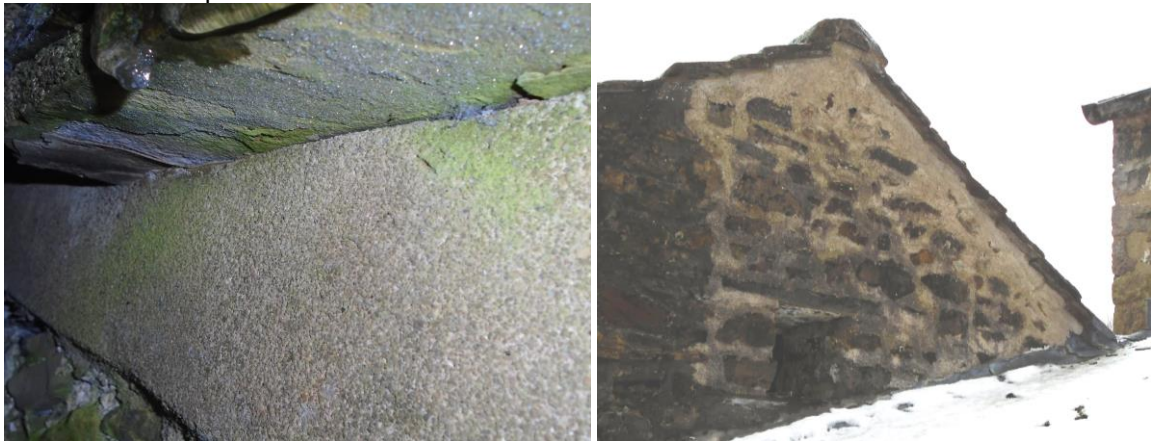
The verges were pointed and were both in good condition with tight abutments to the slate. No cracks or crevices were present

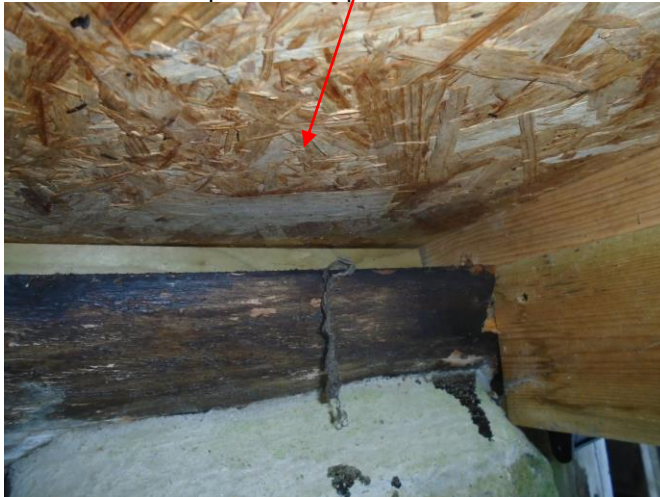
The felt flat roof has an overhang to the front, which is relatively exposed. there were no voids or crevices with the potential to provide roost habitat for bats.

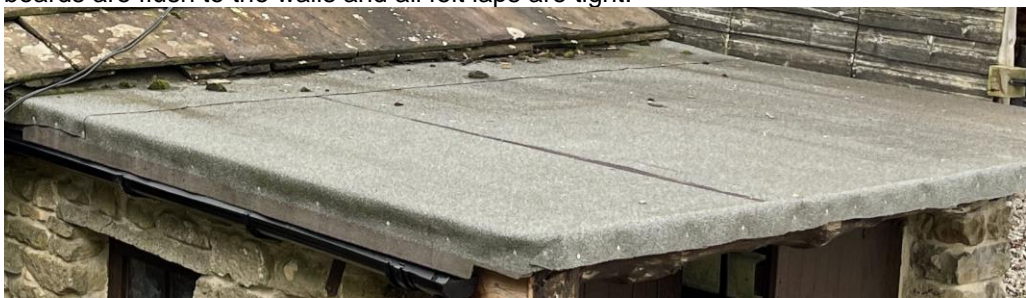
The felt flat is in reasonable condition and does not provide any potential roost habitat. The eaves boards are flush to the walls and all felt laps are tight.

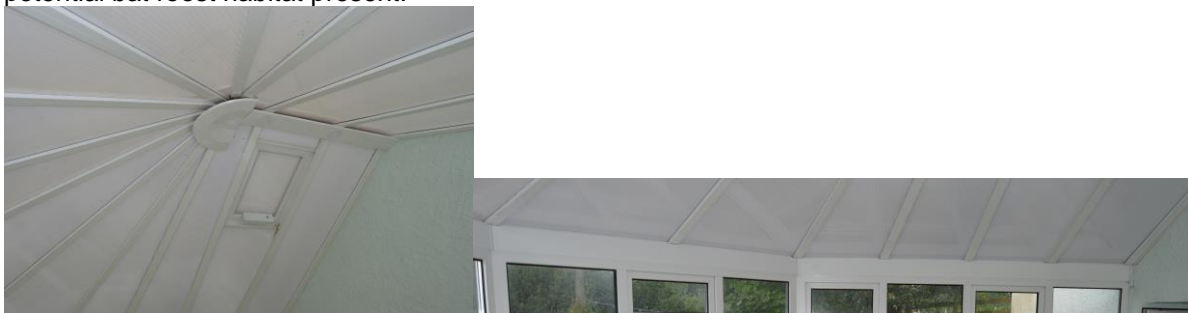
The Conservatory does not have an enclosed roof void the upvc structure is fully visible. There is no potential bat roost habitat present.

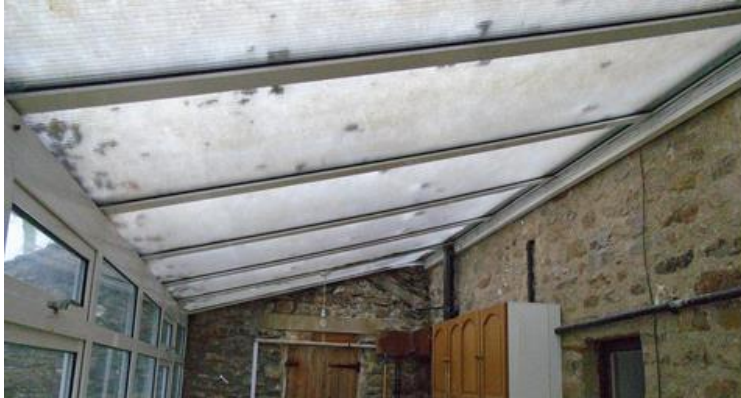
The lean -to roof on the rear elevation does not have an enclosed roof void. all the structure is fully visible. There is no potential bat roost habitat present.

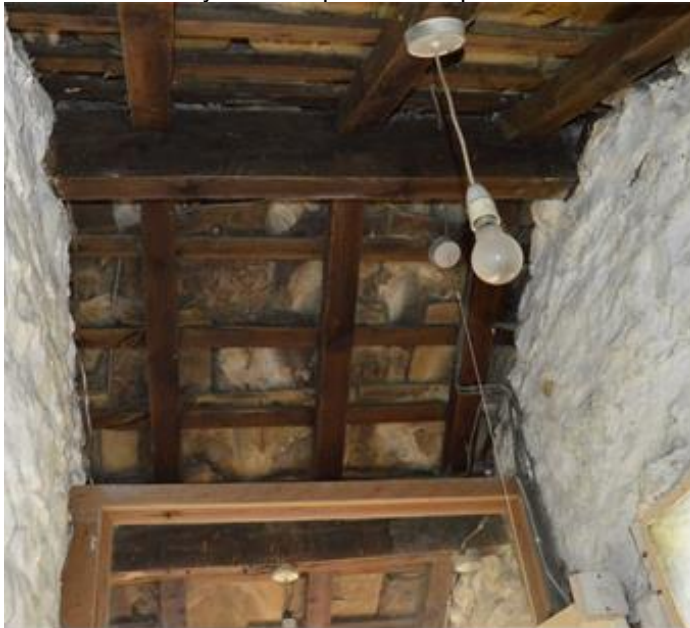
Void over wc section

A small section which houses a wc adjacent to the lean -to. And a further section which is used as a store and garage, both sections are regularly accessed. The timber rafters, purlins and battens are fully visible, no sarking felt / underlay is present. The timbers are all in reasonable/ good condition with no rot or cracks present. The underside of the slates are visible all having tight laps.

All the structure could be inspected closely in a non invasive manner, There were no voids. gaps or crevices internally with the potential to provide roost habitat for bats.
