Advice note

23 Smithy Row, Hurst Green BB7 9QA

This is a note to confirm the findings of a daytime bat survey undertaken on 5th March 2024

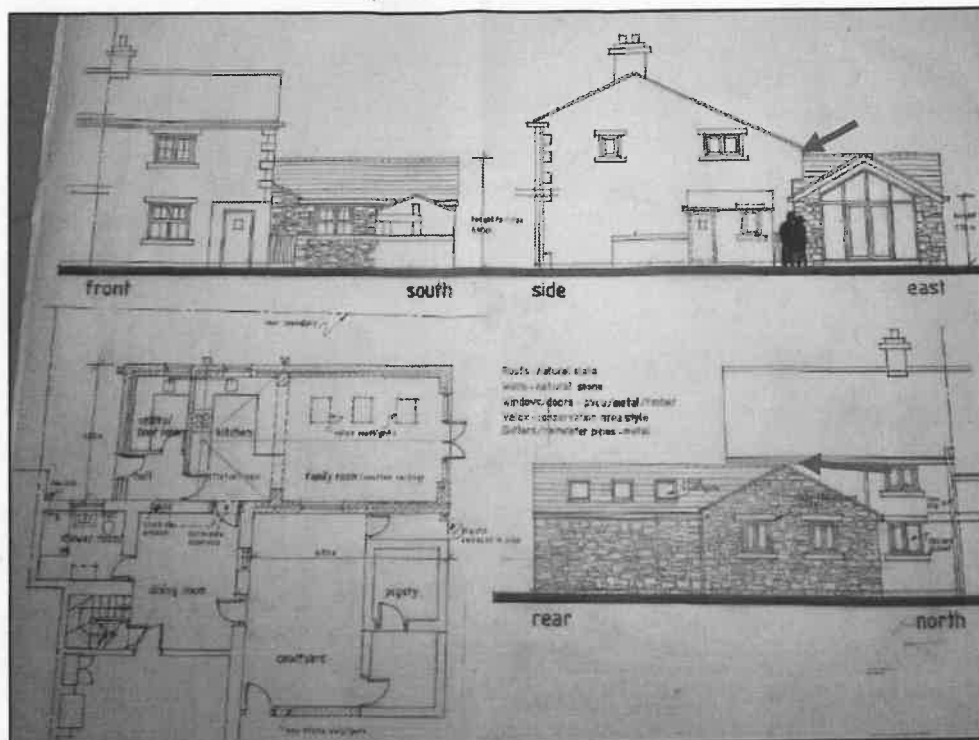
Image showing proposed plans. Note new extension ties into/close to the rear roof edge which is an area of potential bat access (red arrows)

5. Based on the proposed plans, the works are likely to cause disturbance and/or obstruction to bats, affecting their ability to leave and gain entry to the roof space and roof coverings (refer to images included).

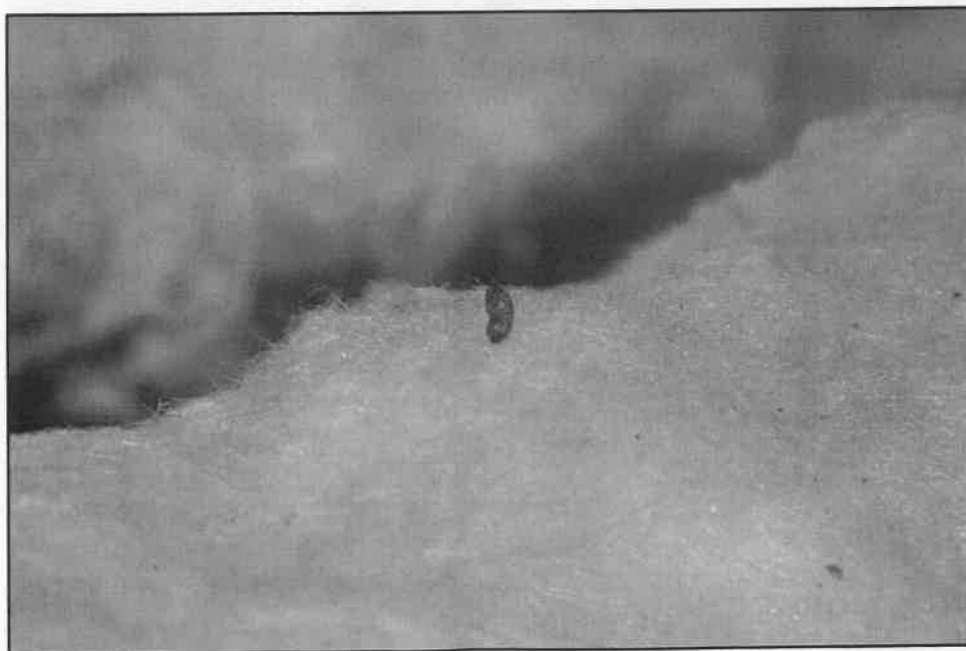
Example of image showing bat dropping found in roof void on 5th March 2024

1. Signs of bat roosting, in the form of bat droppings were found in the roof void confirming bats have been (and still could be) present.
2. The bat species cannot be confirmed at this stage. Several species of bats are known to roost in buildings in Lancashire, the most frequent being common and soprano pipistrelles.

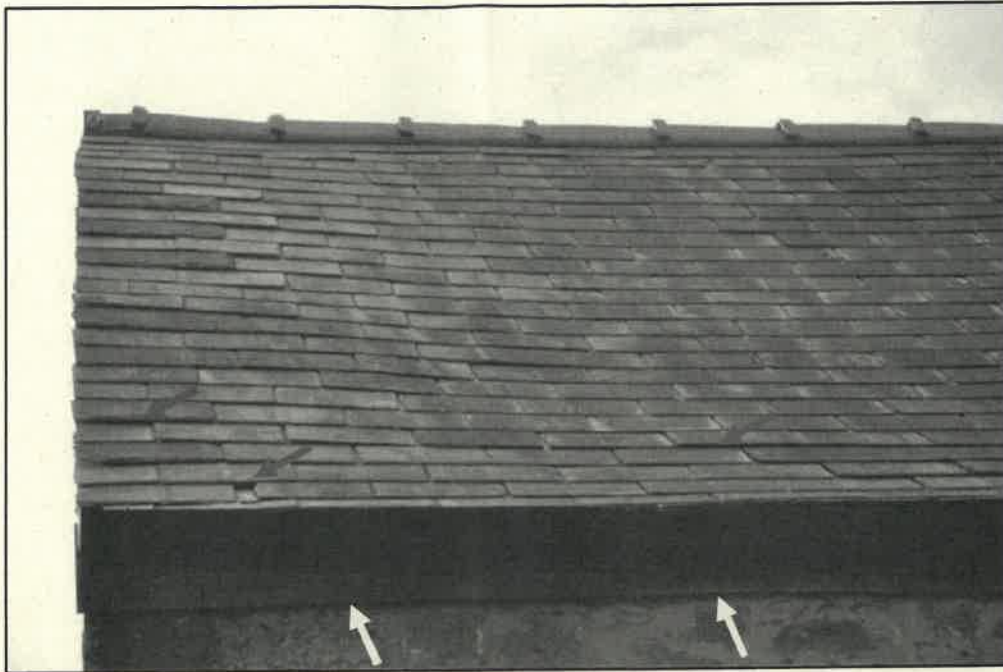
Image of rear roof and roof edge. Note gaps between slates (red arrow) and timber fascia (white arrow). These features provide high potential bat roosting and bat access points on this building.

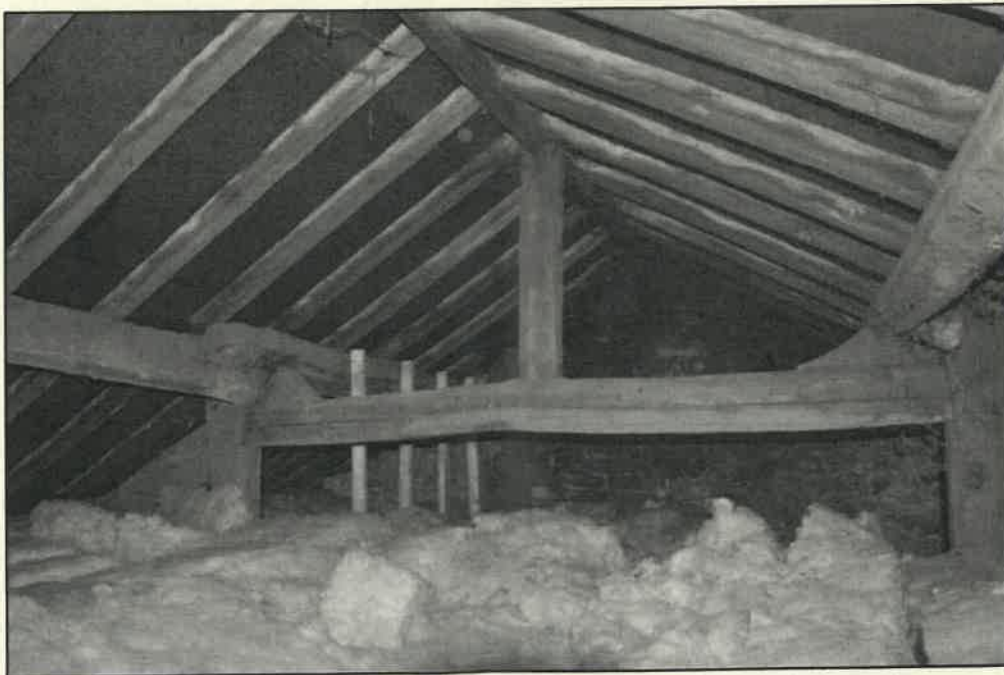
Image of showing roof void showing timber roof supports and bitumastic hessian roof liner. The roof void at 23 Smith Row provides suitable conditions (draught free, dark, undisturbed space) for use by roosting bats.
