**Re: Proposed development at 23 Smithy Row, Hurst Green BB7 9QA
Grid Reference SD 68547 38301**

Thank you for your request for a bat survey at the above site. I understand that the proposed development is for a single storey extension to the north (rear) elevation of the existing dwelling house.

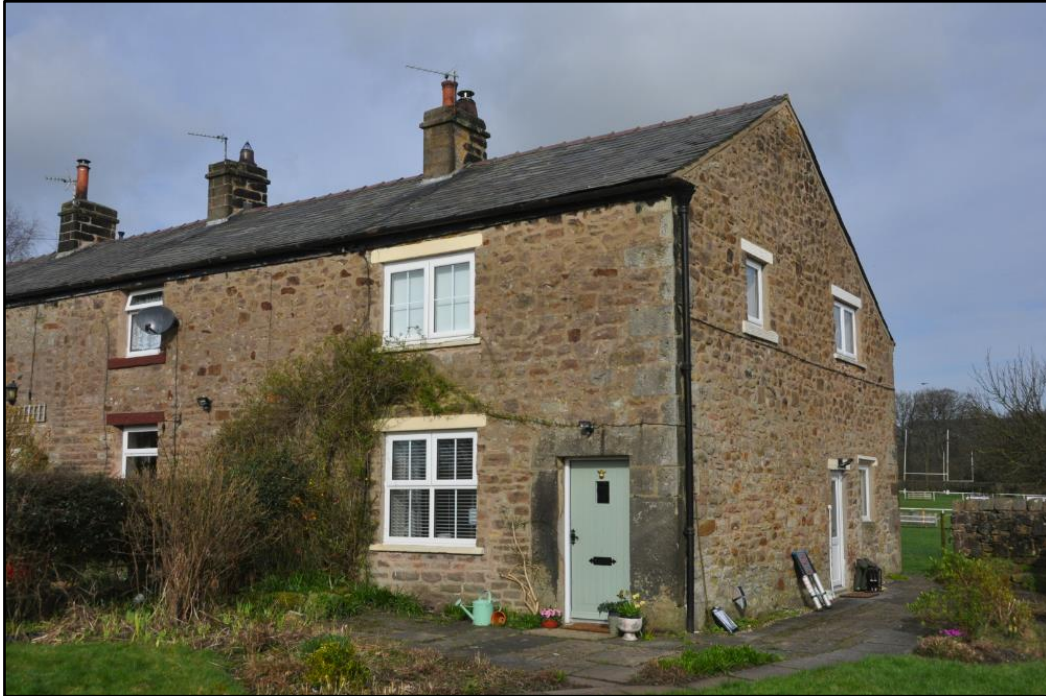
The dwelling house walls are well mortared with no visible gaps and all windows and doors are well sealed. There are gaps associated with slate roof coverings, particularly at the rear (north elevation) as well as gaps along the roof edges on the north and south elevations. The east gable is well mortared but there are gaps associated with roof coverings along the verge.

Image showing north elevation and east gable at 23 Smithy Row

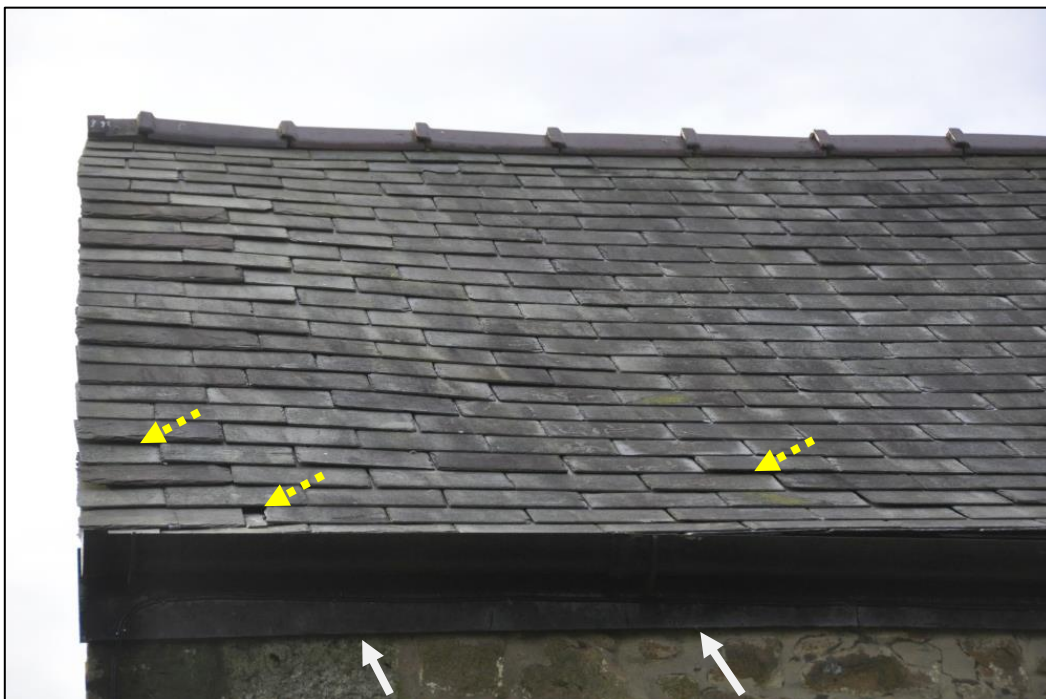
The evidence from the surveys suggests that bats are most likely using the wall tops and/or roof coverings for roosting. Roof edge gaps can provide access into spaces between roof coverings, as well as potential access into the roof void. All of these features provide dark, sheltered warm spaces with little disturbance, and these conditions are favoured by bats for summer day roost sites.

Image of rear roof and roof edge. Note gaps between slates (yellow dashed arrow) and timber fascia (white arrow). These features provide high potential bat roosting and bat access points on this building.

| Protected species | Impacts, Issues and Rationale | Action Required |
|---|---|---|
| Bats continued | | <ul style="list-style-type: none"> ○ retaining suitable gaps along roof edges and behind fascia boards as potential roost features/access points. ○ Installation of external bat box on north elevation. <p>Any features retained or installed must be accessible and free from obstruction including artificial lighting at all times. This will maintain and enhance opportunities for local bat populations</p> <p>During and post development. Recommendation(mitigation): Any new lighting associated within the proposed development should be designed to reduce light spill upwards and where possible there should be no light spill onto the bat roosting features and any vegetation in close proximity. This will help to avoid any impacts on bat activity, including foraging and commuting. During and Post development.</p> |

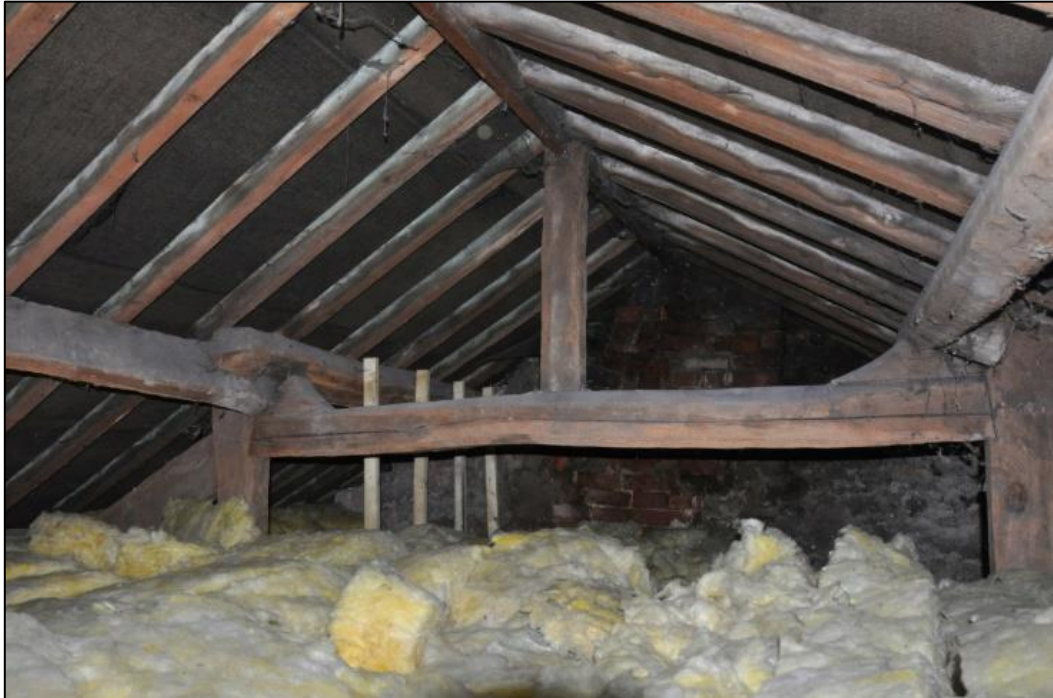
The roof void comprises the original roof timbers with cross and ridge beams as well as some more recent timber supports. The interior walls are brick and stone and there is a dense layer of rock wool on the floor. The roof is underlined with bitumastic hessian roof liner which remains intact, although occasional small gaps due to liner sagging were noted.

***Image of roof void showing timber roof supports and bitumastic hessian roof liner.
The roof void at 23 Smithy Row provides suitable conditions (draught free, dark,
undisturbed space) for use by roosting bats.***

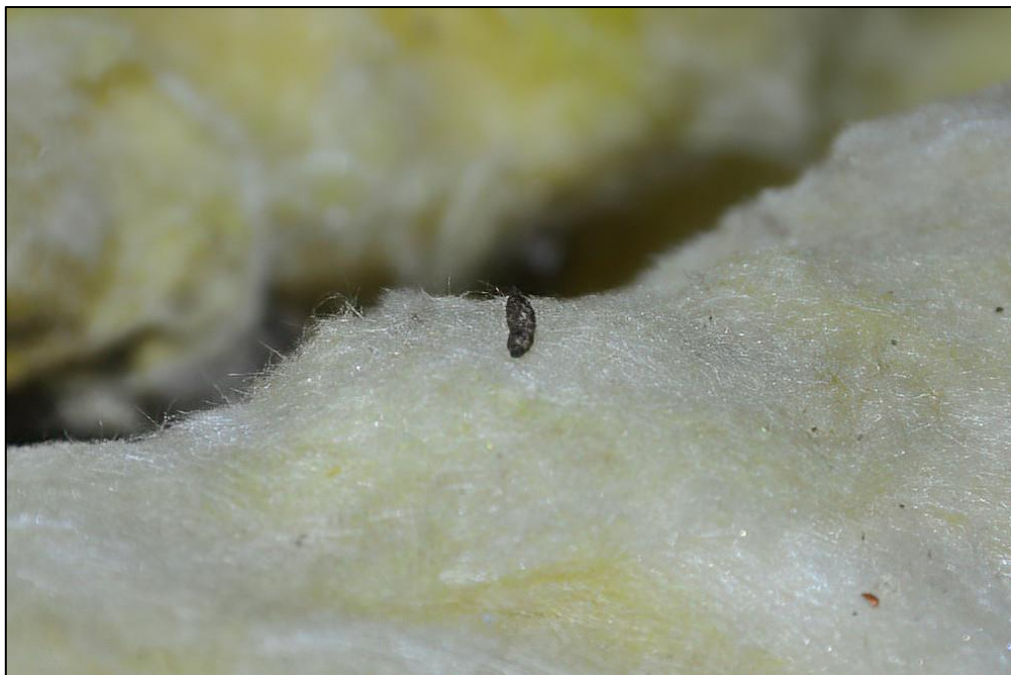
A small number of bat droppings were found below a gap in the roof liner, close to the roof hatch and on top of the rock wool.

A small number of bat droppings were found inside the roof void on top of rock wool insulation; these confirm that a bat roost has been present prior to the 2024 survey.

Image showing bat dropping found in roof void on 5th March 2024

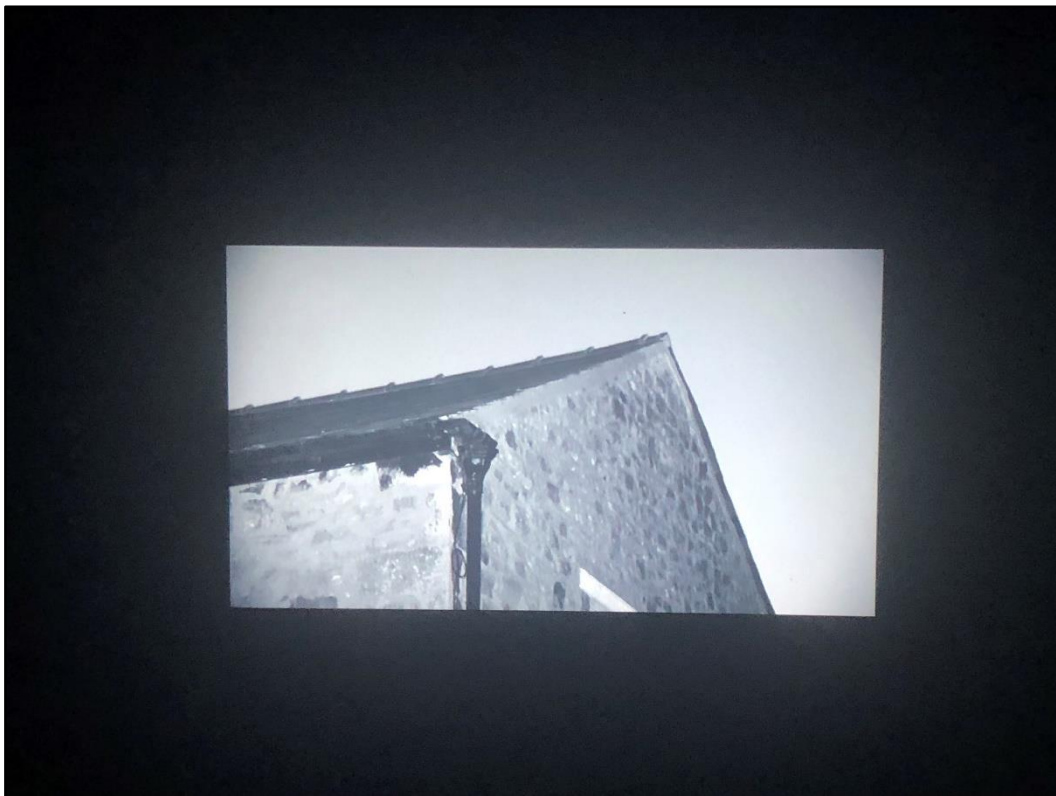
Infrared image of East gable and south elevation of 23 Smithy Row. Image taken at darkest point of the survey during the second emergence survey on 9th August 2024

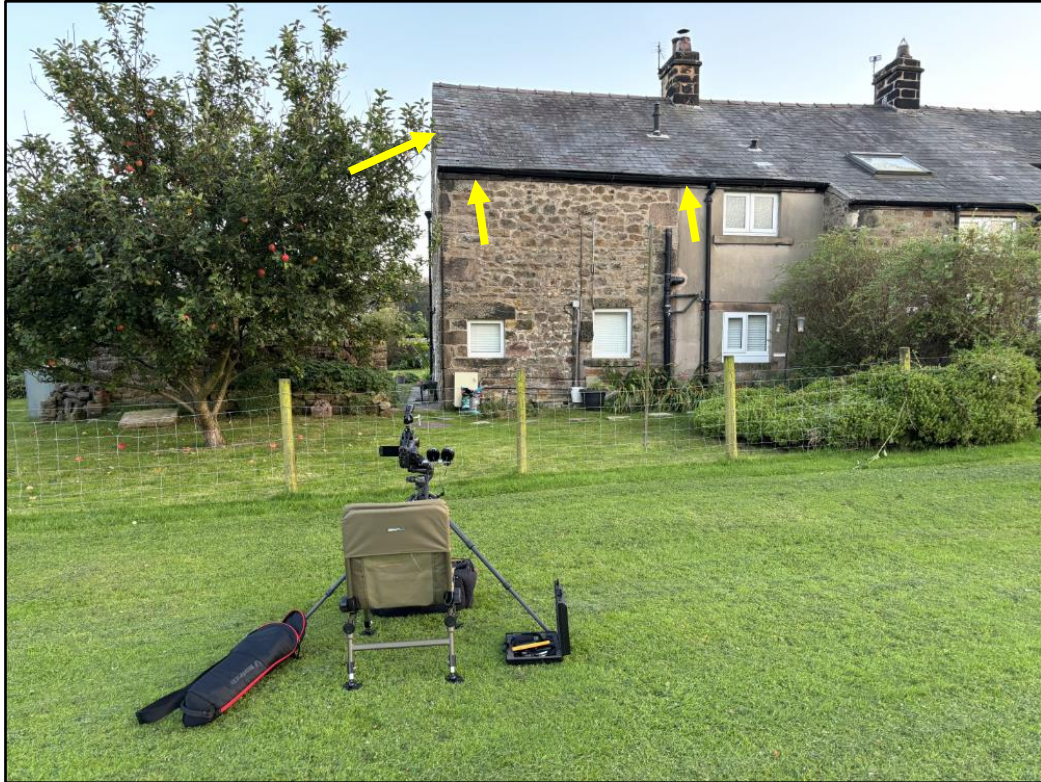
A maximum of 2 soprano pipistrelle bats emerged from the north elevation roof edge during the emergence surveys. This confirms that a bat roost was present during the 2024 surveys.

Image showing survey location and camera set up on the north elevation during evening surveys. Yellow arrow indicates location of bat emergence

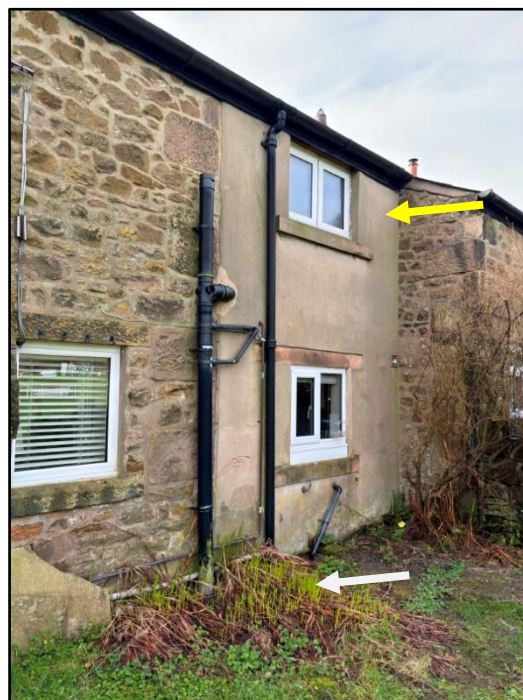
Non-native invasive plant species Japanese rose and Montbretia are present within the garden planting. Montbretia is present at the base of the dwelling house along the north elevation and Montbretia and Japanese Rose are present in close proximity to the former piggery building which forms part of the proposed development site.

Close up image of north elevation showing location of Montbretia (white arrow) and proposed location of new bat box (yellow arrow)

| Non-native invasive species | Impacts, Issues and Rationale | Action Required |
|---|--|--|
| Japanese rose and Montbretia | <p>There are <u>potential</u> impacts as a result of the presence of Japanese rose and Montbretia within the garden planting and immediately adjacent to the proposed development site.</p> <p>The proposed development will involve an amount of disturbance which could result in the spread of species, listed on Schedule 9 of the Wildlife and Countryside Act 1981 (as amended). Section 14(2) of the Wildlife and Countryside Act 1981 (as amended) prohibits 'planting' or 'causing to grow' in the wild of any plant listed in Part 2 of Schedule 9.</p> <p>Environmental Protection (Duty of Care) Regulations 1991. Any waste containing non-native invasive plant species is classified as controlled waste.</p> | <p>Advice (mitigation): The best approach to control the spread of non-native species within small development sites is to avoid any disturbance of the plants and/or ground around them. At all times</p> <p>Advice (mitigation): If the risk of disturbance to Japanese rose and/or Montbretia cannot be avoided, working methods including control, removal and safe disposal of the plant species must be adopted. For this site, hand pulling of individual plants may be sufficient. If larger areas are likely to be disturbed, specialist advice may be required in order to prevent further spread. Prior to commencement of any work.</p> <p>Advice (mitigation): All people working at the proposed development site should be made aware of the legal issues associated with non-native invasive species and their own responsibilities as regards implementation of precautionary measures. Prior to any work commencing</p> <p>Advice (mitigation): All arisings from non-native plant species left in situ (i.e. plants that have been retained during development) as part of normal gardening practises (e.g. cut, pruned and/or removed) should be disposed of responsibly. This advice also applies to infected soils, which must not be exported off site or moved within the site, to prevent spread of non-native invasive species into unaffected areas. Any cut or excavated material should be disposed of, burnt or buried. At all times</p> |

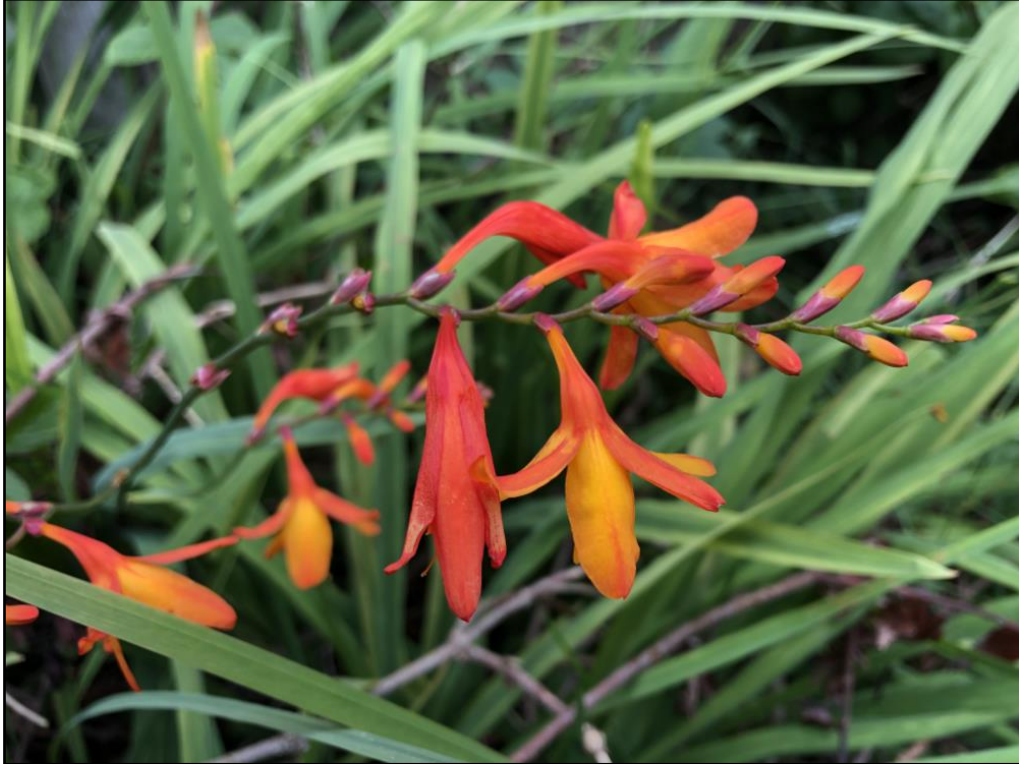
Close up image of Montbretia in flower, August 2024

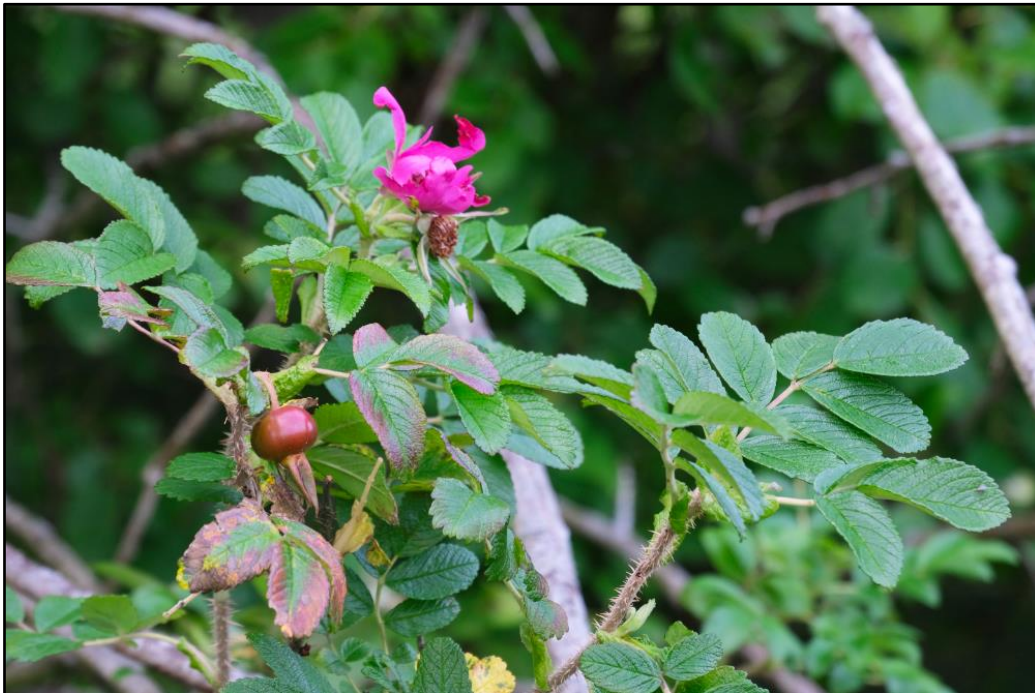
Close up image of Japanese rose, August 2024
