**Bat Survey Report and Method Statement  
European Protected Species (Bats)**

**Reasonable Avoidance and Mitigation Measures**

**Cuckoo Hall Farm,  
Higher Road,  
Longridge,  
PR3 2YX**

**12.02.2024**

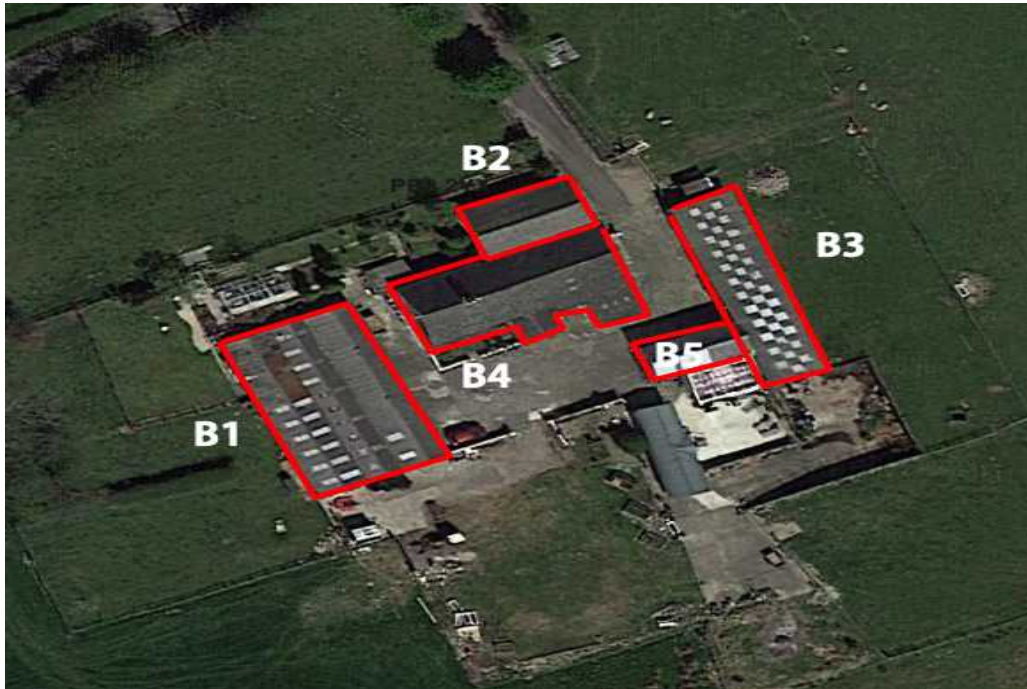
The property consists of a complex of former agricultural buildings and outbuildings which will be demolished as part of the proposed residential development.

*Buildings proposed for development.*

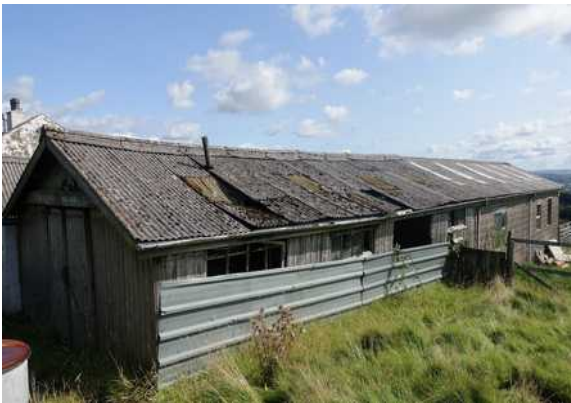
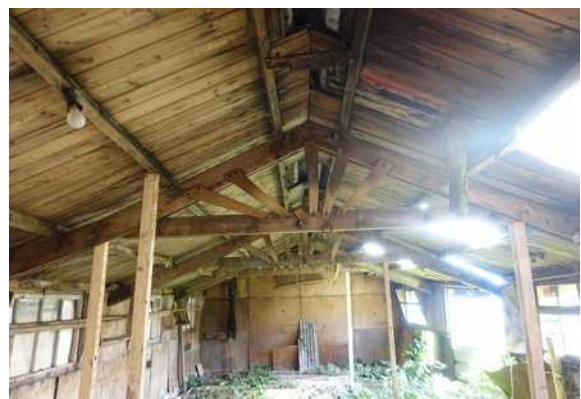
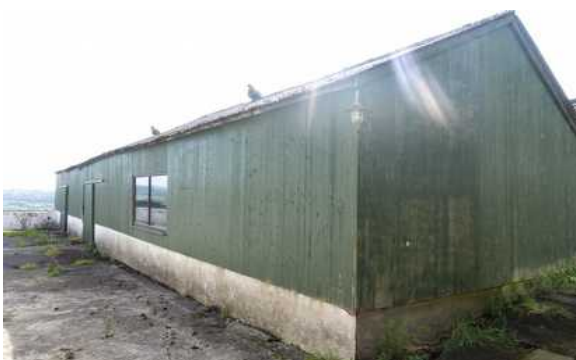
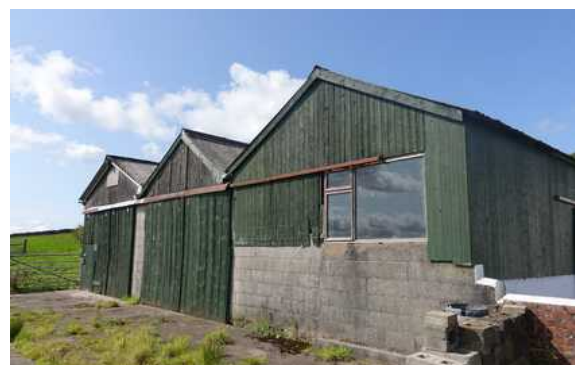
### Building 1

Building 1 is a complex of three single skin single storey outbuildings. Exterior walls are single skin with no obvious cavity, and concrete half walls are well pointed with no obvious cracks, crevices or gaps present. No fascia boarding is present with guttering being directly attached to exterior walls.

Rooflights and windows are present allowing light penetration into the interior.

No evidence, such as droppings, feeding remains, urine splashing or grease marking was observed to suggest the presence of roosting bats despite interior spaces and multiple horizontal surfaces being undisturbed. The building was assessed as offering negligible potential for roosting bats.

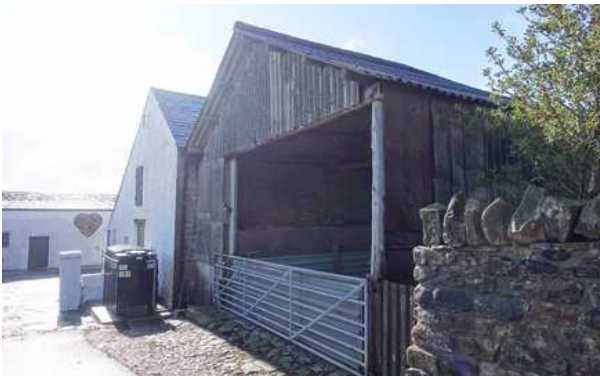
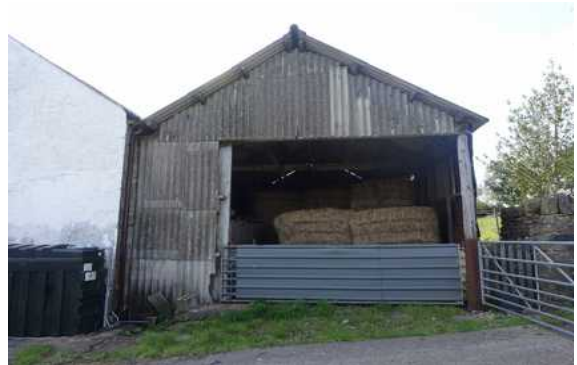
## Building 2

Building 2 is a corrugated fibreboard outbuilding with an unlined double pitched corrugated fibreboard roof. Exterior walls are single skin with no obvious cavity, and well pointed with no obvious cracks, crevices or gaps present. No fascia boarding is present.

The building has a double pitched corrugated fibreboard roof which is well sealed. Roof panels are unlined and the ridge is exposed to the interior.

No evidence, such as droppings, feeding remains, urine splashing or grease marking was observed to suggest the presence of roosting bats despite interior spaces and multiple horizontal surfaces being undisturbed. The building was assessed as offering negligible potential for roosting bats.

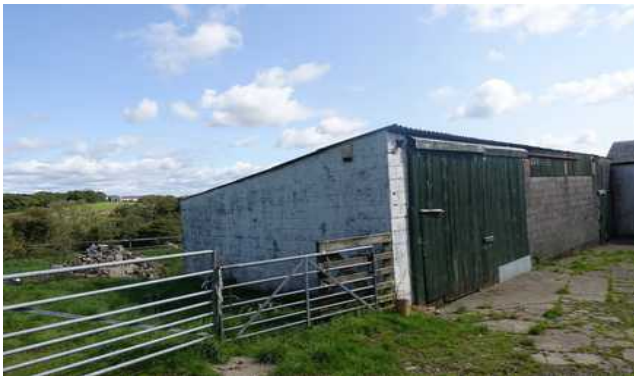
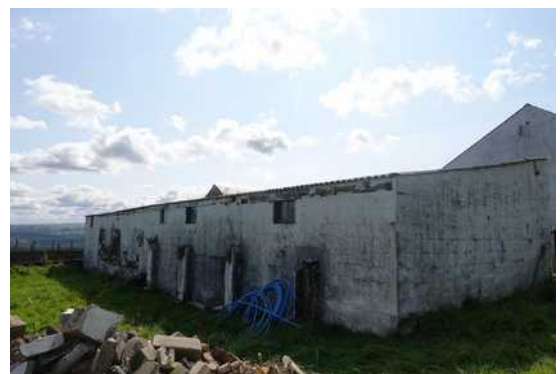
## Building 3

Building 3 is a single storey block built outbuilding with a single pitched corrugated fibreboard roof. Exterior walls are single skin with no obvious cavity, and generally well pointed with no obvious cracks, crevices or gaps present.

The building has a single pitched corrugated fibreboard roof and is well sealed. Roof panels are unlined and rooflights are present allowing considerable light penetration into the interior of the building.

No evidence, such as droppings, feeding remains, urine splashing or grease marking was observed to suggest the presence of roosting bats despite interior spaces and multiple horizontal surfaces being undisturbed. The building was assessed as offering negligible potential for roosting bats.

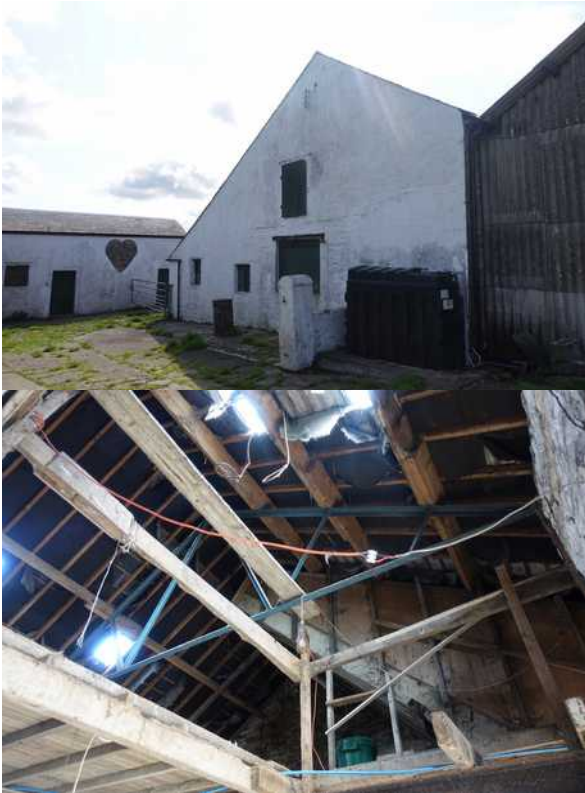
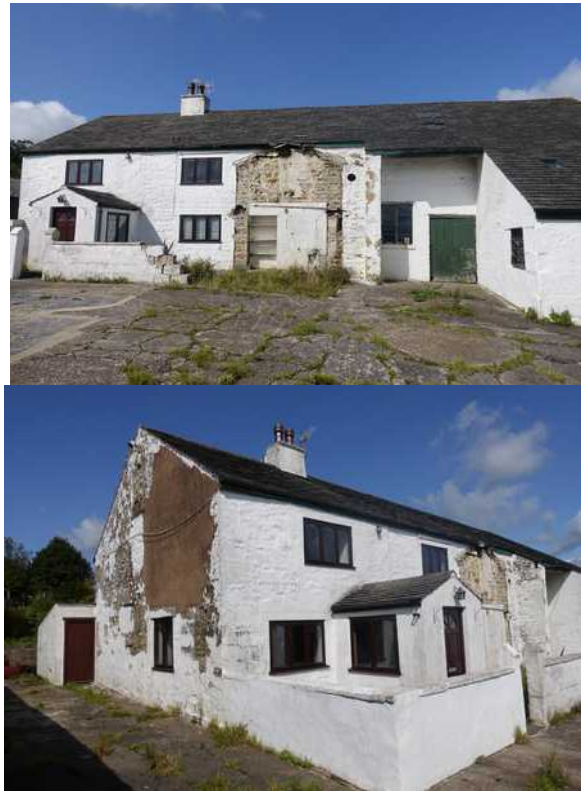
#### Building 4

Building 4 consists of an existing two storey farmhouse with a double pitched slate roof, the property has an adjoining barn, External walls are rendered and painted, with no missing pointing, gaps, or crevices present. Roof slates are close fitting with no obvious missing, slipped or lifted slates. Ridge tiles are pointed and well sealed.

No evidence, such as droppings, feeding remains, urine splashing or grease marking was observed to suggest the presence of roosting bats despite interior spaces and multiple horizontal surfaces being undisturbed.

The property can be considered to be of low potential for roosting bats.

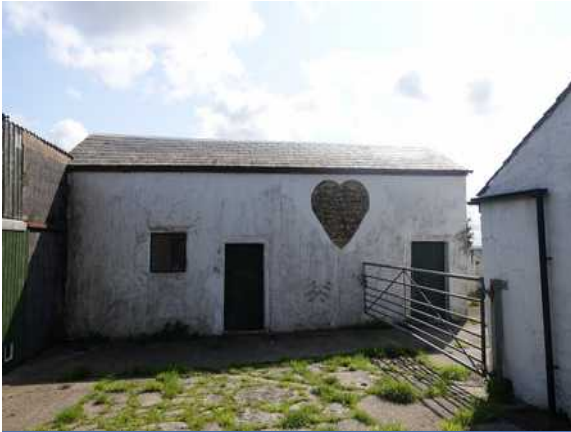
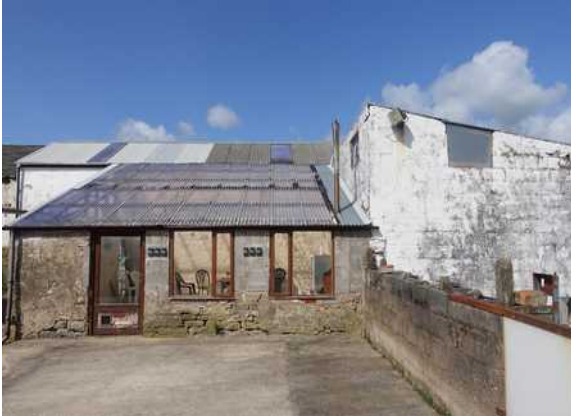
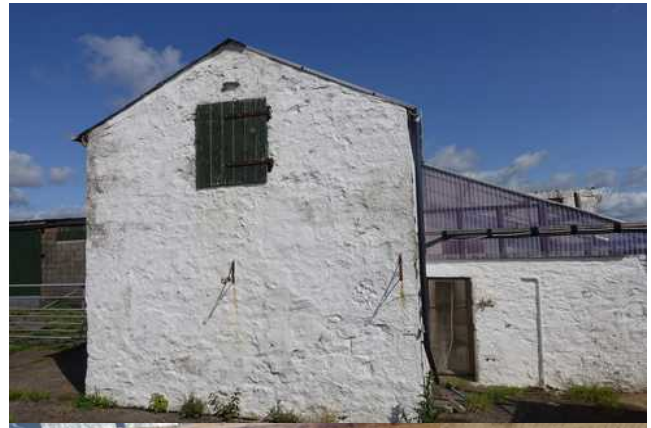
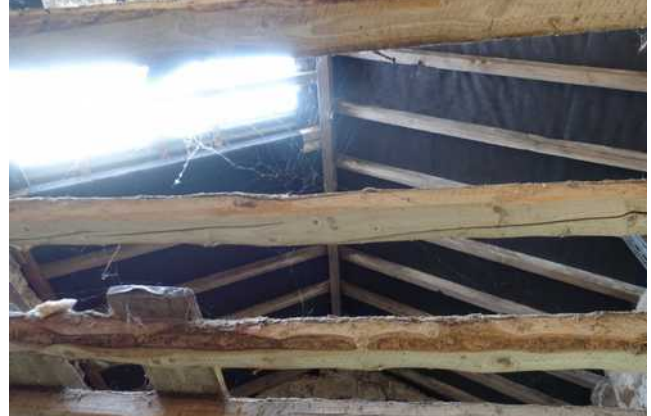
## Building 5

Building 5 consists of a stone built detached barn with an conservatory present on the southern facade. Roofing is a mix of slate and corrugated metal and fibreboard. External walls are rendered, painted and well sealed with no missing pointing, gaps or crevices present.

No evidence, such as droppings, feeding remains, urine splashing or grease marking was observed to suggest the presence of roosting bats despite interior spaces and multiple horizontal surfaces being undisturbed.

The building was assessed as offering negligible potential.
