# **Preliminary Bat Roost Assessment Report**

**Old Mill Cottage,  
Long Buildings,  
Sawley,  
BB7 4LE**

**30.05.2024**

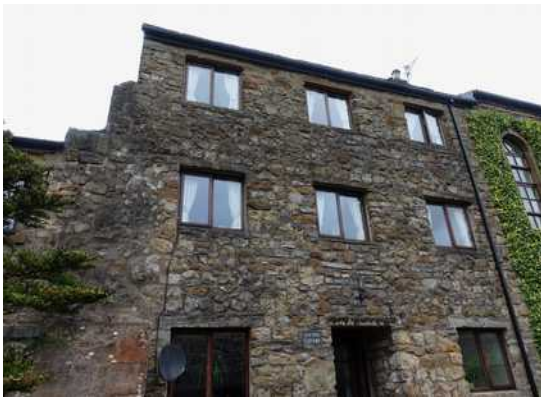
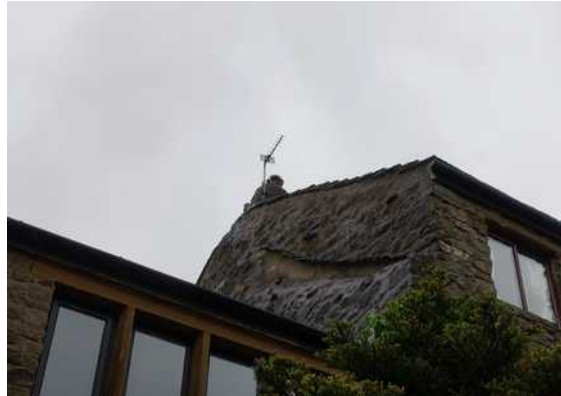
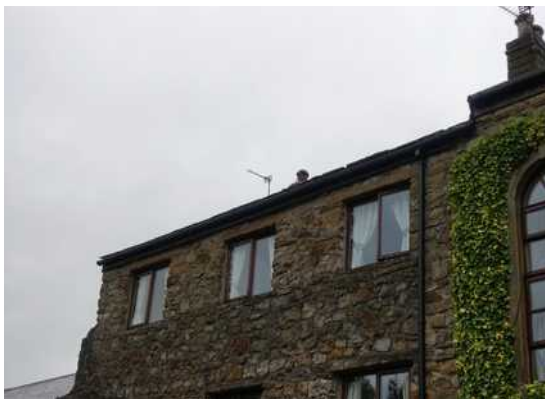
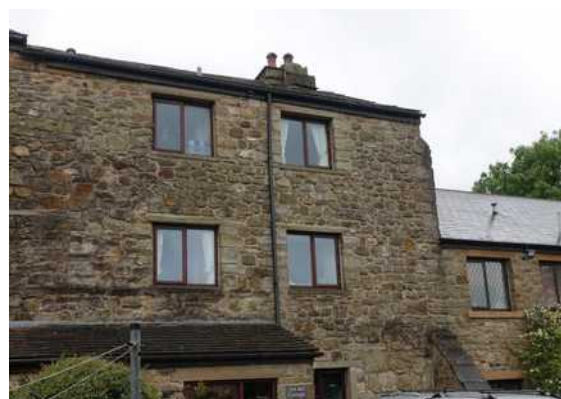
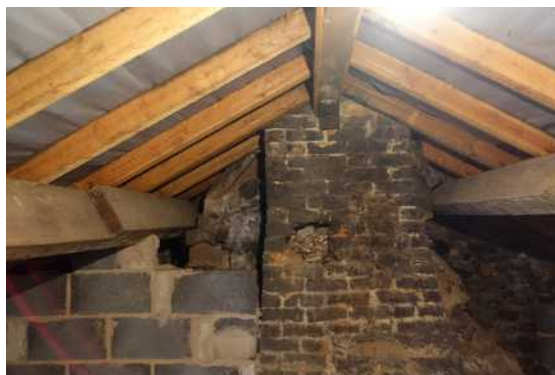
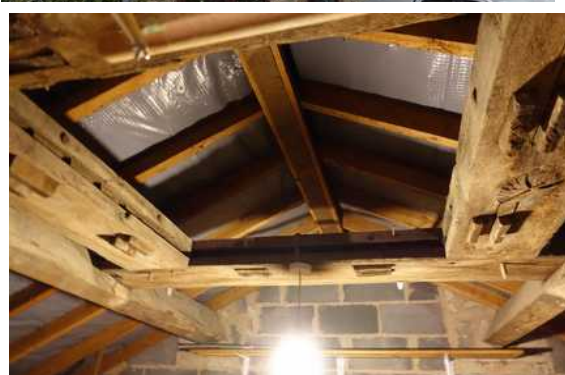
The property consists of three storey stone built midterraced cottage with a double pitched slate roof.

External walls are well sealed with no cracks, crevices or cavities present. The gable end is well sealed.

The roof is in good general condition with no obvious slipped, missing or lifted slates present. Roof slates are lined with a plastic roofing membrane.

Overall the property can be considered to offer negligible roosting potential.
