# **Preliminary Bat Roost Assessment & breeding birds survey**

## **Site: Moorcot, Nickey lane, Mellor**

30<sup>th</sup> April 2024

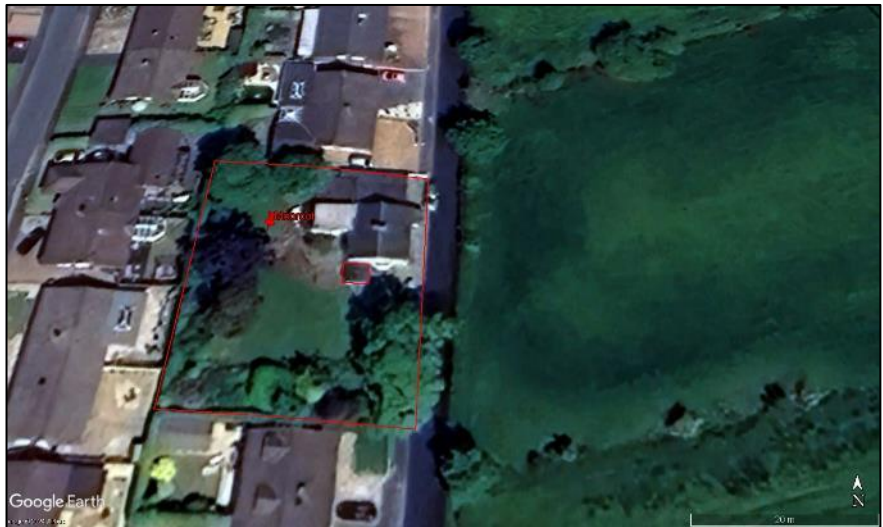
Photo 1: Overview of the site with the structure to be demolished outlined.

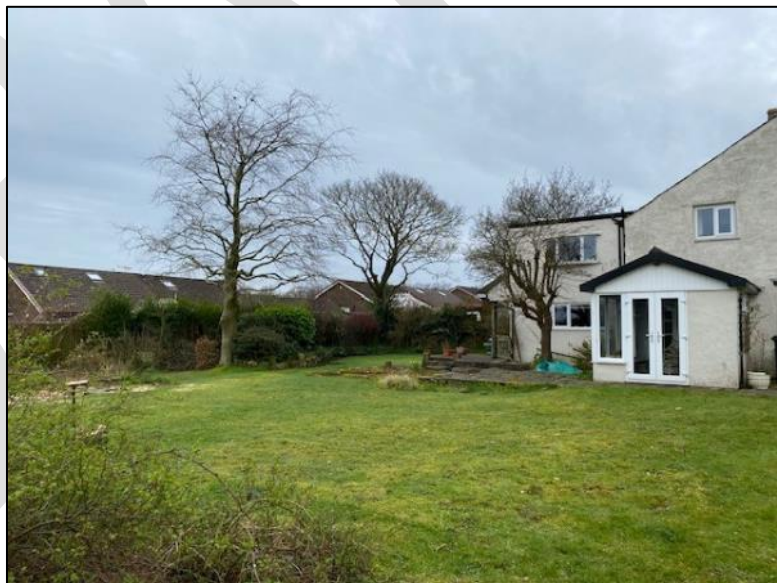
Single storey extension:  
All roofline materials, windows and doors were uPVC and in an excellent state of repair, with no gaps to the wall or cracks that could be used by bats for roosting.

Photo 2: South elevations of the house, showing the single storey extension to be demolished.

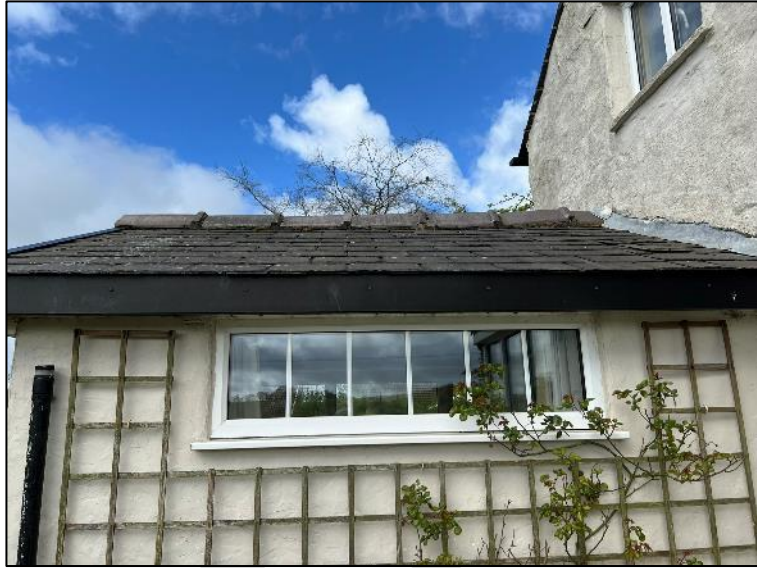
Roofing materials were all in an excellent state of repair, with no lifted or cracked tiles forming potential gaps for crevice dwelling bats.

Photo 3: east elevation of the "summer house" extension, showing roof tiles and ridge in good order.

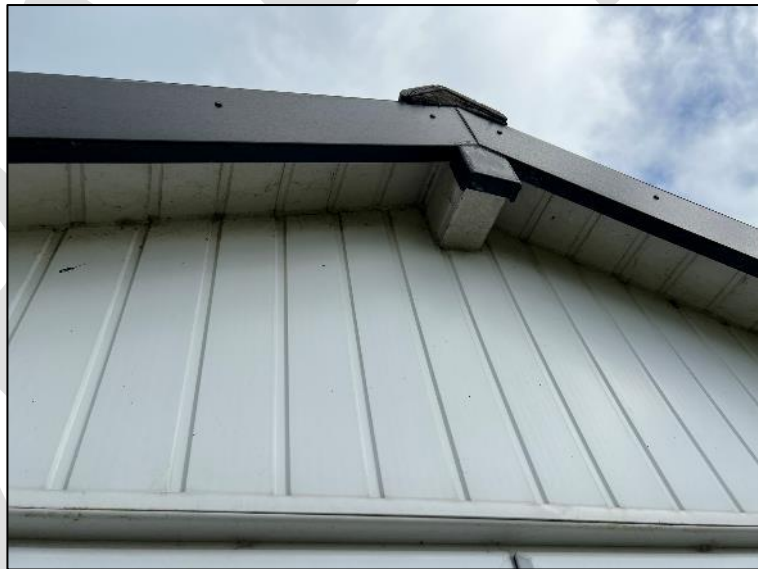
There was some uPVC cladding to the south elevation, all close fitting and in a good state of repair.

Overall, there were no gaps or crevices that could be used by bats for roosting in this extension of the building.

No potential bat roosting features (PRF's).

Photo 4: South elevation showing close-up of uPVC cladding and roofline, all in a good state of repair.

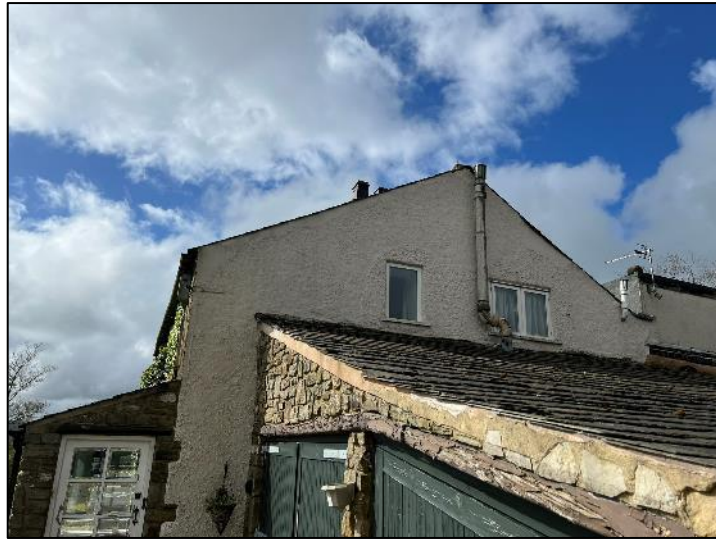
The main dwelling building will require further survey work should this require any roofing or repairs to the window frames etc, as these areas do provide potential roosting features for bats. In addition, the ivy cladding to the west elevation is high quality habitat for nesting birds, and three species were seen showing nesting behaviour at the time of the survey.

Photo 5: Main dwelling showing traditional stone slates and timber facias with potential for bat roosting.

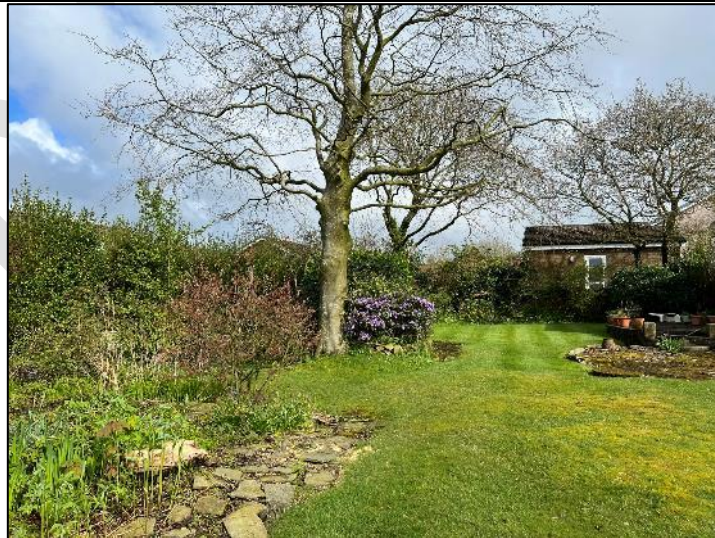
The garden provides some good quality nesting habitat for birds in the surrounding hedges and shrubs, and mature trees on-site. Some large trees appeared to have been recently felled.

Photo 6: Hedgerow and shrubs providing good bird nesting habitat in the garden of Moorcot.

| <b>Recommendations</b> | Any building/tree and scrub removal should be undertaken outside the period 1st March to 31st August. If this timeframe cannot be avoided, a close inspection of the building and scrub to be removed should be undertaken by a suitably qualified ecologist, immediately prior to clearance. All active nests will need to be retained until the young have fledged. Clearing the Site outside this timeframe avoids delays and further costs. |
| <b>Enhancements</b><br><br><i>The Local Planning Authority has a duty to ask for enhancements under the NPPF and circular 06/2005: Biodiversity and Geological Conservation. Para.99</i> | Install a minimum of 2 bird boxes on site, on an existing tree or building e.g. <ul style="list-style-type: none"> <li>• Good quality timber nesting box with hole protection</li> <li>• Schwegler 1B nest box</li> <li>• Schwegler 2H Robin box</li> </ul> Regular nest boxes should be positioned approximately 3m above ground level where they will be sheltered from prevailing wind, rain and strong sunlight.<br>House martin/swallow/swift boxes should be placed under the eaves with clear entrance/exit paths, ideally on the west elevation. |
