Preliminary Bat Roost Assessment & breeding birds survey

Site: Fairview, Back Lane, Wiswell, BB7 9BU

30th April 2024

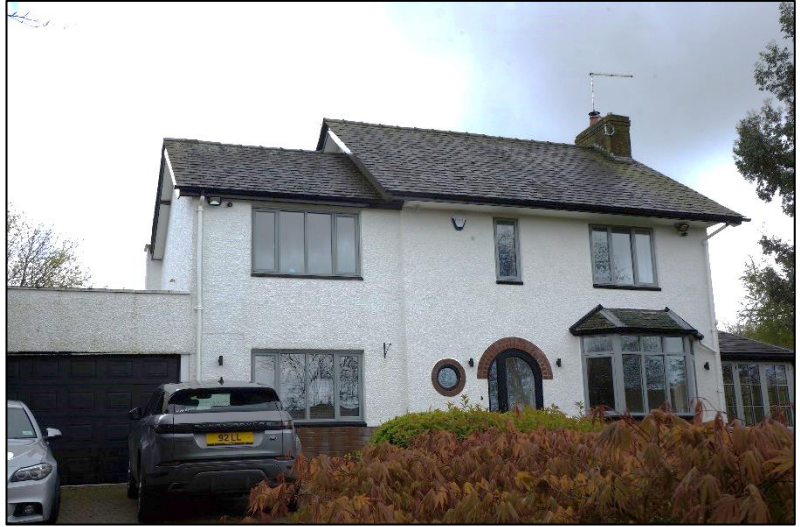
Photo 1: West elevation of the house at Fairview, Wiswell.

The roof slates were all in a good state of repair with no gaps or slipped slates allowing bats to roost. All roofline materials, windows and doors were uPVC and in an excellent state of repair, with no gaps to the wall or cracks that could be used by bats for roosting.

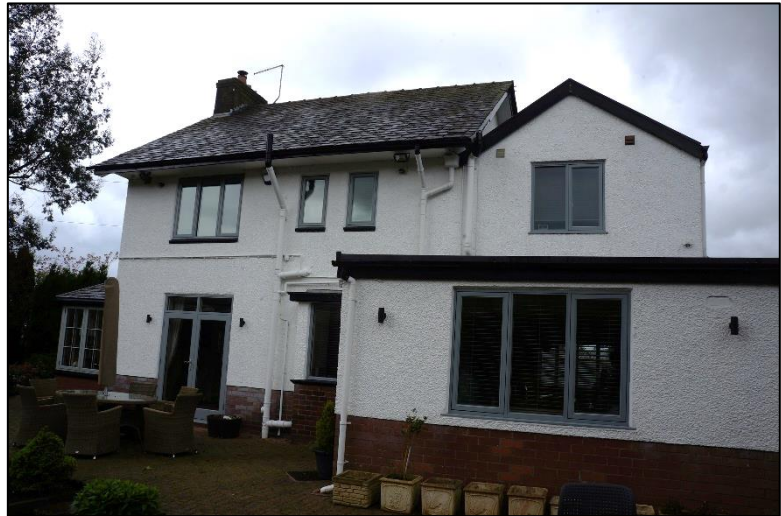
A flat roofed garage extension to the north elevation, again with no gaps or cracks visible.

Photo 2: East elevations of the house, showing the single storey flat roofed garage extension.

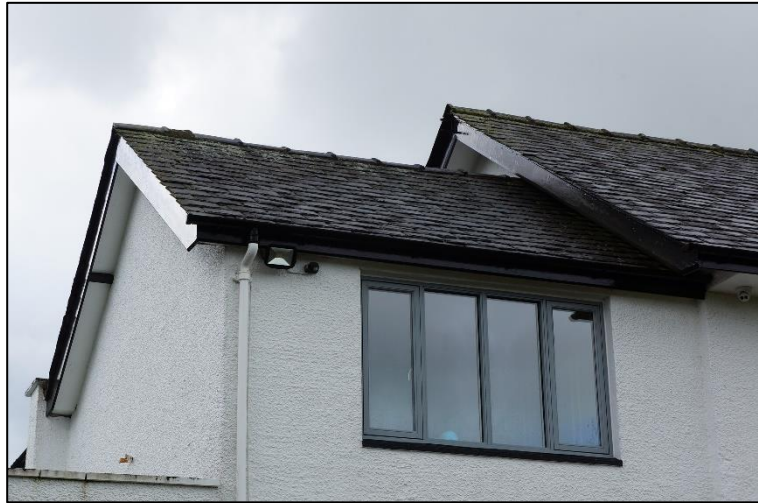
Roofing materials were all in an excellent state of repair, with no lifted or cracked tiles forming potential gaps for crevice dwelling bats.

Photo 3: east elevation, showing roof tiles and ridge in good order.

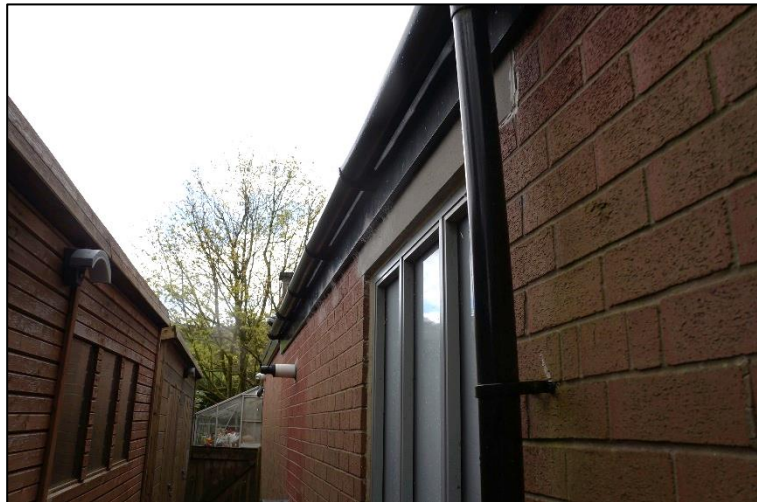
The barge board to the north elevation of the single storey garage was close fitting, with cobwebs along the majority of the length.

Overall, there were no gaps or crevices that could be used by bats for roosting in this extension of the building.

Photo 4: north elevation showing close-up of gutter and back board, all in a good state of repair.

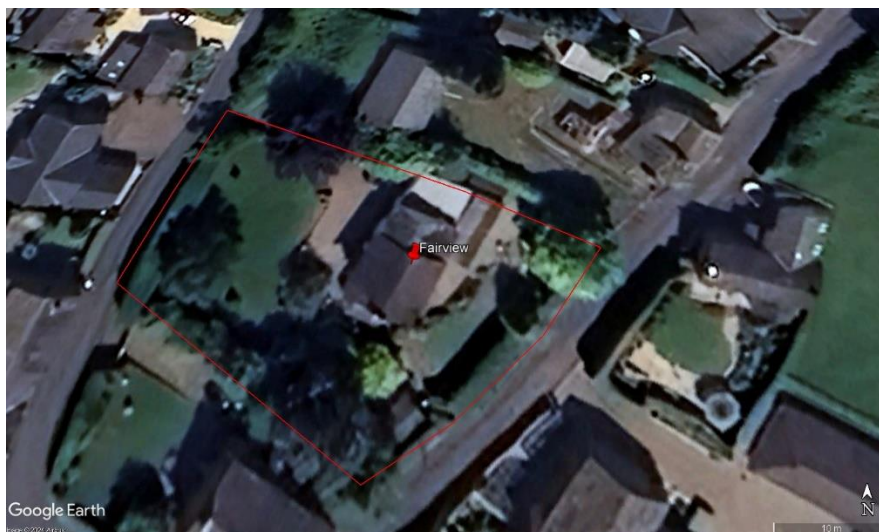
Appendix 1: Survey Plan

There is one survey building on the site which is illustrated in the map in Appendix 1. The environmental variables recorded at the time of the survey are shown in Table 2.
